# CHARACTERIZATION OF MATERIALS USED IN THE QUART TOWERS (VALENCIA, SPAIN) PRIOR TO RESTORATION

Quart Towers are one of the remaining gates in the medieval wall of the city of Valencia (Spain). They were built in the 15th century and have recently been cleaned and consolidated. Prior to this work, a multidisciplinary team conducted a physicochemical study to diagnose the state and composition of different materials. Stone, mortar, patinas, salts etc., have been analyzed as well as their state of deterioration. Remains of previous interventions have been found in mortars of restitution and application of consolidants that have caused damaging salts. The methodology used is optical microscopy, X-ray diffraction and scanning electron microscopy with X-ray microanalysis. The results have been used together with documentary data to identify the components of the materials in order to, if possible, compatibility the material in the damaged areas and to determine the most appropriate techniques and procedures for applying cleaning systems, enabling consolidation and protection of the building without altering the unique characteristics of the original building typology.

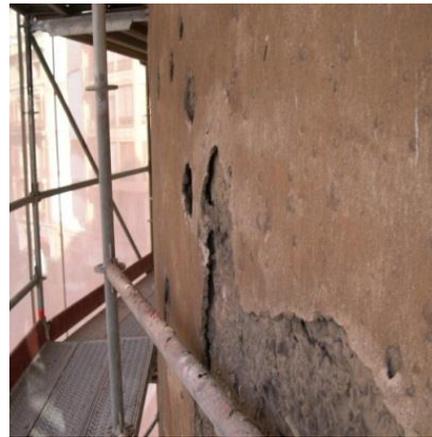
Alteration of the materials was evaluated (Fig. 5, 6, 7, 8) and found to be attributable to different causes:

Figure 6 Fragments of rendering on the north tower with loss of adherence.

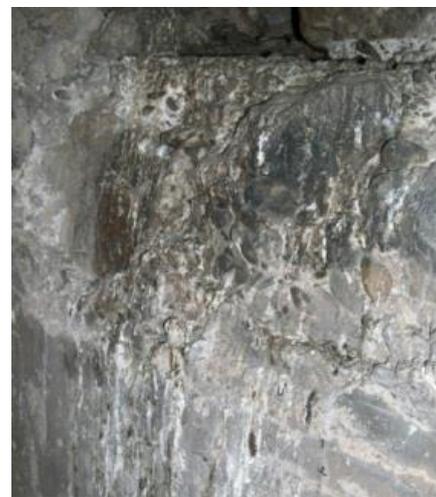
c) *biological*: biodeterioration due to bird droppings, plant growth, lichen development, etc. The continuous cladding on the exterior layer of the towers has been characterised (Fig. 9) and the restitution layer applied to some areas in a previous intervention.

Figure 7 Attack from bird droppings.

The in situ study of the construction materials, their state and the modifications they have undergone and the analytical results permit certain recommendations on the appropriate cleaning, consolidation and protection treatments. Limestone in general has acceptable compactness and therefore plaster crust neof ormation can be eliminated without damaging the stone by a controlled solid microprojection system that will respect the natural and artificial patinas present on the stone. This waterless system also enables the removal of biodeterioration process symptoms (bird droppings, moss, lichens, etc..) and saline deposits.

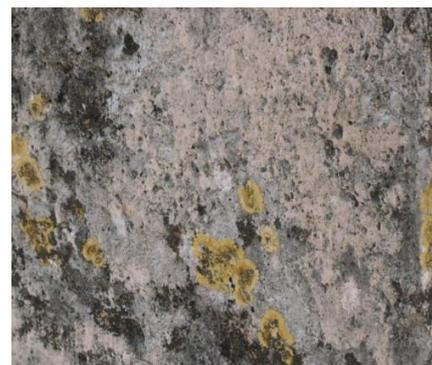
Figure 8 Growth of lichens and moss.

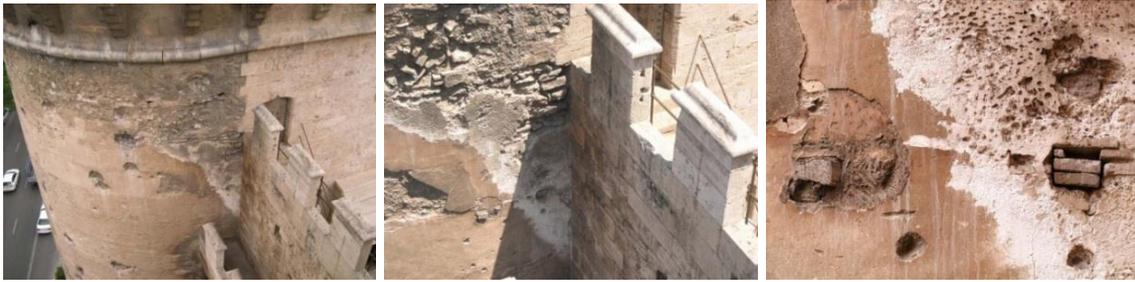
Figure 9 Details of an area of the North tower.

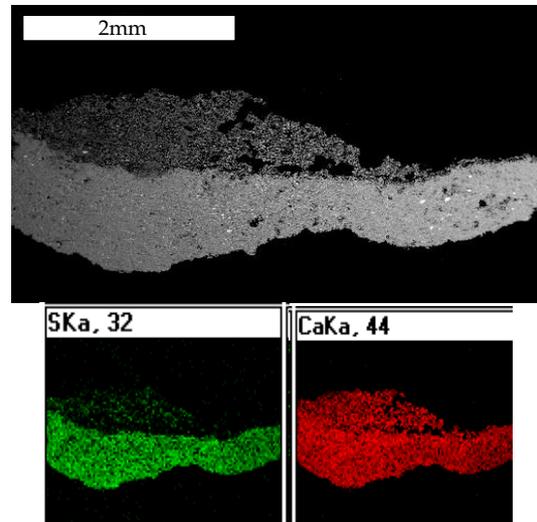
In the deposit of dirt on different materials, (stone, mortars, etc) plaster neo-formation deposits have been observed. The black colouration is due to the presence of carbonaceous products of pollution like soot, dust among others. The results are presented for the masonry work on the battlemented passage in microphotographs at different magnifications and mapping of the distribution of elements in the sample (Fig. 17 and Fig. 18.).

Figure 17 Microphotograph at 25X and mapping of S and Ca.

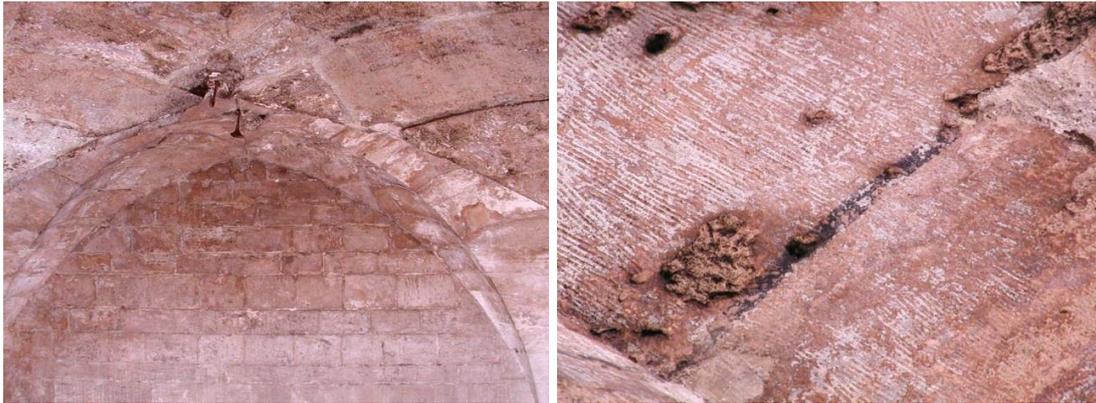
Figure 19 Detail of the vault in the central block.

Observation of the vault exterior in the interior space of the central block shows the dark polychromy of the false ceiling. (Fig. 19) and X-ray microanalysis indicates that a pigment called mineral black was used, whose composition is based on iron and manganese oxides.

Figure 19 shows a potassium compound created by the application of a consolidant in a previous intervention. The analytical results suggest that the product used was potassium silicate. That consolidant is usually applied by dissolution in acidulated water, generally with hydrochloric acid and this has given rise to the precipitation of a transparent vitreous silica gel (Fig. 20)

tral block remains of the application of a previous consolidant have been found. The product used is currently not recommended because it has been shown to generate new salts and form harmful films.

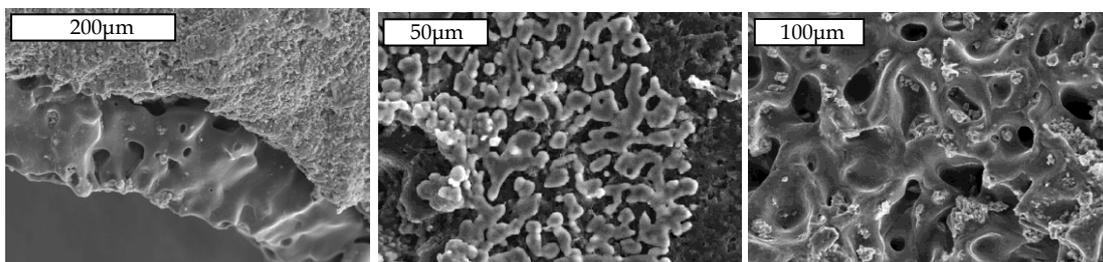
Figure 20 Exterior layer with potassium. The images shows the precipitated silica gel

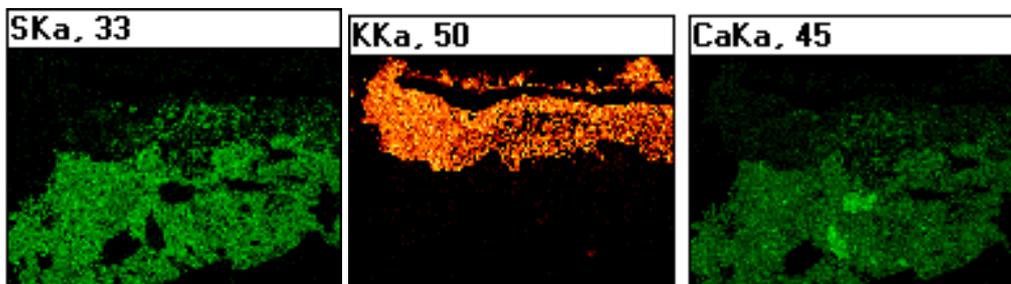
Figure 21 Transversal section. Mapping of S, K and Ca of the silica gel.

together with other reaction products such as KOH. The mapping of the transversal section shown enables evaluation of the distribution of the elements (Fig. 21) with plaster mortar beneath the aforementioned consolidant. In some areas the KOH compound has reacted with  $\text{SO}_3$  giving rise to potassium sulphates which are damaging salts for the stone (Fig. 22).

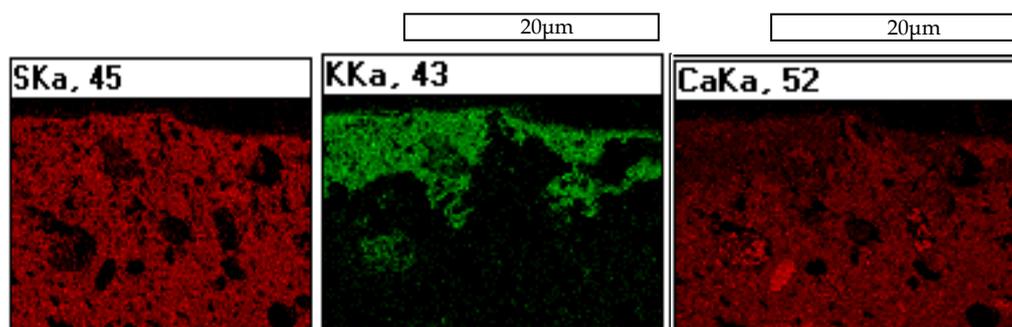
Figure 22 Transversal section. Mapping of S, K and Ca.
