# CONSERVATION PLAN FOR ABILA ARCHAEOLOGICAL SITE – NORTHERN JORDAN

**Al-Naddaf M. and Al-Sa'ad Z.**

Faculty of Archaeology and Anthropology  
Yarmouk University, Irbid-Jordan

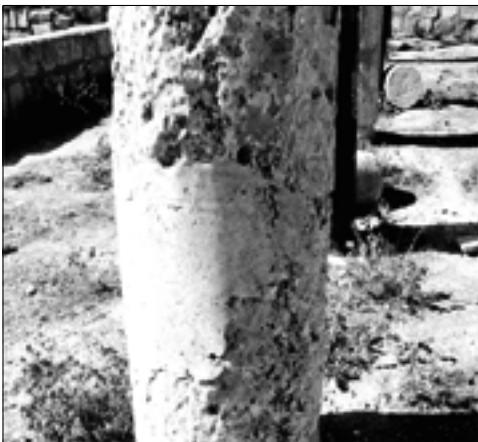
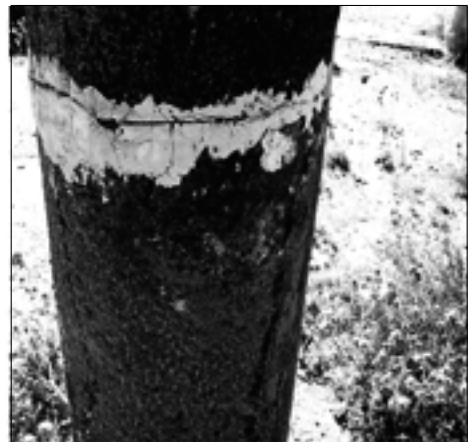
Portland cement, which have been used in the conservation works of Umm El Amad basilica and some other structures at Abila (fig. 3), is a very important source of salt which really began to destroy the original stone and columns of the site. ( A. Charola, and Herodotus, 2000)

Figure 3: The use of Portland cement to restore limestone and basalt columns at Abila.

The uses of Portland cement are obvious in the previous conservation work of the site, in the columns and in the exterior wall of the site (fig. 3). There are many facts related to the use of cement such as: Portland cement is a magnificent material for modern structures, but it is not designed for use in mortars or plaster on historic buildings because of its defects and side effects on traditional materials, it is an irreversible material, which will damage all historical materials if one tries to remove it.

Portland Cement is stronger than most types of building materials at Abila archaeological site, excluding basalt. Therefore, such cement should not be used on limestone, taking into consideration that conservation materials should be slightly weaker than the object to which it is applied (Horie, 1987). Portland Cement has low porosity that prevents evaporation of water in the pore of building stones which will increase dampness in the internal structure, consequently, its damage will be accelerated. Moreover, Portland Cement is considered to be a potential source for salts, which can be dissolved and transported in the pore of the building stones and activate the whole damage of the buildings.

such as Portland cement and iron bars used for the conservation of the monuments at the site should be removed and replaced by other materials which do not negatively affect the building materials. Therefore, ancient mortar should be thoroughly examined, reconstructed and tested to use it as an alternative for the Portland cement. While the iron bars should be replaced by stainless steel ones.

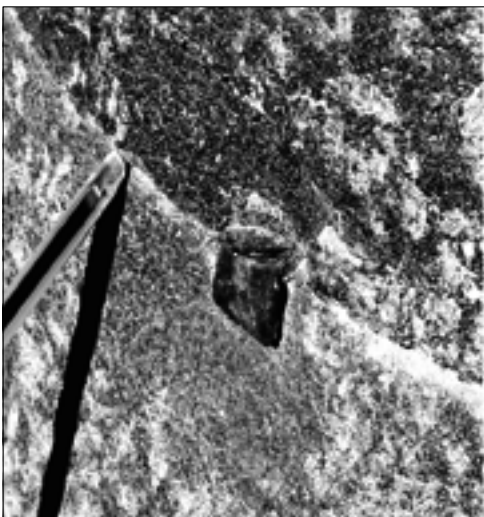
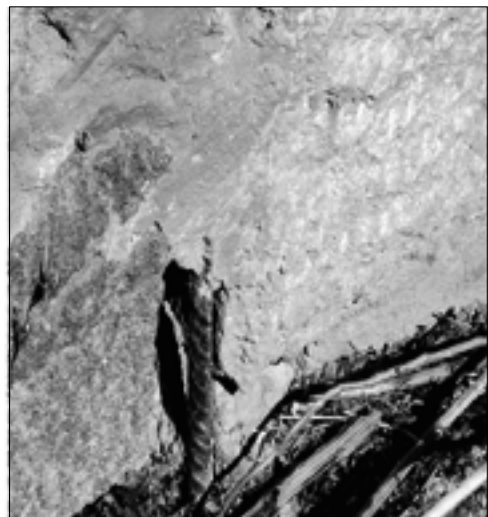
Due to adoption of wrong conservation measures, iron bars were used within the exterior walls of the church and between the drums of the columns (fig. 4). Where the routines of building inspections and maintenance have been neglected, these pieces can be easily exposed to all sorts of defects, and by time action it will destroy the stone itself.

Figure 4: The use of iron pieces for the restoration of the site.
