THE ARCHITECTURAL FEATURES OF THE DIYARBAKIR CITY WALLS: A REPORT ON CURRENT STATUS AND ISSUES OF CONSERVATION

Neslihan Dalkılıç and Adnan Nabikoğlu

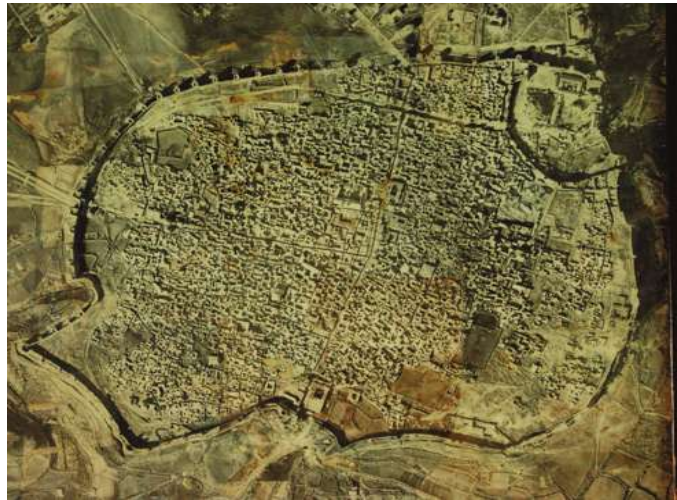
Figure 1. Air photo of inner part of Diyarbakir City Walls (At the beginning of the 1930s)

Diyarbakir Castle is composed of two sections, the Inner Castle (İçkale) and the Outer Castle (Dış Kale) (Figures 1, 2). It is supposed that the Inner Castle, which contains the northeast of the city and is approximately 70 m high from the Dicle River bed (Toprak, 2012), constituted the core of the city and the primary settlement area. It is not definitively known when the Inner Castle was constructed. Within the Inner Castle is another area surrounded by city walls that is known as Virantepe. According to Gabriel (1940, 90), the tumulus that is located here marks the initial settlement area of Diyarbakir. It is known that the Hurris lived in the area and that the city was surrounded by walls in 2000 B.C. The old walls were repaired in 900 B.C. when the city was the capital of the Bit Zamani tribe (Beysanoglu, 1991, 63).

The southeastern and eastern parts of the city walls, which extend from Mardin Gate to Yeni Gate (bastions 50-67) and to bastion 75, are situated on rocky ground that is difficult to reach. This area is also surrounded by the Dicle River, which functions as a natural protector. Because the enemy is not expected to come from the direction of the hillside and because there is no place to position heavy artillery and catapults, the bastions are spaced sporadically. In the positioning of the bastions, it was probably noted that shooting cannonballs at a very low range would not cause sufficient damage to the target (Ahunbay, 2012). The measurements taken indicate the varying distances between the bastions; however, in some areas, the distance between two bastions (282 m between 66-67, 85 m between 70-71 and 127 m between 71-72) increases dramatically. In these areas, the number of retaining walls and buttresses between the bastions is greater, and in some sections, the number of retaining walls is as high as four (between 69-70) or five (between 66-67, 70-71) (Figure 1, 2).

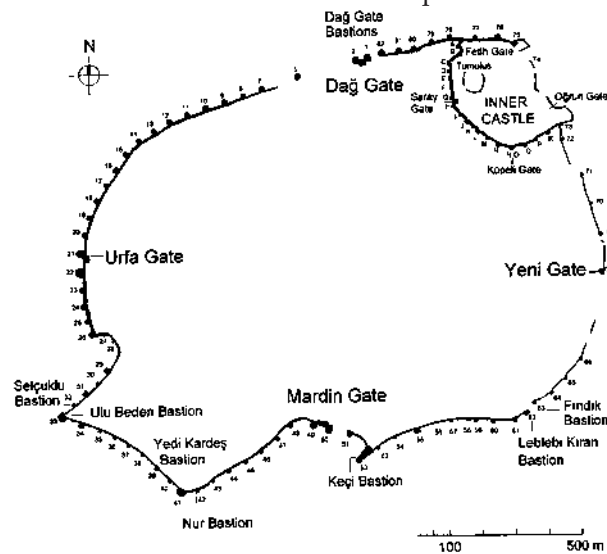
Figure 2. Map of Diyarbakir City Walls and bastion numbers.

between bastions 66-67 is another area that was opened (Figure 2).

Inner Castle is included is approximately 5800 m. As of today, approximately 631 m of the walls have been destroyed or demolished for various reasons (Figure 2).

The walls have four main ports. The walls open to the north with the Dag Gate (the Harput Gate), to the west with the Urfa Gate (the Rum or Halep Gate), to the south with the Mardin Gate (the Tell Gate), and to the east with the Yeni Gate (the Su, Satt or Dicle Gate). These ports have played an important role in controlling entrances into and exits from Diyarbakir. The two main roads that connect the four main ports and intersect at the centre are still in existence today. These roads are 1120 m in length from the north to the south (the road located between Dag Gate and Mardin Gate) and 1610 m in length from the east to the west (the road located between Urfa Gate and Yeni Gate) (Figure 2, 4).

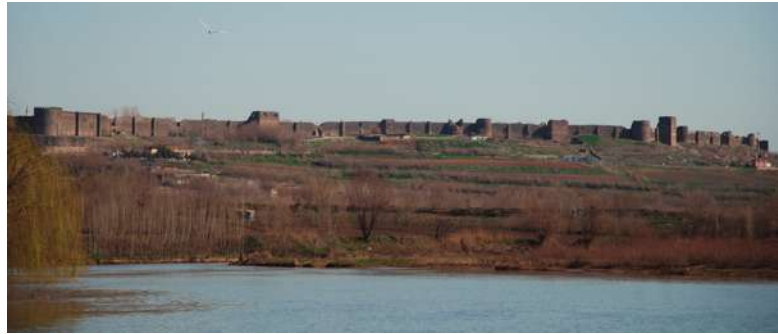
Figure 3. A view of southeast part of Diyarbakir City Walls

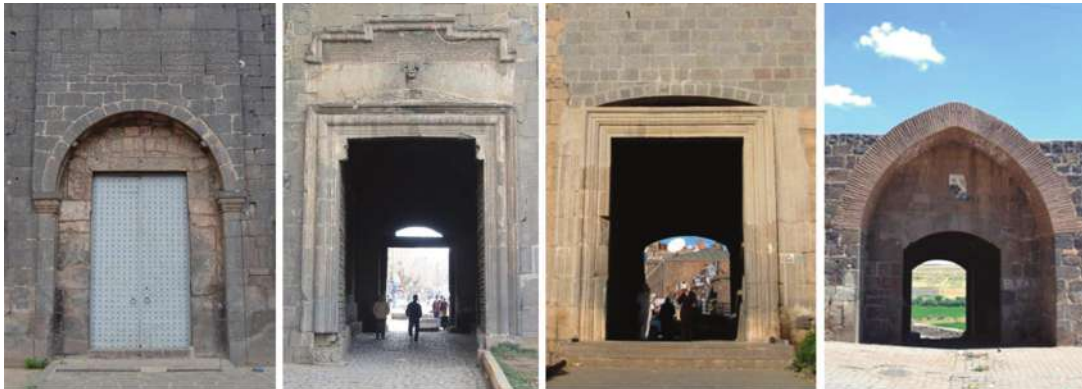
Figure 4. The main ports of Diyarbakir Exterior City Walls

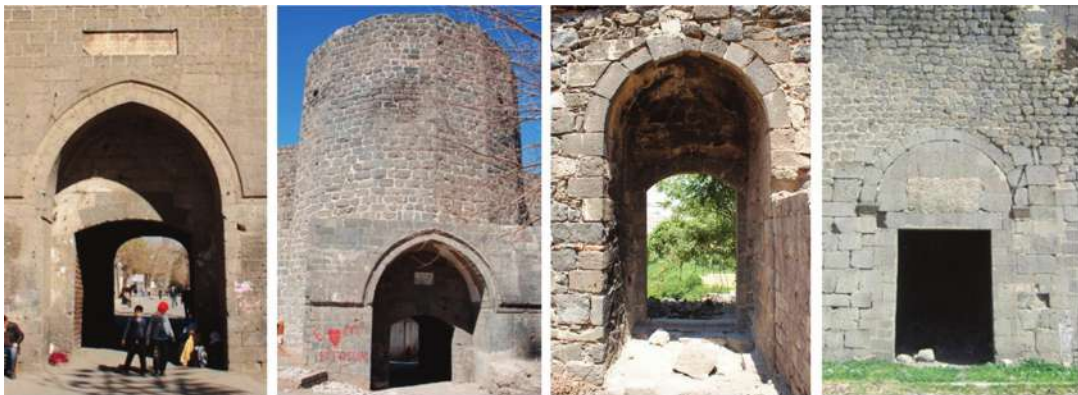
Figure 5. The main ports of Diyarbakir Inner City Walls

The Inner Castle, which is located in the northeastern corner of the area surrounded by the walls, opens to the walled city through the Saray Gate and the Kupeli Gate and to the outside through the Ogrun Gate and the Fetih Gate (Figure 2, 5). In addition, 17 secret ports were identified by Albert Gabriel in the 1930s, most of which are still in existence today. In subsequent years, the Cift Gate and the Tek Gate were constructed for the passage of automobiles, and four smaller ports were constructed for pedestrians.

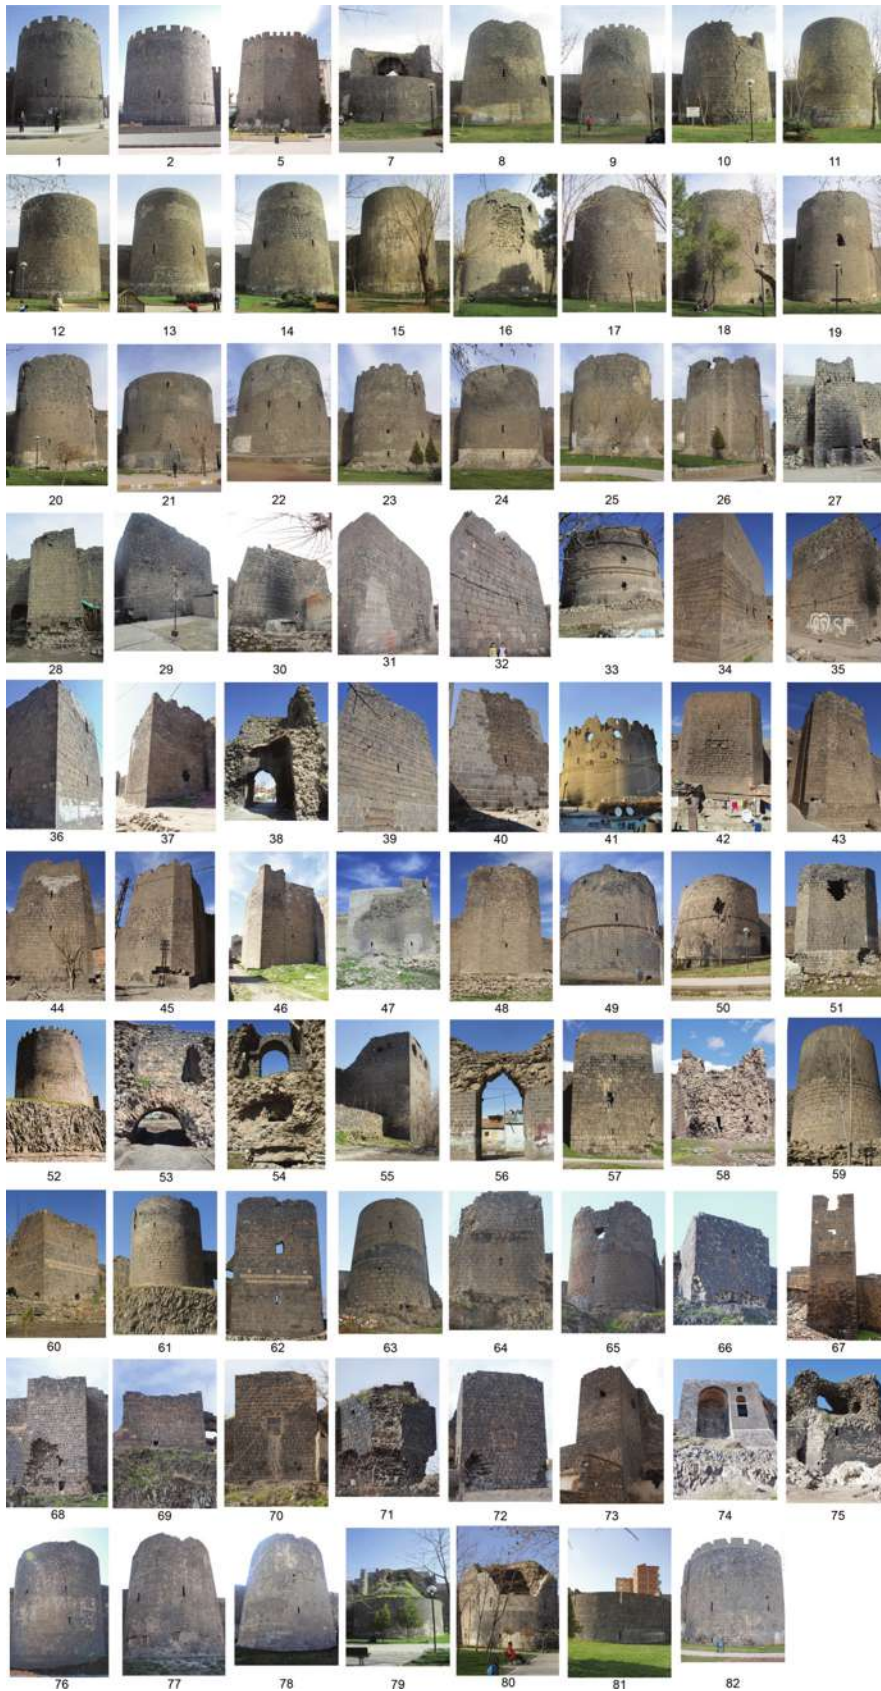
Figure 6. View of the exterior surface of the bastions.

The city walls were repaired in different periods, and new bastions were added. Of these Bastions, the Dag Gate Bastions (bastions 1-2), the Yedi Kardes Bastion (bastion 41), the Ulu Beden Bastion (bastion 33), the Keci Bastion (bastion 52), the Nur Bastion (bastion 42), the Selcuklu Bastion (bastion 32), the Leblebi Kiran Bastion (bastion 62), the Findik Bastion (bastion 63) and bastion 55 are the most magnificent due to their inscriptions, their form and their magnitude (Figure 6).

Bastions 1-26 and 75-82 were circular and were positioned high at frequent intervals because they were situated in a flat area that was difficult to defend. Of these bastions, only bastion 5 is a polygon. The distance between these bastions is 40-45 m. There are one or two retaining walls between the bastions in this area. There are square bastions in the south and the east, around the Yeni Gate, which faces the Dicle Valley. Bastions 27-60 are often square. In particular, bastions 43-46 and bastion 51 are square, and their corners are chamfered. However, the Mardin Gate bastions (49, 50), bastions 58-59 and the Ulu Beden (33), Yedi Kardes (41) and Keci (52) Bastions are circular (Figure 6).

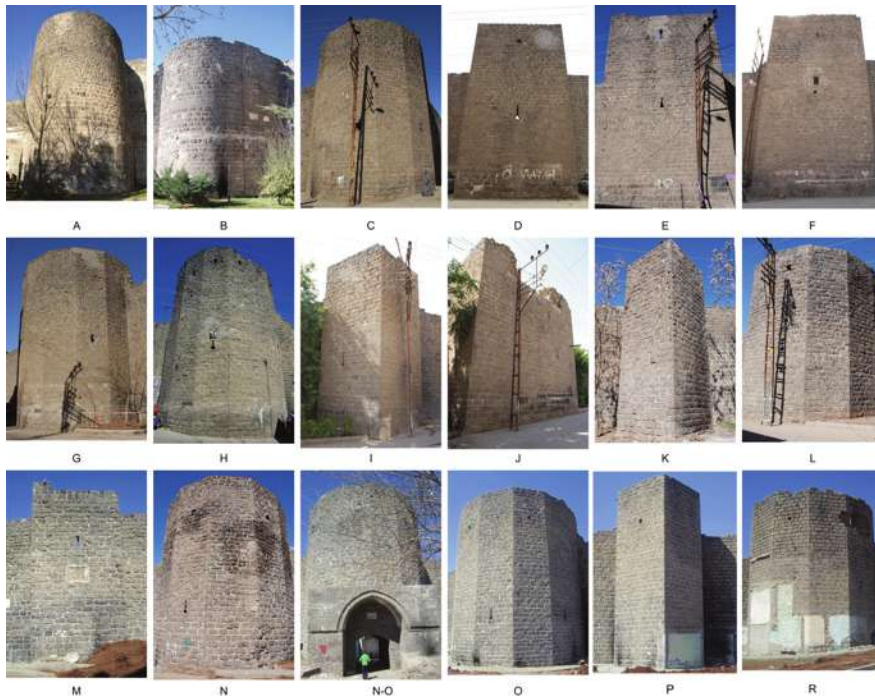
Figure 7. View of the exterior surface of the bastions.

The bastions surrounding the Inner Castle are circular, triangular, square and polygonal (hexagonal and octagonal). Bastions A and B are round; bastions I, K and P are triangular; bastions D, E, F, J and M are square; and bastions C, G, H, L, N, O, R and N-O are polygonal (Figure 7).

The walls and bastions of the Inner Castle are in better condition than the exterior city walls because they were constructed at a later date (in the 16th century) (Figure 7).

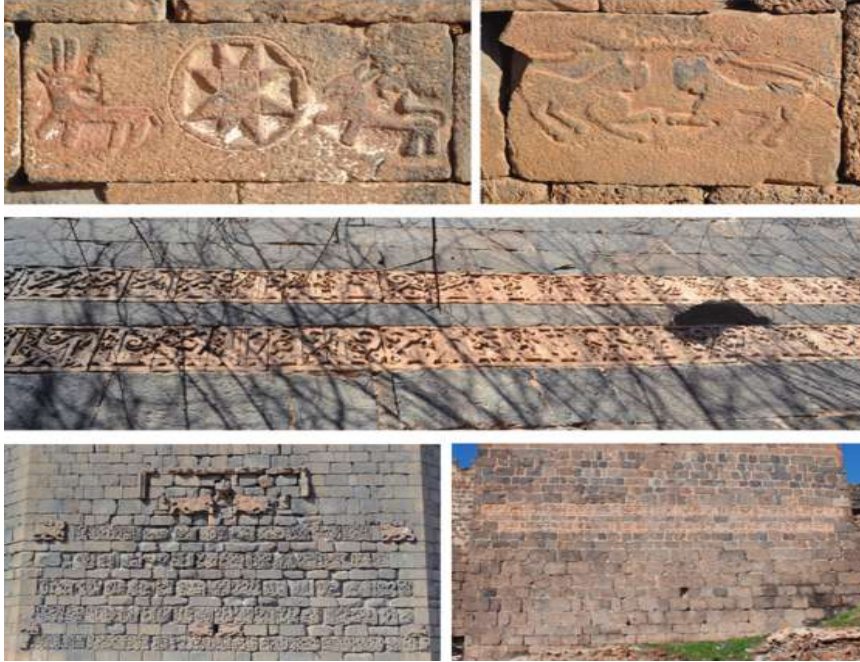
Figure 9. Inscriptions, motifs and symbols on the Diyarbakir city walls.

large-scale repairs were made, the ruler responsible for the repairs and the repair date were indicated in the inscriptions (Parla, 2012). All of the symbols on the walls present information regarding the period in which the construction project occurred (Akargul, 1980, 172). There are numerous inscriptions, motifs and symbols associated with various stonemasons, especially near the Mardin Gate and the Dag Gate. In addition, the sun and stars; reliefs of lions, bulls, goats, tow-headed eagles, scorpions and horses; and weapons, fruit and grains are all imprinted on the walls and the bastions. Remarkably, there is even a relief of a "naked woman", the likes of which is rarely observed in Islamic art, on bastion 42 (Figure 9).
