DETECTION AND QUANTIFICATION OF MATERIAL DISPLACEMENTS AT HISTORICAL STRUCTURES USING PHOTOGRAMMETRY AND LASER SCANNING TECHNIQUES

Yahya Alshawabkeh and Mohammed El-Khalili

Queen Rania Institute of Tourism and Heritage, Hashemite University, Zarqa, Jordan

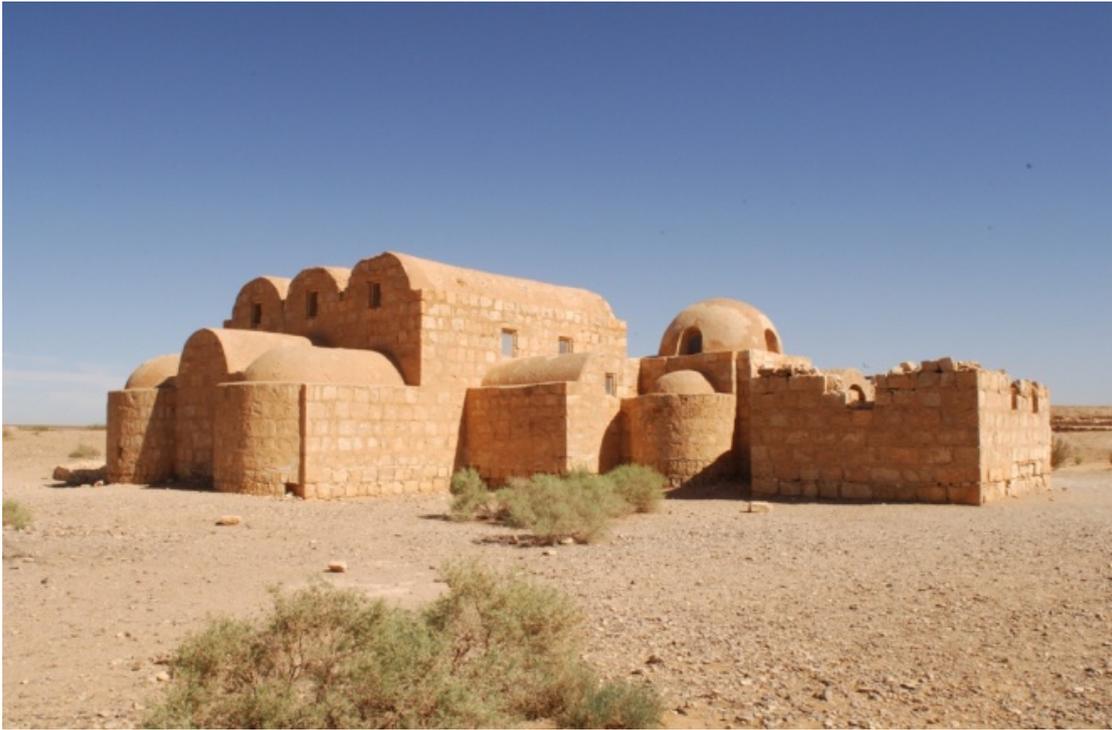
Built in the early 8th century, Amra palace, depicted in figure 1, is the well-preserved and known desert, a UNESCO World Heritage site. The Umayyad caliph Walid built the palace as a vacation residence or rest stop (Bianchin et al., 2007).

Figure 1. Amra palace, a UNESCO World Heritage site.

The vibration can induce stresses inside the material. The effect is clearly visible through the serious cracks in the walls, as can be depicted in figure 1.

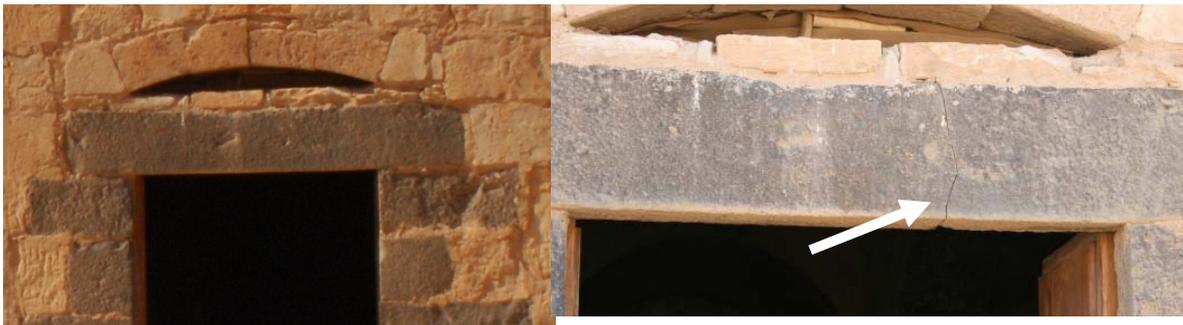
Figure 2 shows the progress of the cracks in two images of the main door of the palace taken in different epochs (six months time). Thus, a comprehensive study is needed to assess the current threats and the conservation needs of the palaces to ensure its sustainability. This raises the need to have a permanent monitoring of the palace.

Figure 2. Images for the main entrance door of Amra palace taken in different epochs the white arrow in right photo shows a serious crack was created in the upper part of the door.

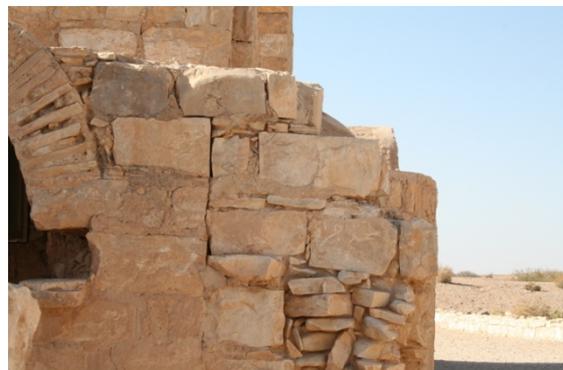
3D laser scanning system GS100, manufactured by Mensi S.A., France was applied. Different high-resolution images have been collected for the damage areas using portable calibrated camera, Canon 400D, which provides a resolution of 3888x2592 pixels with a focal length of 20 mm, depicted in figure 3.

Figure 3. High resolution images for the studied wall taken using calibrated camera, Canon 400D (3888x2592) pixels.

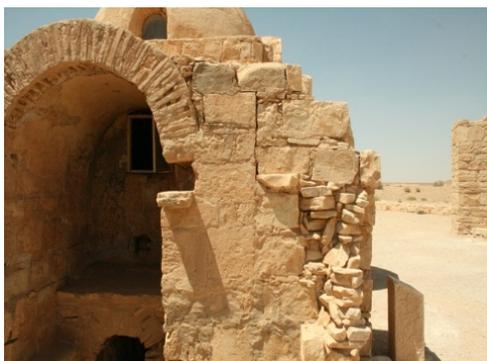
Figure 7. Registration of 2D image with corresponding 3D model using interior and exterior parameters of the image shown in the left.

Figure 7 shows the 3D model of Amra palace wall textured with the corresponding image. Texture mapping is generated using an algorithm proposed by the author using C++.

coordinates between image and laser scanner were then measured using the Photomodeler software, which was also applied to calculate the camera position and orientation in the coordinate system of the geometric model.

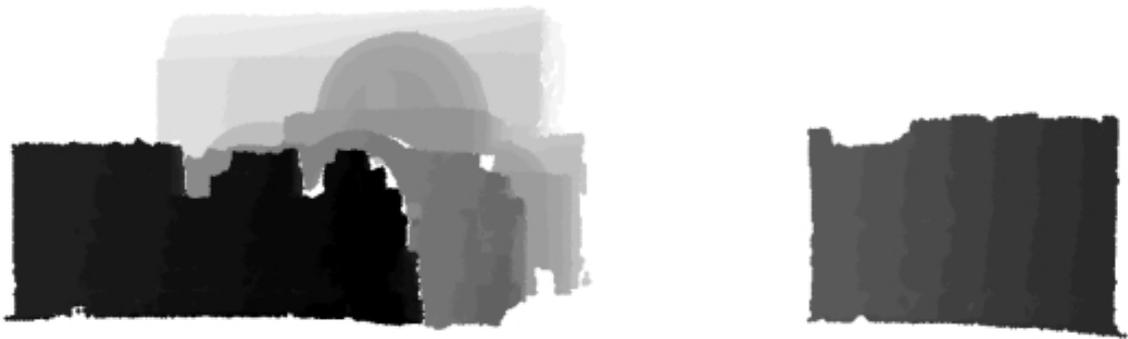
Figure 9. Generating depth map of the wall surface with the same size of the required orthophoto

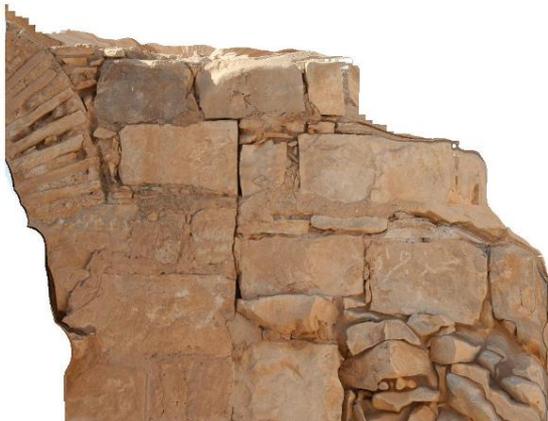
Figure 10. True orthophoto for the image with pixel size 2 mm at object space.

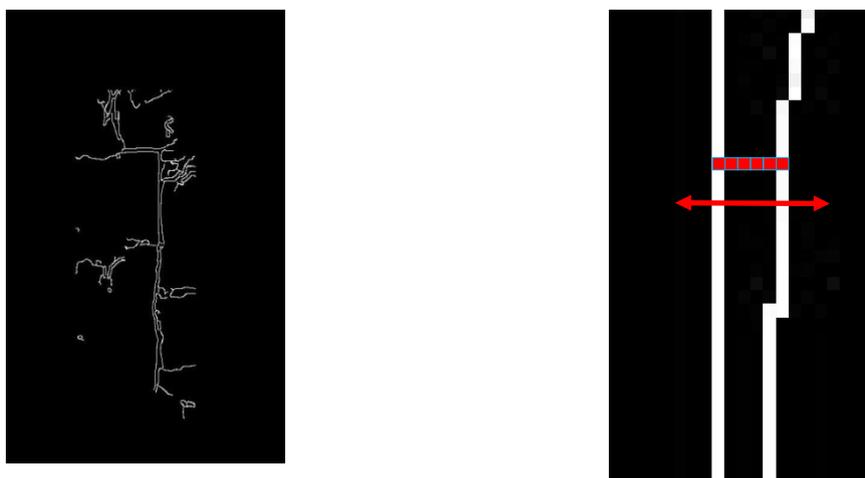
Figure 12. The binary edge map for the concern region using high threshold values, and measurement of the crack width
