IN SITU MOSAIC CONSERVATION: A CASE STUDY FROM KHIRBET YAJUZ, JORDAN

Mahmoud Arinat

Faculty of Archaeology and Tourism, The University of Jordan, Amman, Jordan

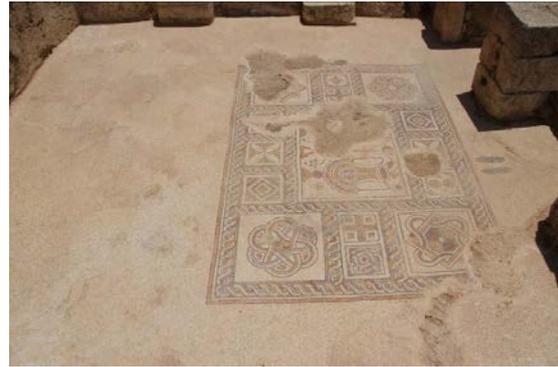
Figure 2 General View of the Byzantine Bath

The Byzantine Bath was discovered during the excavation work carried out in 1998 in the south-eastern area of the site (Fig. 2) (Suleiman, 1999).

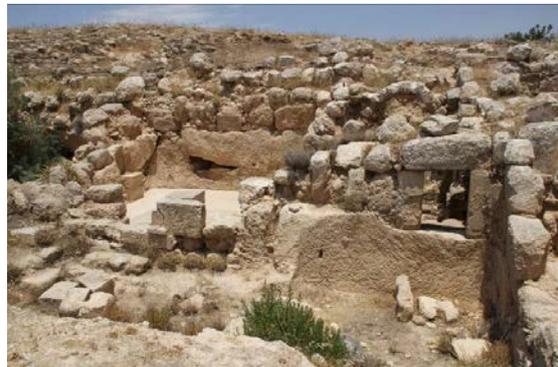
Figure 3 General View of the Mosaic Floor

The mosaic floor located at the middle room of the bath and is not particularly large, measuring approximately 4m.W x 5m.L. The room paved with mosaic floor of plain white tesserae. The southern side of the room and in front of the entrance is decorated with a rectangular polychrome mosaic.

The polychrome mosaic subdivided into squares and rectangular panels and surrounded by a braided guilloche. The panels contain a variety of geometric patterns. The middle of the mosaic has two amphora on a high pedestals with a vine pomegranate and grapes between them. Also, the area in front of the entrance of the room is decorated with a pair of sandals (Fig.3).

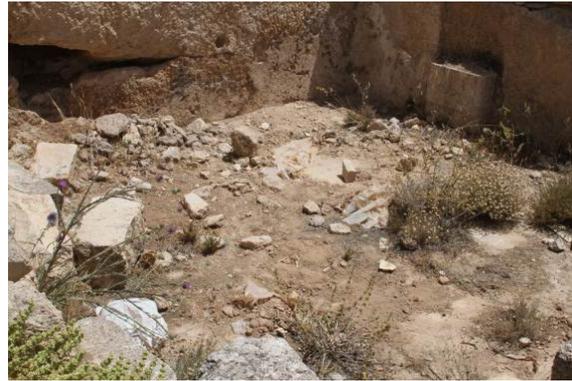
Figure 4 The mosaic before backfill removed

There were stones collapsed and grassy plants over the sand backfill. The plants were passed through the plastic layers and reached to the mosaic preparatory layers (Fig. 4).

The sand layer was removed manually and by brushing. The action has to be carried out with special attention to avoid disturbing the plastic layers, and then the plastic layers were removed only after they had been allowed to dry out gradually to prevent salt crystallization on the mosaic surface. Under the plastic sheets, plants and small roots were also existed (Fig. 4). There were removed by using hand tools during the removal of the plastic sheets.

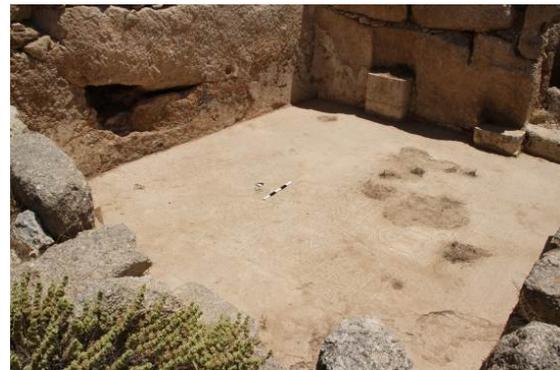
Figure 5 The mosaic after backfill removed

After brushing the soil, the mosaic showed a number of lacunae (Fig.5) and disintegrated tesserae (see below Fig.10). Several tesserae were detached from the bedding layer, which were under the risk of disintegration.

Two methods of treatment were implemented according to lacunae size and shape. In the case of small lacunae, tesserae of the same size and color were placed to fill the lacunae with lime mortar. To point out the new integrations in the ancient mosaic, the tesserae were placed under level.

These interventions were carried out with the help of old slides and photos, which had been taken in 1998 showed the mosaic in fairly good state of conservation. In addition, a great numbers of original tesserae were collected in situ and its original positions are unknown, the decision was taken to utilize these tesserae to fill in the lacunae. In case of large lacunae, it was enough to fix the internal edges of the lacunae by lime mortar.

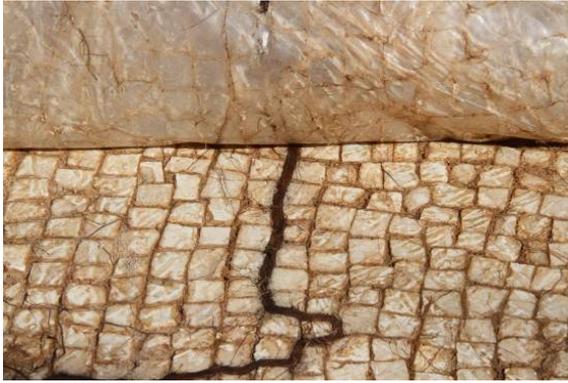
Figure 6 Plants have grown over tessellatum

The plants and roots under the plastic sheets were evident and caused significant mechanical damage on the tessellatum (Fig. 6). This means that the plastic sheets not work well against vegetation by preventing their growth. It is well known that the plastic sheet stop any liquid-water-vapor transport, then the water trapped under the plastic sheet will foster vegetation growth (GCI, 2011), as well as, the sand backfill was found inadequate to allow the ground water to evaporate completely. In addition, some dark colored residues caused by roots and plants and many spots of microorganisms were evident on the tessellatum (Fig. 7). However some of them were easily removable by hand tools, brushes and water, the others were needed a chemical cleaning.

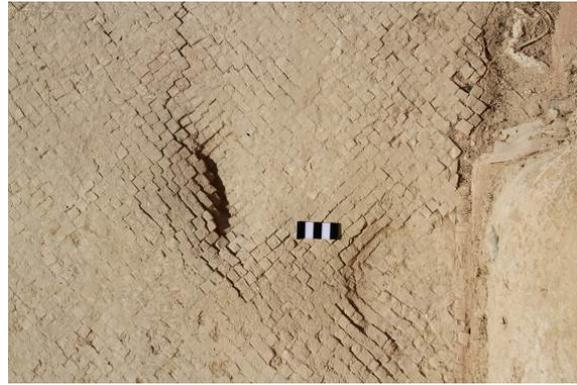
Figure 8 Depression of Tessellatum

Generally, the mosaic layers are still intact, but there is some of areas of the mosaic affected by different level of detachment between its layers, which required grout injections. Some depressions in different forms were presented in some areas of the mosaic floor, which may be due to the general weakness of the foundation layers or was result of loading or collapse of heavy objects over the mosaic floor (Fig.8). The mosaic also affected by different forms of bulges caused by plants growth (Fig.9).

Injection grouts were used in a few cases, this process was applied to the sections of mosaic which showed lack of cohesion. Fluid mortars made of hydraulic lime, limestone powder and marble powder in 1:1:1 proportions were used for this treatment.

Before proceeding with the application of the injection, the areas of detachments were detected and marked, then several access points to the areas of detachment were created by removing some tesserae. The tesserae were cleaned, numbered and placed on a sand tray in the same position as found to facilitate putting them back in their original place. Then a small hole was made by digging. After cleaning the hole by blower and removing the deteriorated mortar, the hole was wetted by injection of distilled water to prevent the absorption of water from the repair mortar.

Fluid mortars were made and injected gradually in the hole using a suitable syringe. Finally the removal tesserae were put back to their original location.

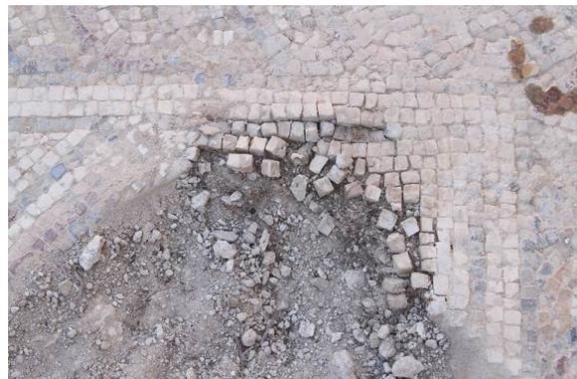
Figure 10 Disintegrated tesserae

The mosaic had also some fragmented and deteriorated tesserae, especially the black ones, because the structure of the black tesserae is weak and subject to mechanical alteration. Moreover, some deposits were found on the surface of the tesserae in the form of dirt, soil, and other hard deposits (Fig.11).

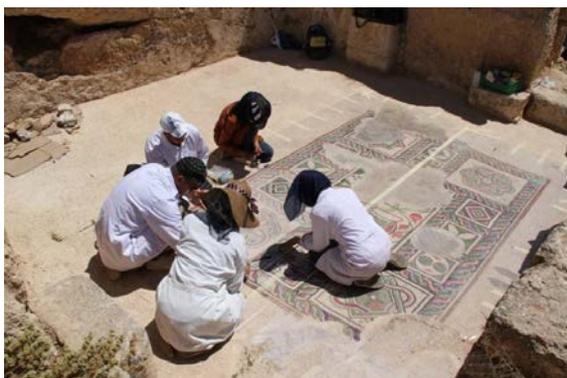
Figure 12 Documentation of the mosaic by scale 1:1

Documentation was implemented in the form of drawings and photographs, in both traditional and digital formats. The mosaic was photographed using digital camera by placing measurement points at intervals of approximately 70cm.

These photos were then used as the basis for developing base map in Auto CAD. Also, all the mosaic was recorded in scale 1:1 on polyethylene sheets. These methods of documentation were used for documenting the state of conservation of the mosaic as well as the phases of mosaic interventions (Fig. 12). After all interventions on the mosaic, a general view of the mosaic was taken by using a digital camera.

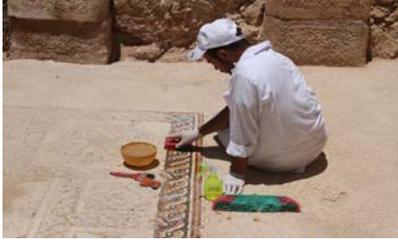
Figure 13 Wet cleaning

This operation is carried out using mechanical and chemical methods. The mosaic surface was cleaned from dirt and dust accumulated by using water, plastic brushes and sponge (Fig. 13).

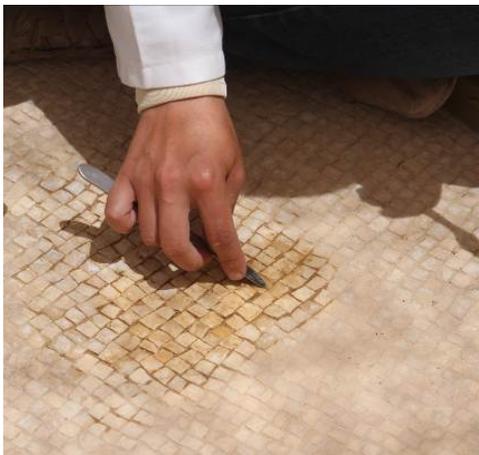
Figure 14 Manual mechanical cleaning

In addition, Cellulose fiber (Paper pulp) saturated with AB57 solution was applied for four hours. Before proceeding with the application, the tessellatum was wetted in order to reduce the penetration of the chemical, and then the poultice was laid in the mosaic surface, covered with plastic film to prevent drying out. Immediately after the removal of the poultices, the surface was washed with water and plastic brushes. Furthermore, scalpels and small chisels were used to remove the solidified deposits such as hard crust (Fig. 14).

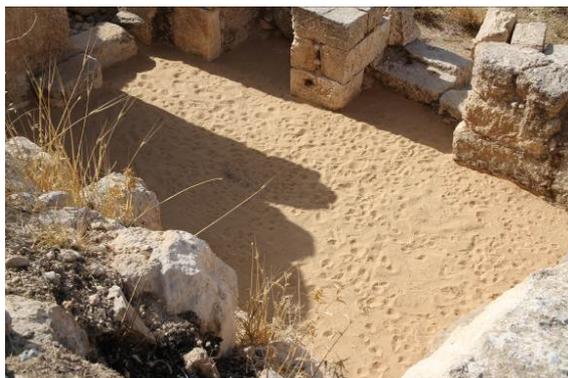
Fig 16 Mosaic reburial

The mosaic was reburied with the layer of sand about 50cm thick, and then the sand was treated with the herbicide Thymol (3% spray solution in water) and sprayed on the sand backfill in order to prevent plant intrusion and fungal growth (Fig.16).

The reburial was carried out using local sand in order to protect the mosaic from the environmental factors. The sand was used without plastic layer which have proved to be dangerous to the stability of the mosaic floor.
