Mediterranean Archaeology and Archaeometry
Vol. 19, No 3, (2019), pp. 119-138
Open Access. Online & Print.

VULNERABILITY STUDY OF EARTH WALLS IN URBAN FORTIFICATIONS USING CAUSE-EFFECT MATRIXES AND GIS: THE CASE OF SEVILLE, CARMONA AND ESTEPA DEFENSIVE FENCES

Moreno, M., Ortiz, P. and Ortiz, R.*

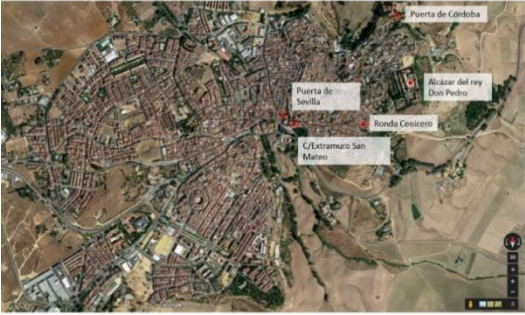
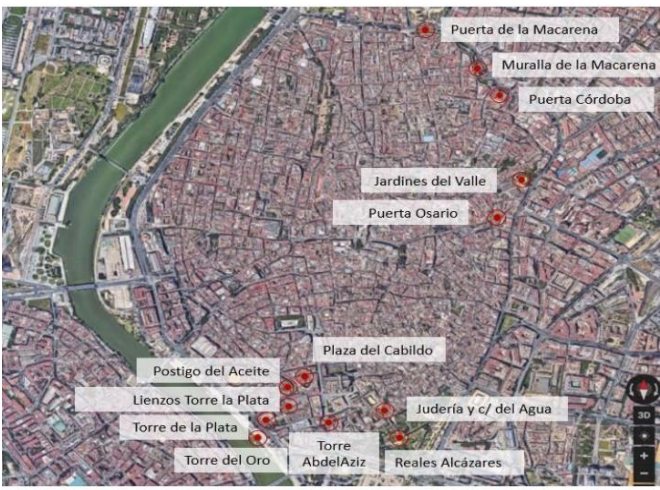
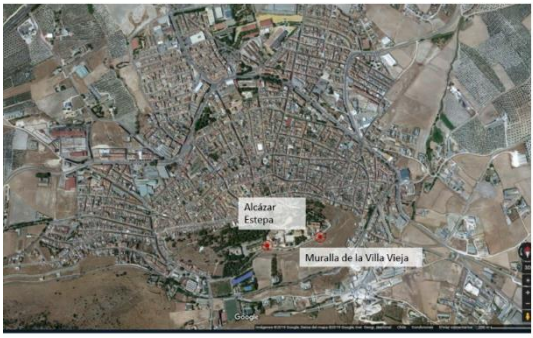
Table 3: Fortifications walls divided in sections in Seville, Carmona and Estepa (Google Maps, 2019).

<p data-bbox="754 1753 1417 1787">*Defensive fences have been divided in MUAs (sections, towers and gates)</p>

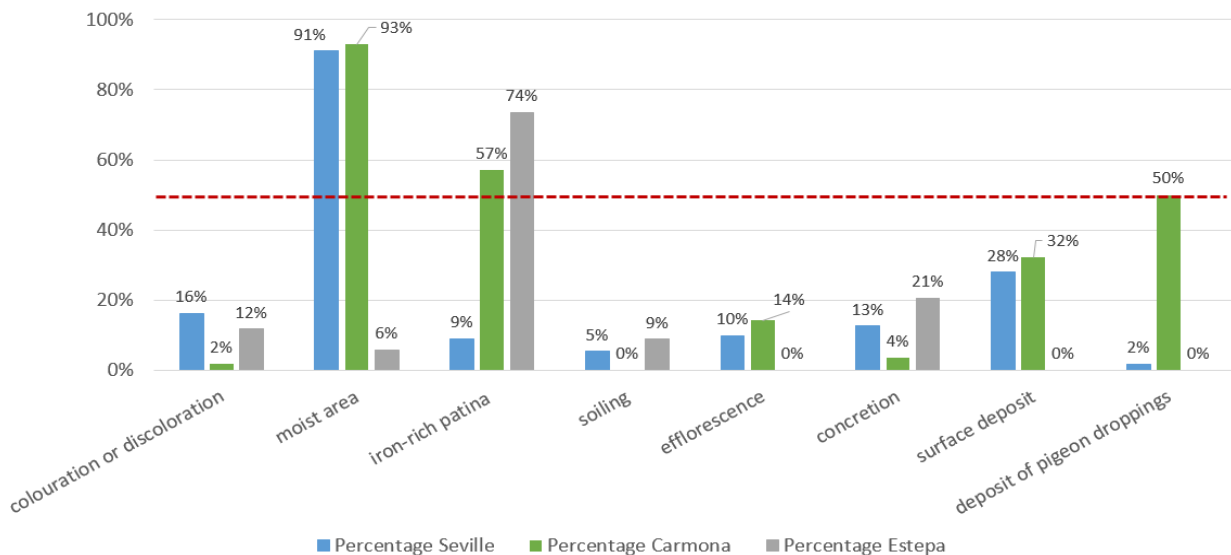
Figure 1: Total relative frequency of decoloration and deposits weathering forms.

Related to discoloration and deposits weathering forms: moist areas and iron rich appear in more than 50% of the studied fortifications (Fig. 1).

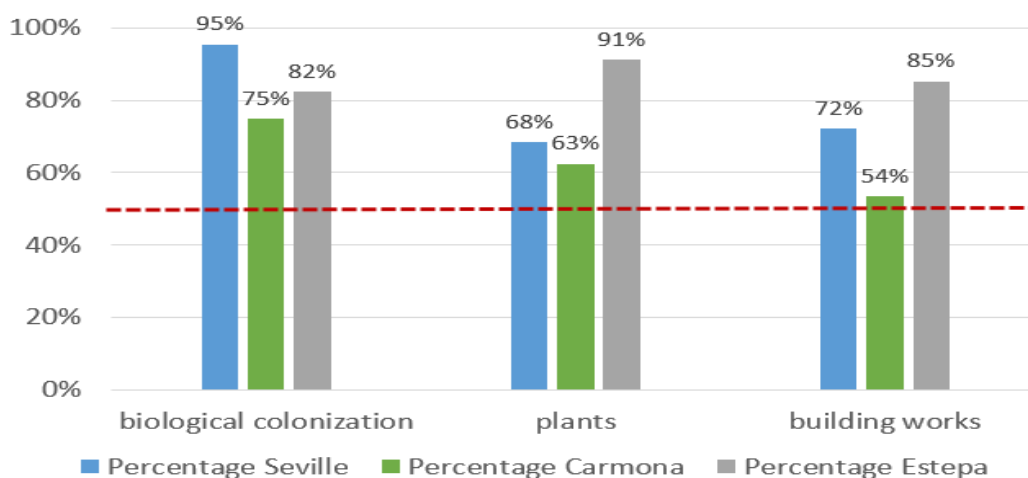
Building works appear in 72% of MUAs in Seville, while it is 54% in Carmona and it is 85% in Estepa (Fig. 4). Most of ancient and modern interventions have compatibility problems. In Seville the use of Clinker cement promotes concretions, efflorescences and fractures while the use of lime goes to sanding and detachment and those MUAs repaired with mud show sanding. The same problems are observed in Carmona, where geotechnique features have also caused fractures and fragmentation. In Estepa, there are concretions due to the use of clinker cement and loss of cultural value caused by lack of documentation and respect to different historical periods. Table 8 shows the frequency of problems due to interventions, and it is mainly low or medium in Seville and Carmona, while problems due to interventions have a high occurrence in MUAs of Estepa.

Figure 4: Total relative frequency of biological colonization and others weathering forms.

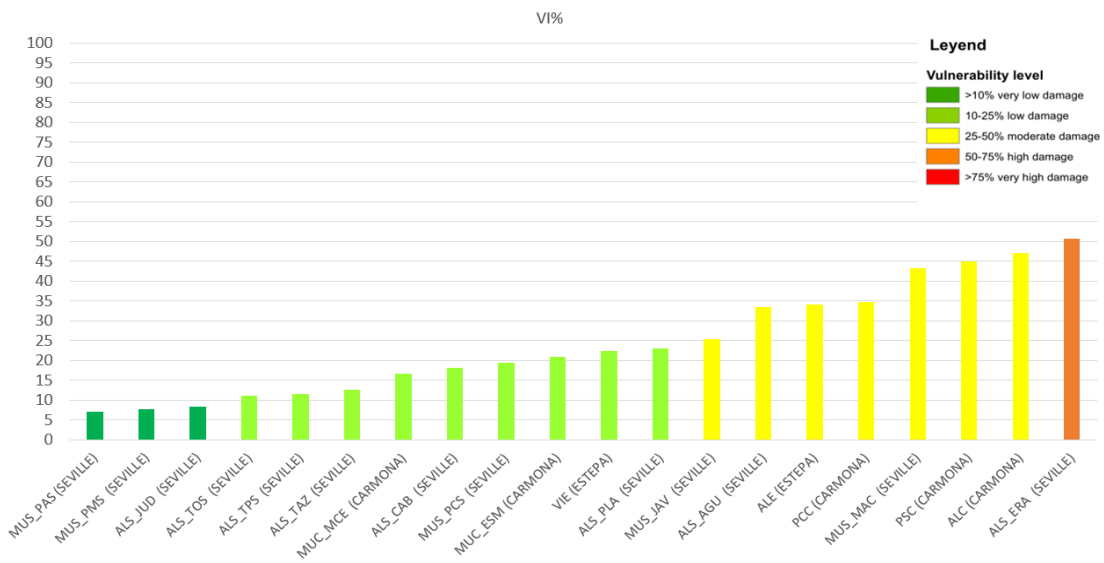
Figure 8 shows the vulnerability index of all the fortifications analysed in Carmona, Estepa and Seville. Using this data, a vulnerability map of each historical centre has been drawn using GIS (Figs. 9, 10 and 11).

Figure 8: Vulnerability index of defensive fences in Seville Carmona and Estepa.

Twelve of the structures studied have low or very low vulnerability index due to periodic restoration and conservations works. Meanwhile eight of the fortifications have moderate or high vulnerability index. These sections with higher vulnerability indexes correspond with the Alcazars because of their constructive complexity versus urban walls. Different materials, constructive systems mixed together have compatibility problems and this increase fragmentations and fractures.
