THE DETERIORATION PROBLEMS OF THE WALL RELIEFS OF KOMIR TEMPLE, ESNA, EGYPT

ABSTRACT

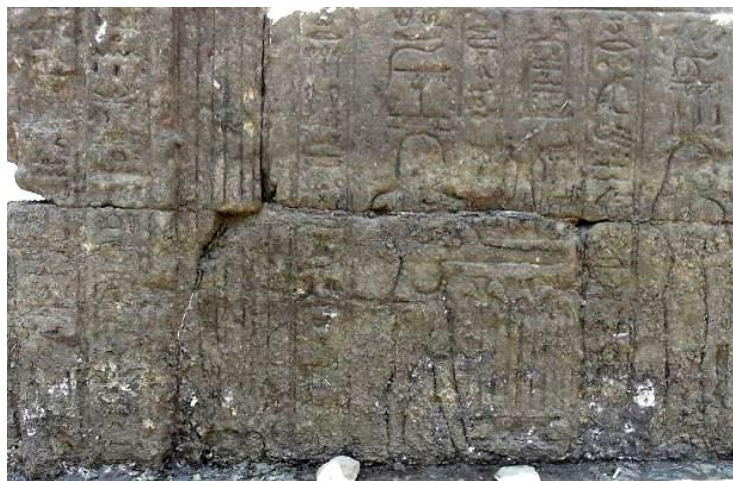
Figure 2 wall painting at Komir temple represented the king Antoninus Pinus introduces the offerings to a goddess.

of the modern houses were removed and revealing some blocks of sandstone wall bearing the cartouches of Antonius Pius, thus indicating the date of the place approximately. The next excavation phase started in 1979, M. Es-Sagher and V. Dominique completed the excavation in Komir and they discovered nearly 600m represented the back foundation part of the temple. It is noticed that, presence of extension for the discovered part of the temple under the adjacent houses. At the end of this excavation period the temple site showed the same excavation status as today. The general description of the discovered part of the temple as may be seen from the plan (figure 1a). The temple in its present state forms a rectangle of 20m, E-W by 15m, N.S, its orientation being perpendicular to the Nile. Its entrance is to the east. The main parts of the temple are; 1- a hypostyle hall, with no extant columns, only partly excavated, the rest still being under the houses to the east of the temple (figure 1b). 2- The inner hypostyle hall or the outer vestibule, this hall measures 7.60m NS × 3.04m EW. 3- The second Vestibule hall, this hall has some dimensions as the previous one, its northern wall is completely destroyed, but it seems that it contained a stairway leading to the roof of the temple. The southern wall wasn't cleared because of the village houses. The western wall lies under the road left for the inhabitants of the village. 4-The Sanctuary; this is a rectangular chamber lying east to west and measuring 4.30×3.20m. It has a central chamber with two rooms (Es-Saghir and. Dominique 1979). The wall paintings of the Komir temple were carved with sunken and raised reliefs represented the king of Upper Egypt, Antoninus Pinus, facing north, wearing the white crown and a short skirt introduces the offerings to a god or goddess African, Asiatic, and figures of the personified cities and tribes subdued by the Emperor (Fig.2). They are bound together with papyrus stalks in a symbolic

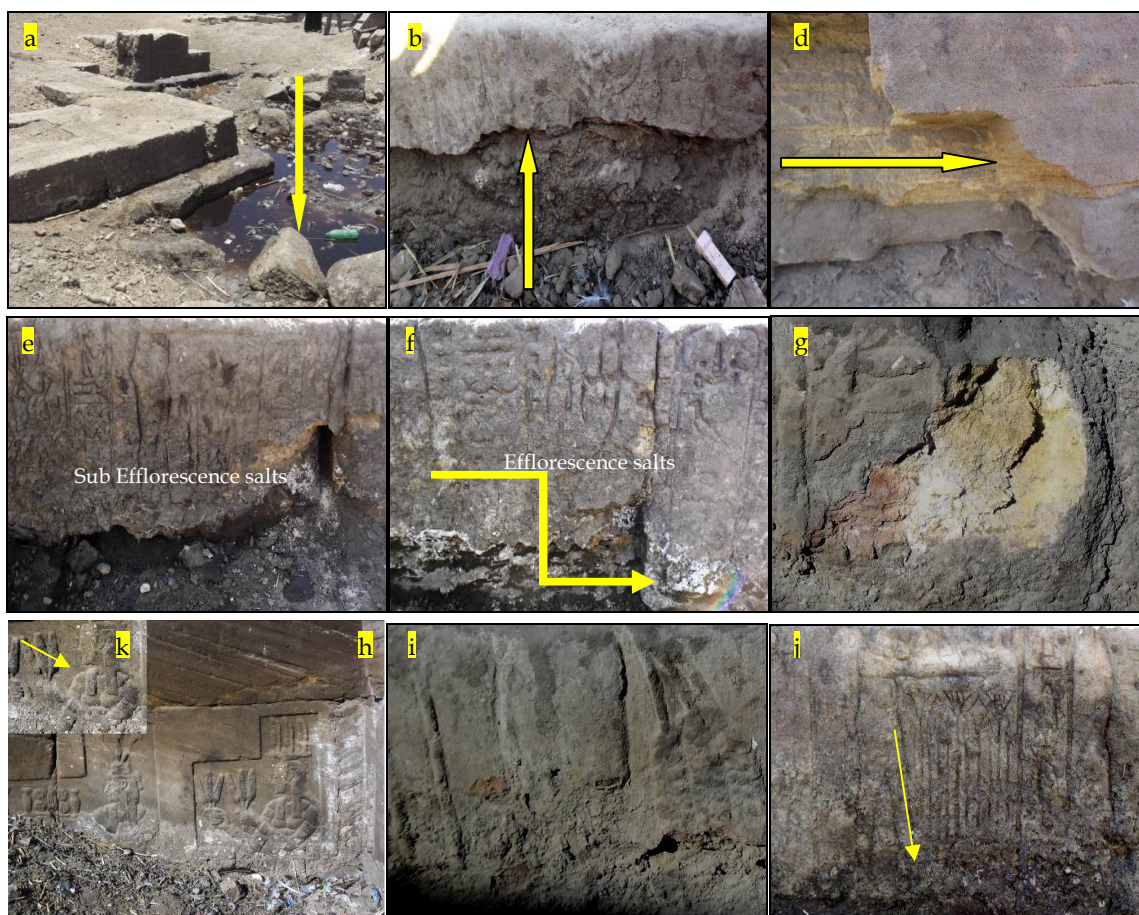
rusts, biological attacks and effects of human exploitations were found in the surface of stone blocks (figure 3a-j). The stone surface of the temple became blackish in appearance due to deposits of dust, dirt and dried vegetation and micro vegetation. Due to these deposits the aesthetic beauty of the reliefs is seriously affected. A lot of deterioration factors play an important role in the degradation of reliefs at Komir temple. The most cited affecting the site is a moisture source

(ground water) resulting from dramatic rise of the water level. The main reason for the water rise is the location of the Komir village. It occupies an ancient mound now becomes located two meters under the level of the surrounding cultivated land and it is located to the east of the modern El-Ramady Canal and opposite the village of Esh-Sharawan on the east side of the Nile. In addition to the village situated two meters under the level of the Nile. Also the main reason for the water rise is the seepage from land reclamation areas, sewage water from cultivated lands and waste water from homes located two or more meters above the level of the temple. This water rich in chloride and total dissolved solids reacts with the lower parts of the engraved stone blocks and partly buried parts causing several damages and cracks. Also water sometimes penetrates those cracks and causes the surface layer to peel off, detachment of the superficial layers of reliefs and may even cause large stone blocks to fall off. The temple is subjected to the severe action due to the climate. Komir village lies at the bank of the Nile valley in a desert environment. According to the bio-climatic provinces of Egypt, the area is hyper-arid with mild winters and hot summers (Said 1962). Average annual rainfall of 1 mm, mainly in winter, in some years 4–6 mm are recorded, in some years there is no rain at all. The evaporation rates are lowest in January (2.5mm/day) and highest in June (9.4mm/day). The maximum temperatures is 45°C in summer, 15° C in winter, the monthly average of air temperature ranges between 12–32°C. The maximum relative humidity (RH) during winters sometimes exceeding 60% and reaching a maximum of 78% in the early morning and it reaches 30% in August. In the desert situation of the temple heavy wind is very common and the average wind velocity ranges between 3.7 and 12km/h. The extensive changes in air temperature favors the crystallization/re-crystallization cycles of salts, which led to the loss of stone material

as the relief in the form of small pits, cohesion between grains and caused the current detachment of individual grains. Poorly adhesive deposits of salt aggregates lead to discoloration of stone surface, salt efflorescence, blistering, disintegration and formation of many salt encrustations on the reliefs (Mahmoud et al 2010; Ismail, 2001) . Salt weathering is one of the principle deterioration factors in Komir temple, these salts can be observed directly as efflorescence and appear at the surface of the wall painting at Komir temple. Sandstone containing iron oxides which leave disfiguring reddish -brownish stains as shown in (figure 3f). These stains are weakness zones and can cause several alteration features in rock reliefs because these minerals can be dissolved, transported to and then leached from the surface of the temple walls and these nodules would be more susceptible to deterioration than grains of quartz the main constituent mineral. The wall paintings in Komir temple suffered serious damages, due to shock environment. After the discovering of this reliefs, they were leaved without any treatment until now exposing to the environmental shock. The hesitating of sub-surface water, salts, the direct sunshine and the micro-organisms that resulted in the outside surface layers caused weakness of stone and let a lot of clay particles and a lot of foreign materials on the surfaces which disfigured, discoloration of stone surface and hid their reliefs. In addition to the natural weathering causes there are many human deterioration impacts like the former use of the temple as a quarry for building stones from the inhabitants of the village. Alterations that hint to fires inside the temple are frequent. On the walls there are many relics of soot from burn weeds and waste by inhabitants. The surfaces are black and react more to heat impacts as shown in (Fig.3j).

Figure 3a-j weathering forms of the reliefs at Komir temple **a** rising in sub-surface water at the temple **b** peel off the surface layer **c** detachment of the superficial layers of relives **d,e** Efflorescence to light-colored crust tracing the surface and sub efflorescence salts **f** iron oxides which leave disfiguring reddish -brownish stains **g** Light-colored crust changing the surface **h** pitting and obliteration of relives and dark-colored crust tracing the surface **i** micro cracks, cavities, clay particles pits and destruction of walls by wasp nests and saliva, **j** the impact of fire at wall painting.

The previous study clarifies that the wall painting at Komir temple had been exposed to aggressive deterioration factors mainly due to environmental conditions and different sources of moisture (i.e. groundwater and domestic waste water) containing high level of different harmful ions. Therefore, the following recommendations should be taken for protecting the wall painting such as:

There are many problems need a lot of scientific work before satisfying conservation plan will be established as Preventive Conservation. Preventive conservation measures of more immediate effect are usually concerned with keeping water out of the stone and with controlling the relative humidity and temperature of the air around the stone [Price, 1993]. The main purpose of relative humidity control is to prevent salt damage which can be carried out by reducing the subsurface water level under the Komir temple by

treatment the reasons for rising (i.e. converting Ramady Canal to covered drainage system and conversion the system of farmland irrigation in the surrounded area to drip irrigation, that reduce the rate of water leaks into the walls of the temple.

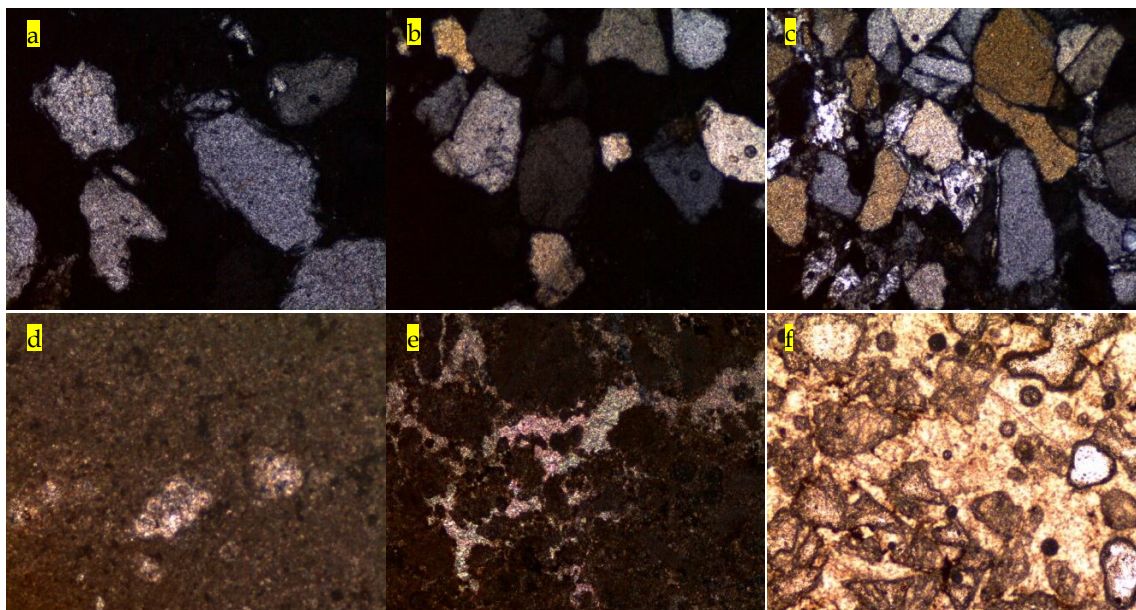
Examination of thin sections of the sandstone samples under polarized light microscope (PLM) indicated that, it composed of quartz (main component); Quartz grains occur as turbid color, it displayed quartz crystals are angular to subrounded in shape and fine to medium

grained. It was affected by mechanical breakage and chemical process which produced micro-fractures and cleavages dissecting the quartz grains into several subindividual grains. They are surrounded by feldspars (partially altered to Sericite), with cement of calcareous and iron oxides.

In these samples small contents of calcite and gypsum were found. The sandstone used in Komir temple described as arcose arenites characterized by a brownish to

yellowish red color in general related to its stone properties (Fig. 5a-f).

Figure 5a-f: Polarizing microscopy view of sandstone samples; **a,b**: samples taken from hypostyle hall shows quartz grains and feldspars (X40), **c,d** samples taken from the inner hypostyle hall shows quartz grains and feldspars with cement of calcareous and iron oxides as spots, **e,f** samples taken from the second Vestibule hall shows quartz grains and feldspars with ferruginous cement (X40).

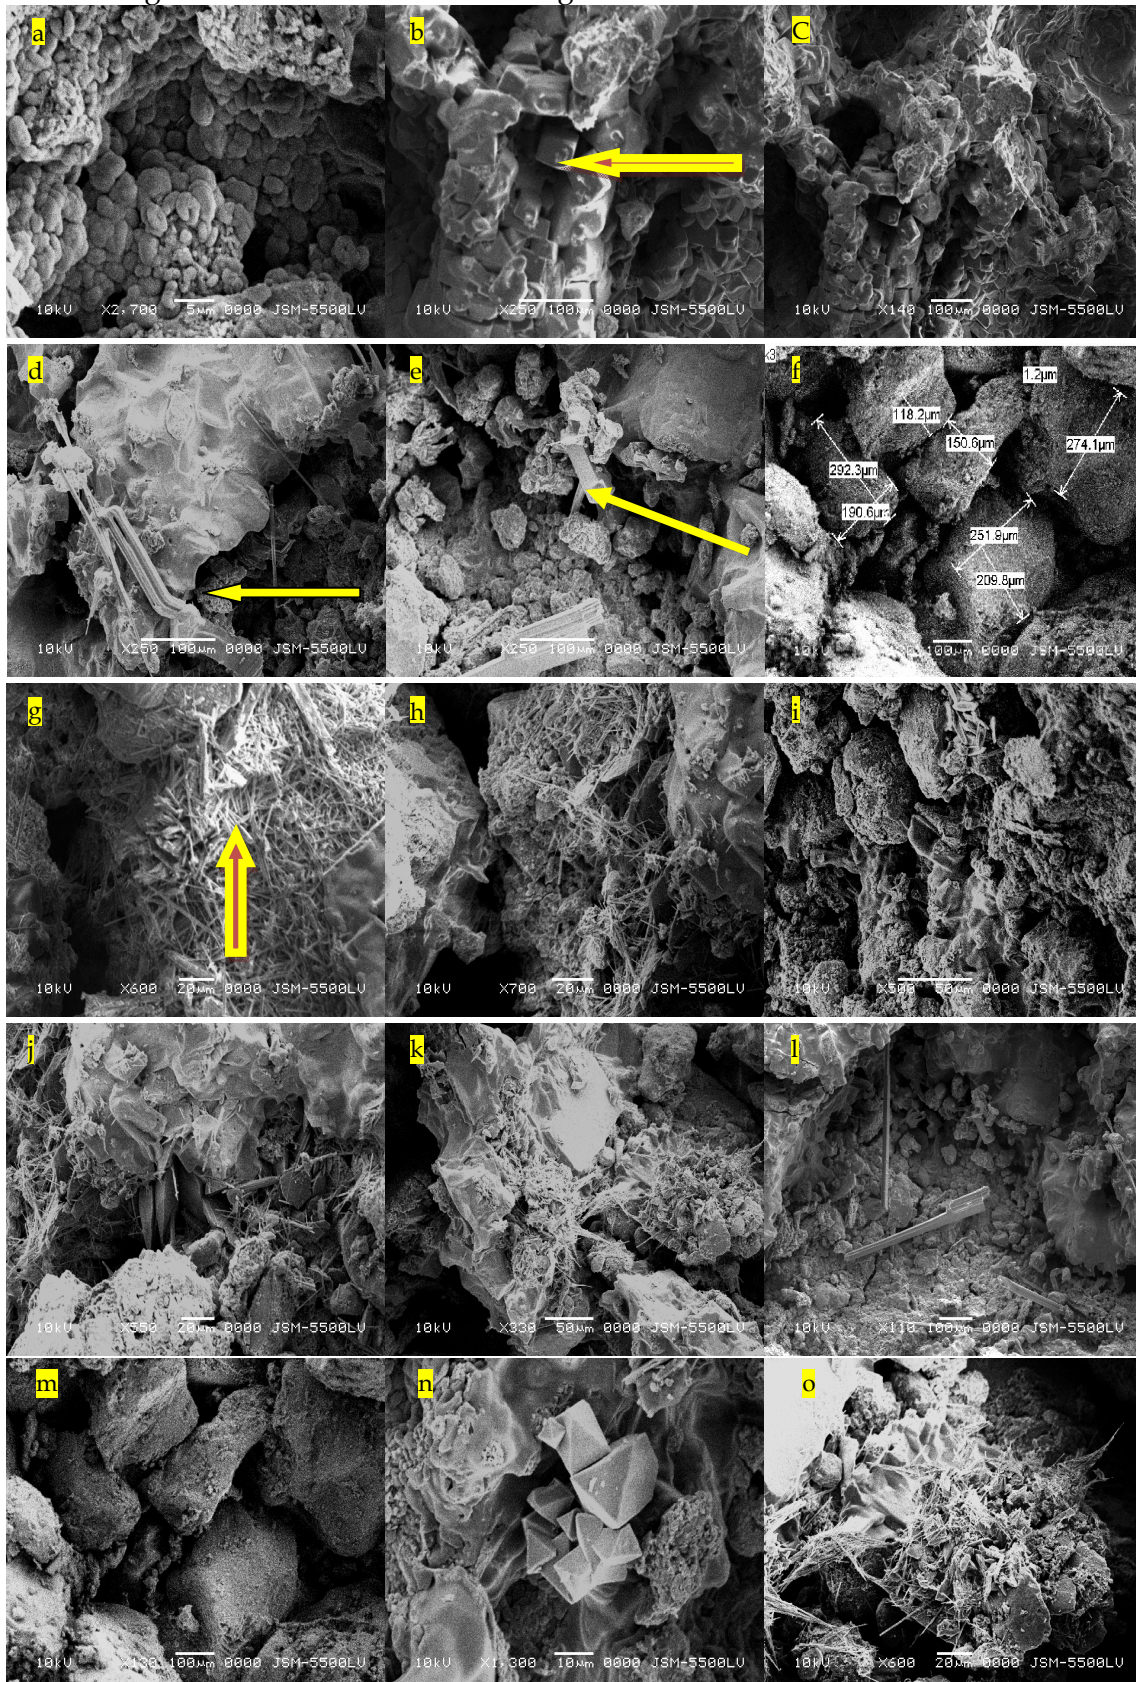
Based scanning electron microscope (SEM) observations (Fig. 7a-p), the rock are very weak and have low compactness and durability. SEM image of samples shows a dense coat of halite crystals (Fig.7a) which covers the pores of the stone. Halite was identified in SEM micrographs as large euhedral cubic (Fig. 7b) aggregates (Fig.7c), prism and needles (Fig.7d, e). SEM micrograph indicated that most of the pores were affected by the crystallization of the salt and that a crystal growing in smaller pores (up to several microns) which is capable of exerting sufficient pressure to start or propagate a crack. Gypsum crystals grow within the pores as thin plates and tiny white dots causing many deep pits (Fig. 7g,h). The gypsum salts indicating the existence of sulfur ion, exist as a result of environmental pollution or microbiological activities, especially

with the presence of aggressive alternative cycles of drying and wetting (El-Gohary, 2010). Clay minerals crystals are visible with patches of irregular surface in formed by quartz intergrowth possibly due to deterioration factors (Fig.7i). Bumpy surfaces and disintegration of the sandstone were detected. Moreover, the sandstone shows many micro-weathering phenomena such as micro-pitting, micro-cracking and covering the stone surfaces with dirties cracks, pores and cleavage plane enlarging the cleavages and dissected it into several flakes as shown in (Fig.7j:l). Micro-exfoliation and dissolution of cements occur in the samples (figure7m,n) which leads to an increasing in porosity and loss of cohesion of the stone as shown in (figure7m, n). Quartz crystals seriously deformed and lost its original shape (Fig.7o). It must be

mentioned that weathering attacked strongly the rock formations which started from the surface and continuing inward thus losing the mineral fabric. Scanning

electron micrographs show growth of mite (phylum: Arthropods) between grains (Fig. 7p).

Figure 7 SEM microscopy view of sandstone samples **a** dense coat of halite crystals, **b** large euhedral cubic aggregates **c** sodium chloride as aggregates **d,e** prism and hair grains, **f** grain size of quartz of komir temple **g,h** loss of cohesion of the surface quartz grains due to secondary gypsum growth. **i**, clay minerals with patches of irregular surface **j:l** micro-pitting, and micro-cracking and cleavage plane **m,n** micro-exfoliation and loss of cohesion of the stone, **o** deformed of quartz grains p growth of mite.

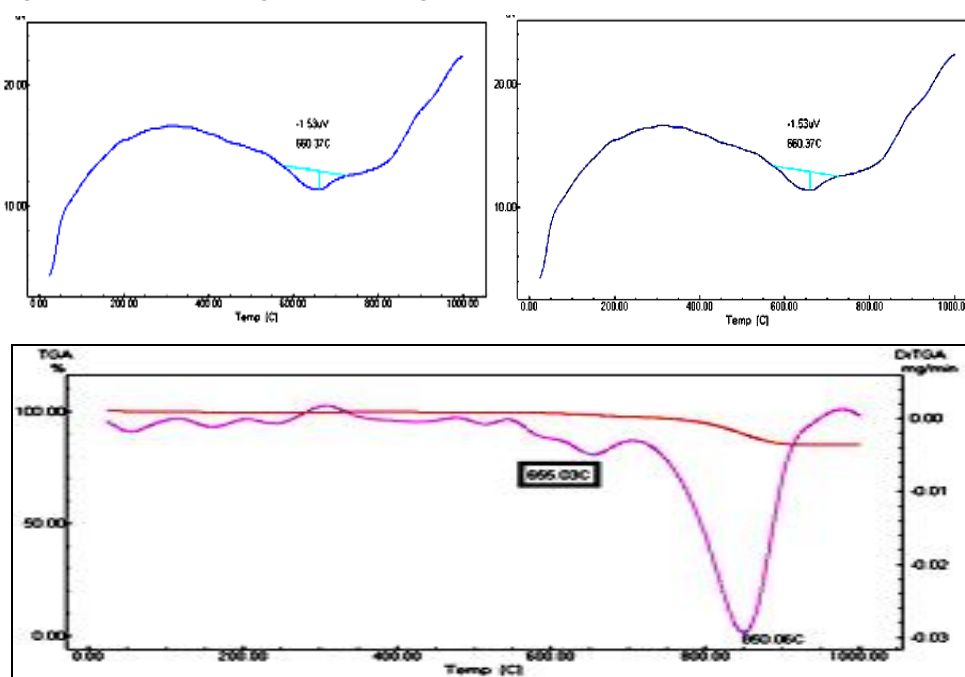
The DTA - TGA data show the clay fraction of sandstone consists of Smectite and Kaolinite. The total loss in weight due to heating is 14.790% (0.377mg). Smectite exhibits three peaks on DTA curve, the first is a large endothermic peak at temperature 100-110°C due to the enter layer water of Smectite was lost, the 2nd is endothermic at temperature 500°C due to rapid loss of

hydroxyl group (OH), the 3rd peak is exothermic at temperature 870-900°C due to decomposition of the structure. Kaolinite exhibits two peaks, the first one is a medium endothermic peak at 525°C due to loss of hydroxyl group and the 2nd is a very small exothermic reaction at temp.915°C due to the structural change of the mineral. Calcite gives medium

endothermic peak at temperature 762°C, Gypsum gives a double endothermic peak, the 1st small endothermic peak at 108°C due to a loss of 1.5 molecules of water to give Hemi-hydrate, the 2nd at temperature 182°C related to loss $\frac{1}{2}$ molecules of water to give anhydrate. Quartz exhibits a small peak at temperature 675°C due to transformation of α -Quartz to β - Quartz. The heating cycle are graphically recorded as shown in (Fig.9). This declares the great problem of hydric expansion and shrinkage due to absorption and loss of water. Hydric expansion is one of the most important reasons for deterioration of sandstone. The aggregation/disaggregation or swelling/shrinking of

the clay particles occur when these particles interact with water causing a whole series of identifiable pathologies in building stone. The swelling types of clay minerals were linked with their crystallographic structure and bonding properties, especially in the case of interlayer spaces (Colas et al 2011). Osmotic swelling occurs for all clay mineral types in response to an electrolyte concentration increase in the double diffuse layer on clay mineral surfaces. Different clays react differently to hydric expansion while the textural anisotropy of clay bearing stones appears to play a critical role on swelling- shrinking related damage.

Figure 9 A,B show diagram of DTA of sandstone sample revealed that the sample consisted of montmorillonite and its peaks recorded at 118- 237°C and 822-877°C besides peaks of calcite

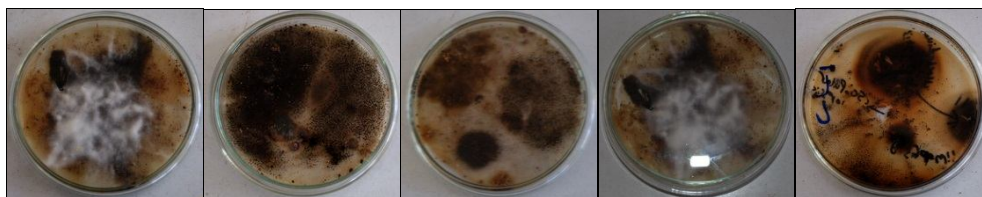
During the present investigation 12 fungal floras were identified that caused deterioration of the wall relieves (Table 3). The fungal species *Aspergillus nidulans*, *Aspergillus niger*, *Aspergillus sydowii*, *Aspergillus terreus*, *Aspergillus flavus*,

Alternaria alternate, *Uloclodium botrytis*, *Stemphylium herbarum*, *Scopulariopsis*, *Cladosporium oxysporum*, *Fusarium sp.*, *Penicillium sp.*(figure10,11). Also it *Bacillus sp.*, of bacteria were identified (figure12).

**Figure10 a-e Different colonies of isolated fungi from Komir temple.**

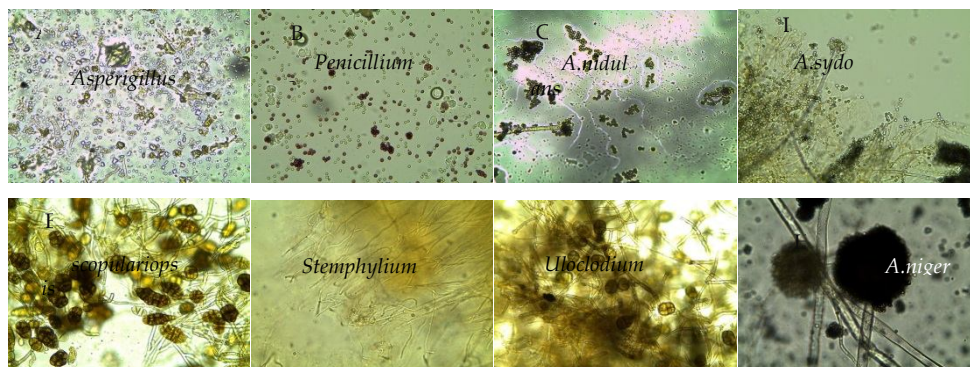
**Figure 11a-h. Light microscope photos of isolated fungi from komir temple: A *Asperigillus terreus* B *Penicillium Sp.*, C *A.nidulans*, D *A.sydowii*, E *scopulariopsis*, F *Stemphylium herbarum* , G *Uloclodium botrytis*, H *A.niger*.**

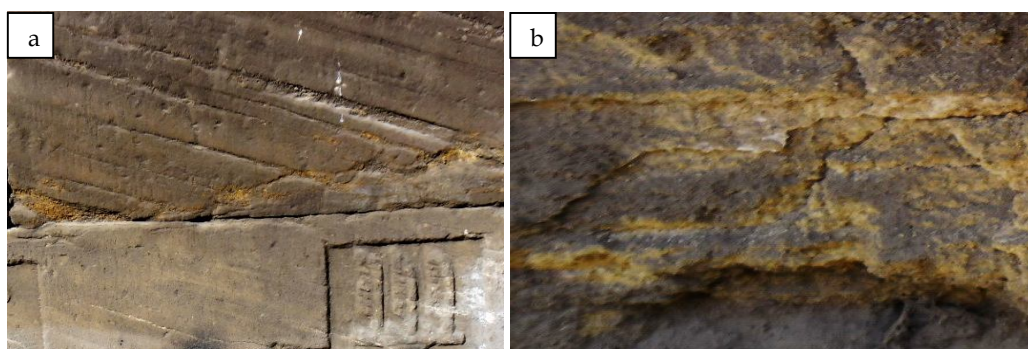
Field observations and lab analysis indicated that, there are many types of damages that wall painting can undergo in the Komir temple. All building and decoration materials of Komir temple have been investigated concerning the contamination with soluble salts. Soluble salts represent one of the most important causes of stone decay that may precipitate on the external surface ("efflorescence's") or in proximity of the surface ("sub-efflorescence's") [Brai et al 2010]. The degradation induced by soluble salts on wall painting in Komir temple was studied by sampling efflorescence's from different places and studied by XRD and XRF. Samples confirmed the presence of chlorides and sulphates species in the form of the following crystalline phase "anhydrate and dehydrate calcium sulphate, CaSO_4 and $\text{CaSO}_4 \cdot 2\text{H}_2\text{O}$ (gypsum)" and sodium chloride (NaCl). Also scanning electron microscope examination confirmed the existence of Halite and Gypsum as the kind of salts in Nubian sandstone. The source of these salts is ground water which carried into masonry by rising damp in the absence of damp coursing. Also Ground water carried

these salts into the pores of the sandstone during burial leaving them behind when the water evaporates. After excavation, these salts crystallized at or just below the surface of the wall painting in Komir temple causing damage caused by the mechanical stress induced by the crystallization cycles of salts (Gauri 1982), which weakens bonding between the grains in the sandstone and causes the spalling, flaking, powdering, sugaring and current detachment of individual grains and pushing surface layer of stone. The contamination of the sandstone with soluble salts, mainly sodium chloride bears a considerable risk for the preservation (Saleh et al 1992). Sodium chloride thus migrates to higher areas and re-crystallizes under volume expansion. Moisture can convert the halite salt from the solid state to the solution and during the day when temperature become high, the water will evaporate and the salt crystallize, this lead to crusting, white blooms and a lot of stress which lead to micro crack, blistering, delamination, scaling, disintegration and separation of some parts from rock inscription as shown in (figure 13a,b) (Maureen et al 2003).

Figure 13: Salt induced deterioration of sand stone at Komir temple (a) Incipient Flaking, (b) scaling parallel to bedding.

Reduction of salts should be done. Desalination of relives from soluble salts as sodium chloride is usually attempted through the use different types of poultices, which may consist of clay, paper pulp, or cellulose ethers. In instances of calcium sulfate hydrate (Gypsum) and black rusts can be cleaned by using two poultices, the first one was absorbent poultices loaded with mixture of 10% sodium thiosulphate ($\text{Na}_2\text{S}_2\text{O}_3 \cdot 5\text{H}_2\text{O}$) + 5% ammonium carbonate with distilled water. After that, distilled water with ethyl Alcohol used to rinse treatment places to remove ammonium sulphate with severe susceptibility to water solubility. The second one employs the sodium salt of the ethylenediaminetetra-acetic acid, abbreviated as (EDTA) as active ingredient.
