ANALYTICAL STUDY OF PAINT LAYER IN MURAL PAINTING OF KRABIA SCHOOL (19th c.), CAIRO, EGYPT

Nabil A. Bader¹ & Waeel, B. Rashedy²

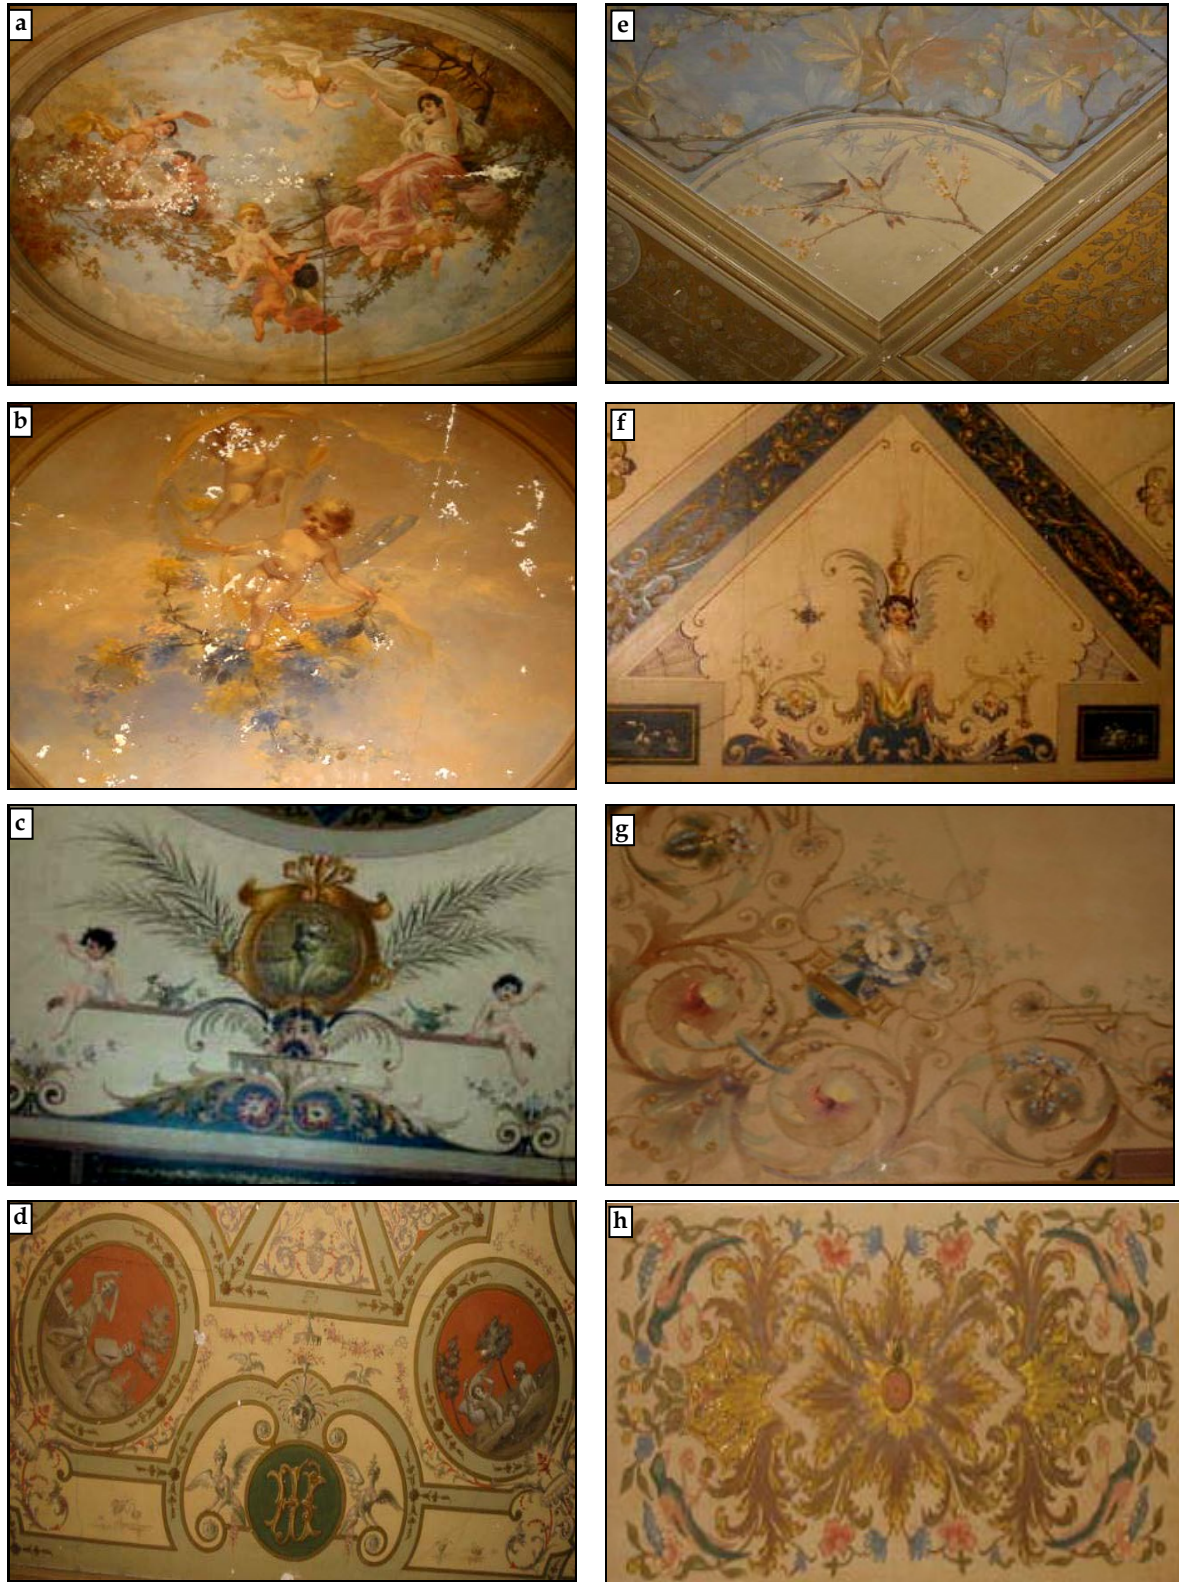
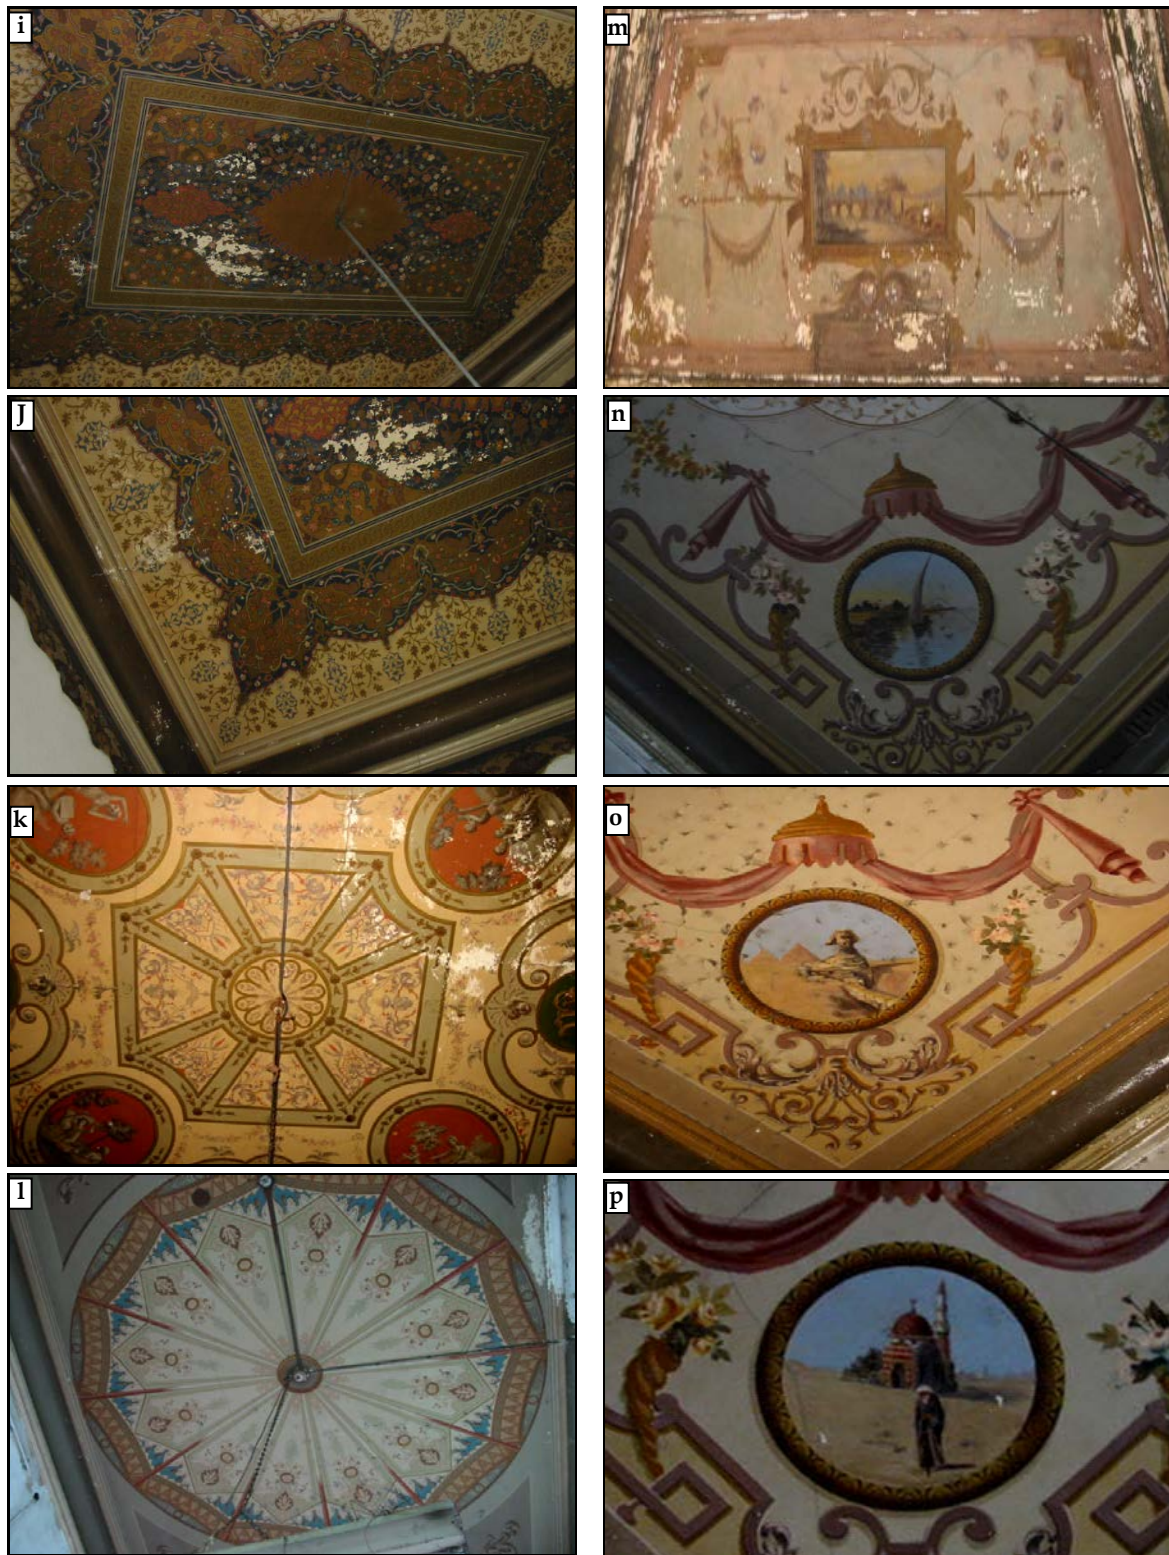
Figure 3. Details from the wall paintings at the Kerabia School (Continued next page)

Figure: 3 Details from the wall paintings at the Kerabia School

Ceilings are one of the most important architectural elements in the architecture especially in Egypt. It was not only used for structural purposes but it was widely used to add aesthetics and creativity in terms of the building. The ceiling is the prominent part of the Krabia School and decorated with multiple ornaments in various colors. The ceilings of the rooms, halls and some walls of Krabia School were originally prepared to receive mural paintings with the application of two plaster layers which decorated with amazing paintings, which showed the effects of Islamic art in European artists. Wall paintings have some diversity in the context of the decoration. Units and decorative items were multiple in the ceiling: beauty and the love goddess "Venus" (Fig.3a), children of love "Kiobid" (Fig.3b), an old man with a mustache and

beard (Fig.3c), figurative human drawings painted in the third room to the left of the main entrance on the first floor (Fig.3d), butterflies, animal drawings, birds, doves, eagles, wings painted inside the ceiling of the shed entrance (Fig.3e). Legendary animal drawings were painted and showed a legendary animal with an animal head and a plant body ending in a spiral shape (Fig.3f). Plant drawings frequently showed wrapped branches ending in a spiral shape containing triple paper petals and ending with in a heart shape (Fig.3g).

Chalice-like leaves, Roman alakantes, sheets, equity, and Roman alanthimon, flower God, as bilateral and trilateral exchange, Quartet, Quintet, six, eight, and twelve Hill, grape leaves and his bunch of grapes, the vases out of branches, flowers, sunflowers appeared (Fig.3h). Baroque and Rococo, the flower of the roman alrozet, trees, arabesque and half fans palm (Fig.3i,j).

Architectural decoration also appeared in the roof of the School and decoration of frames used in dividing the bishop to spaces and specific regions within which the painters performs his decoration, featured quadrilaterals, Quintet, and forms of assistive devices, circuits, and plagues of the seas, the lobate, contracts, shapes of eight ribs, and forms of stellar dishes (Fig.3k,l). Besides the above-mentioned decoration, other forms and decorations were represented at the ceiling as stick; flames and charges fees of cloudy skies were painted (Fig.3m).

In addition, some landscape represented by River Nile (Fig.3n) or some ancient buildings as Sphinx and pyramids (Fig.3o) and Shrines (Fig.3p) (El-Rashidi, 2010).

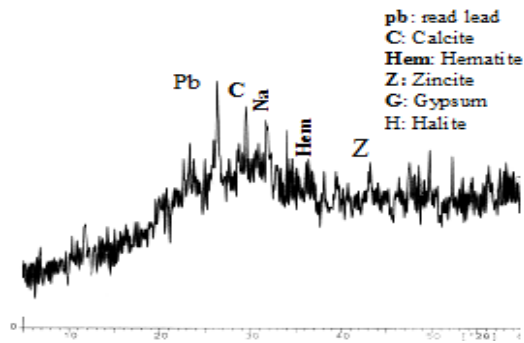
XRD patterns of the red sample (Fig.10) shows the presence of red lead (minium, Pb_3O_4), calcite, hematite, gypsum, zinkite and halite.

Figure 10 XRD pattern of of the red color at the ceiling of Krabia School

The FTIR spectrum of the red paint, gave the characteristic bands of red lead, it was detected in the areas and gave a weak band at 3540.67, 2922.59, 1620.88, 1421.28, 1116.58, 668.214, 527.436, 447.404 cm^{-1} . The above results suggesting that, this colored paint could be prepared by the use of mixture of red lead (minium Pb_3O_4) and iron oxide, calcite, gypsum and zinkite is originated from preparation layer and the presence of halite is due to salt contamination.

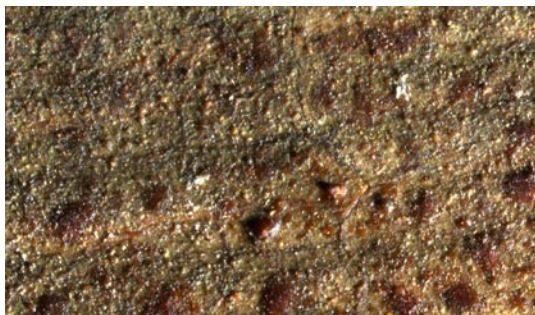
The examination of brown color by LOM (Fig.11) shows, the color and the preparation layers are inhomogeneous in thickness, most probably due to inadequate preparation of the paint layers and shows brown spots and sand grains mixed with matrix.

Figure 11 photomicrograph of the brown color at the ceiling of Krabia School

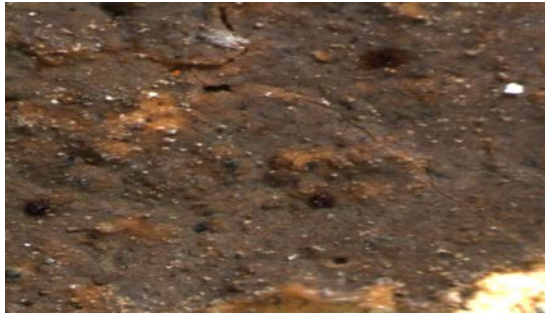
The photograph of LOM (Fig.14) shows the pale brown layer tends to yellow and the paint layer is inhomogeneous in surface and rich in voids and coated with dirt. The paint granules of olive green color were undefined by SEM. The elemental composition analysis of the pale-brown color surfaces (Fig.15) indicate that it is mainly composed of calcium (Ca), Zinc (Zn), sulphide (S), barium (Ba), iron (Fe) and silicon (Si).

Figure 14 Photomicrograph of the pale-brown color at the ceiling of Krabia School

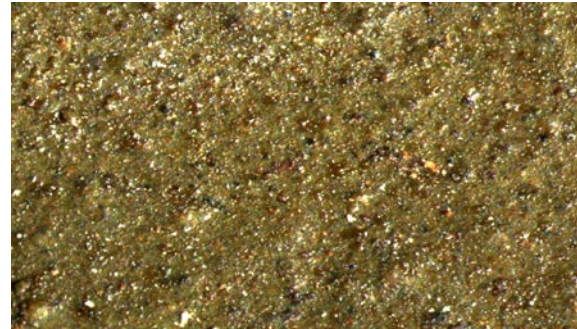
The optical investigation of the lemon yellow paint (Fig.17) shows that the paint layer is homogeneous in surface and has a brown spots. SEM observation show that, the paint comprised of fine prism grains

Figure 17 Photomicrograph of the lemon yellow color at the ceiling of Krabia School

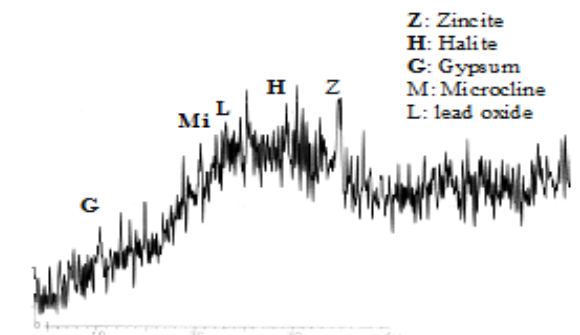
Mineralogical composition of the color composed of zinkite (ZnO), gypsum ($\text{CaSO}_4 \cdot 2\text{H}_2\text{O}$), microcline (KAlSi_3O_8), lead oxide (Massicot, litharge PbO) and halite (NaCl) (Fig.19).

Figure 19 XRD pattern of lemon yellow color at the ceiling of Krabia School

Considering the elemental analysis, it can be claimed that a Massicot, litharge (PbO) is responsible of the lemon yellow color. Lemon yellow was first used as a color name by the early nineteenth century British colourman Field, although the composition was not given at the time (Eastaugh, et al., 2000).

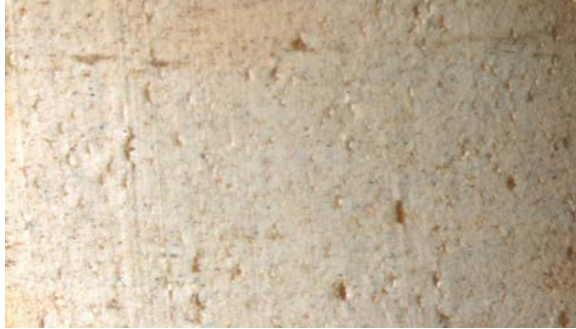
Among the various pigments that were used in the decoration of the Krabia School, the white pigment. Optical microscopic investigation shows the pigment layer is slightly thick with different chromatic hues range from red to yellow, rich in voids and covered with dust (Fig.20).

Figure 20 Photomicrograph of the white color at the ceiling of Krabia School

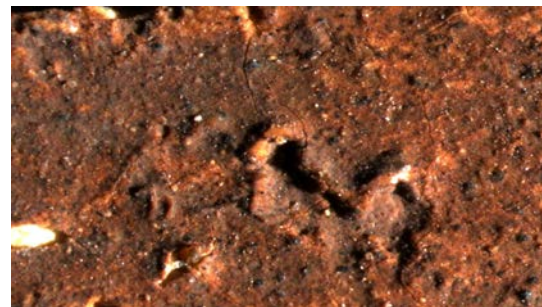
The optical investigation of the orange pigment sample (Fig.23) shows that the paint layer is inhomogeneous in surface and rich in voids.

Figure 23 Photomicrograph of the orange color at the ceiling of Krabia School

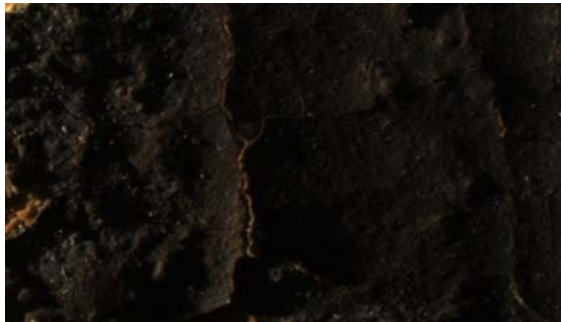
The photograph of LOM (Fig.29) shows the olive-green layer tends to black and the paint layer is inhomogeneous in surface and rich in cracks, voids and coat of dirt and salts grains. The SEM photograph shows disintegration and rich in voids and cracks. The elemental composition analysis of the color surfaces indicate that it is mainly composed of zinc (Zn), calcium (Ca), Barium (Ba), sulphite (S), iron (Fe), sodium (Na) and silicone (Si) (Fig30).

Figure 29 Photomicrograph of the olive-green color at the ceiling of Krabia School

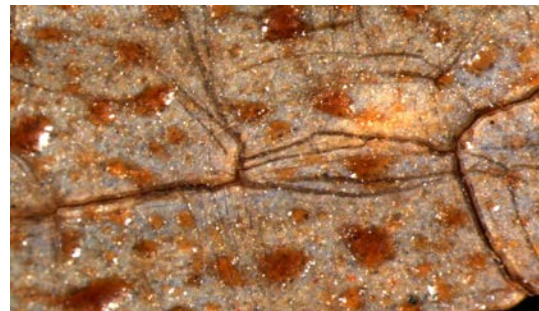
The color was observed in the back ground of the painting. The morphological observation of the Beige color sample (Fig.32) shows that the paint flakes from the under painting, fall of cracks, crumbling and dropping off in small particles, also it is covered with organic spots which resemble organic binder, the presence of these spots may be related to organic varnish.

Figure 32 Photomicrograph of the beige color at the ceiling of Krabia School
