Architectural Heritage Conservation in the City of Qurh: Assessing and Stabilizing Islamic Era Mud Brick Structures

Qurh is an early Islamic city located in the al-Ula governorate, northwest of the Kingdom of Saudi Arabia. It dates to the Umayyad dynasty during the 1st/7th C AD and continued until the Abbasid era during the 6th/12th C AD. The city of Qurh occupies a strategic location on the Syrian pilgrimage route, on the bank of Wadi al-Qura, one of the most important sources that provided the city with abundant quantities of water for drinking and agriculture. The city contains a large number of buildings and various archaeological remains, some of which have been excavated and the rest, which constitutes the largest part of the city, is still under the sand. Since the main building material in Qurh is mud brick, the city's architectural structures are subject to deterioration and collapse. Mud brick is one of our ancestor's precious legacies; however, they face changing factors of deterioration from harsh weather, which caused mud brick decay and mechanical properties reduction which need to be urgently consolidated. To our knowledge, it is the first report on the application

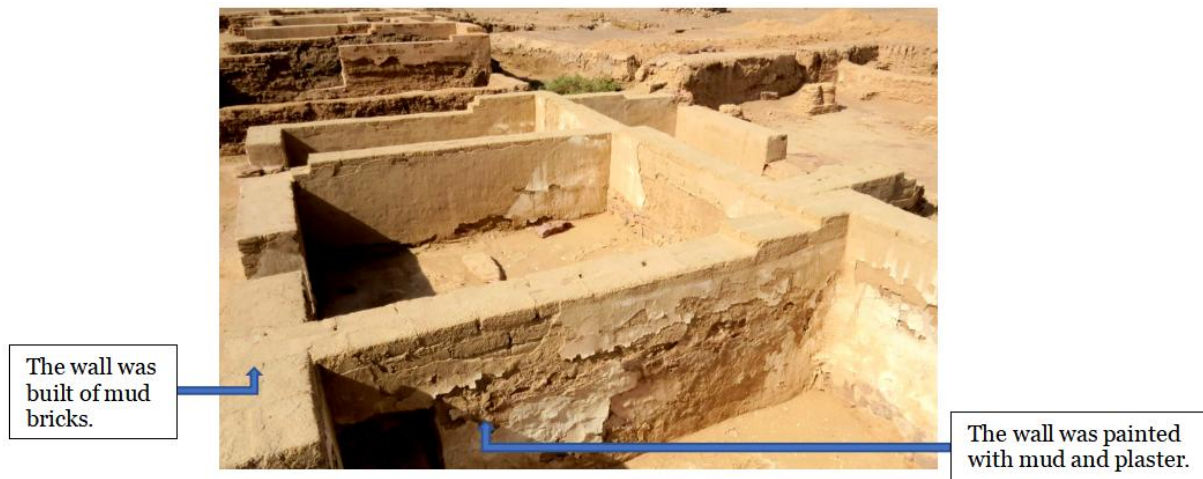
Qurh contains various architectural elements built with multiple materials, including mud bricks, stones, bricks, gypsum, and lime. The walls were built of mud-brick and brick. Most of the walls are destroyed. Numerous finds of buildings constructed of mud bricks and painted with mud and plaster indicate that Qurh had several phases of residential life. Each phase left its own historical and archaeological imprint (Figure 3). Clay bricks are available in a variety of shapes, sizes, textures, and colors, which makes them serve structural purposes in construction. They were used in ancient times and still are today (Calderón, Sandoval, Araya-Letelier, & Aguilar, 2023). Structural clay bricks are widely used in building construction as they provide thermal comfort, among other advantages that make them an attractive material as a cost reducer and easy to use when formed into building blocks (Azeredo, Alexandre, Azevedo, Xavier, & Monteiro, 2015).

Figure 3. The Walls of Qurh was Built of Mud Bricks and Painted with Mud and Plaster

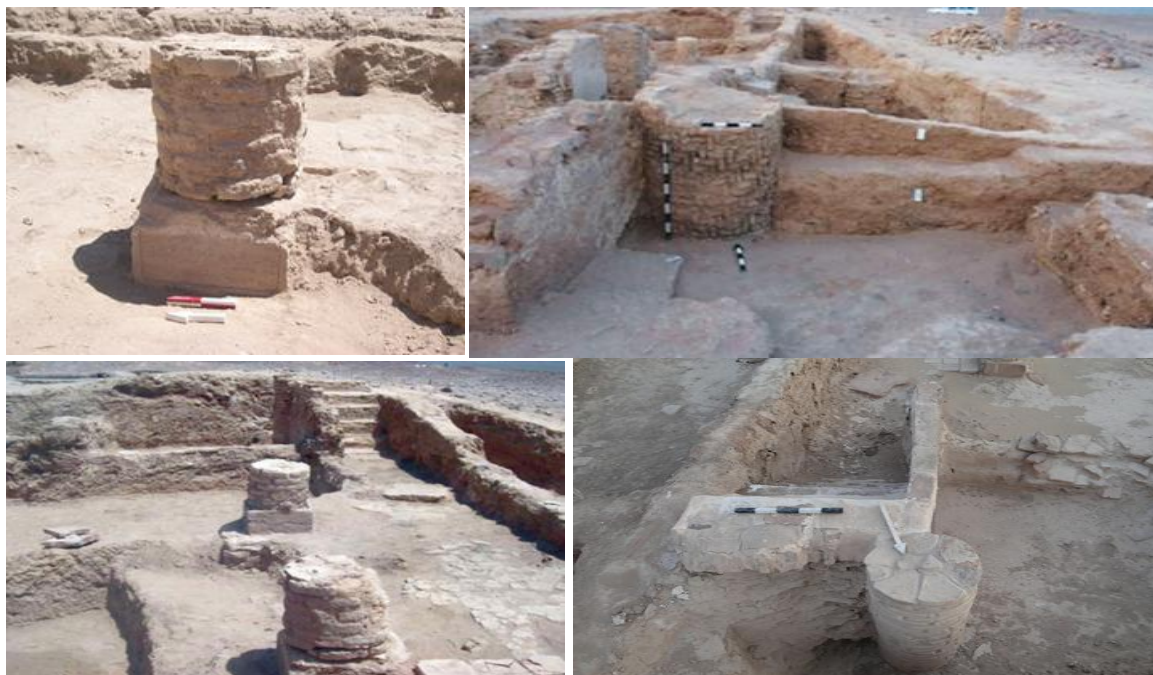
Indeed, the Islamic city of Qurh is a scattered collection of archaeological hills, which confirm the existence of a rich civilization that had great significance in the past. Extensive excavations were conducted in the city by the archaeological excavation missions at King Saud University, as we mentioned above. These excavations indicated that the site constitutes a large Islamic city rich in archaeological and civilizational components and distinguished by its unique decorations and architectural styles. Among the most important architectural features of the city are the buttresses and columns and the clay floors covered with brick tiles (Figure 4). The buttresses are square in shape and different-sized. They have been characterized by the good paving of the stones that have been installed and the filling of spaces between them with plaster material. Some of the buttresses are made of stone, and others are made of mud brick. Columns are constructed from triangular brick tiles where triangles are rounded and repeated until the required height is reached, and the pillars appear in three patterns. First Pattern: slim circular columns with a square stone base where the rib length of the triangles of the wage tiles is 20 cm and the thickness is 5 cm, and they are left with spacers measuring 4mm horizontally and 2 mm vertically to place the fastener anchor material. Second Pattern: it is the same as the first style, but the size of the brick triangles differs, as the length of the two sides of the triangles is 27 cm and the thickness is 5 cm. The third pattern is double circular columns (Al-Aboudi et al., 2019).

Figure 4. Examples of Mud Brick Circular Columns in Qurh

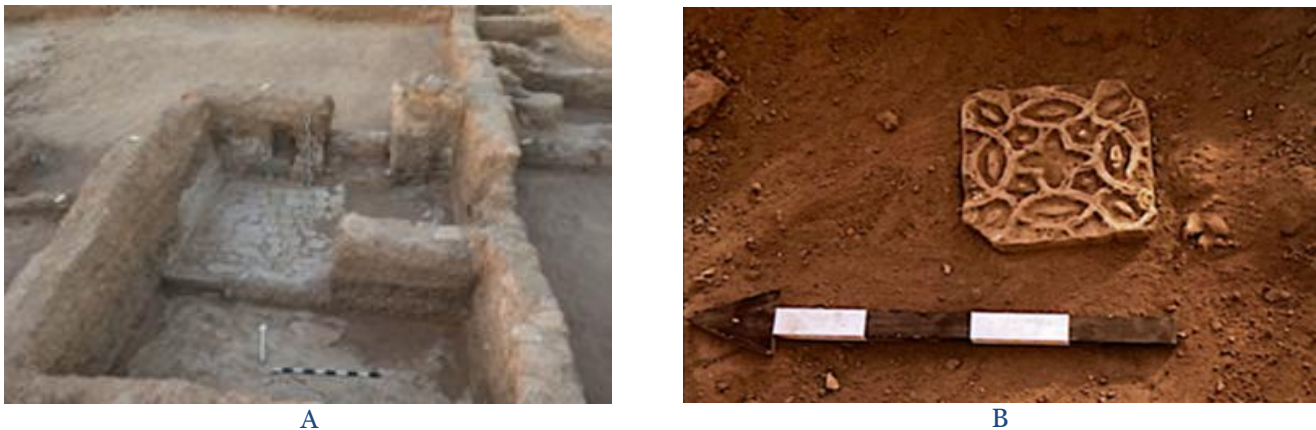
As for mud brick tiled floors (Figure 5), they were formed with different templates in shape and size and used for paving the floors of units, residential facilities, lower doorsteps of entrances and stairs, as well as the cladding

of wall facades. The mud brick tiles came in four different forms: the first form is smooth square tiles with three sizes: large (25 cm×25 cm), medium (20 cm×20 cm), and small. The second one is square tiles contain geometric and plant decorations, printed with a uniform template. The third and fourth forms are triangular and circular.

Figure 5. (A) Smooth Tiles, (B) One of the Decorative Mud Brick Tiles

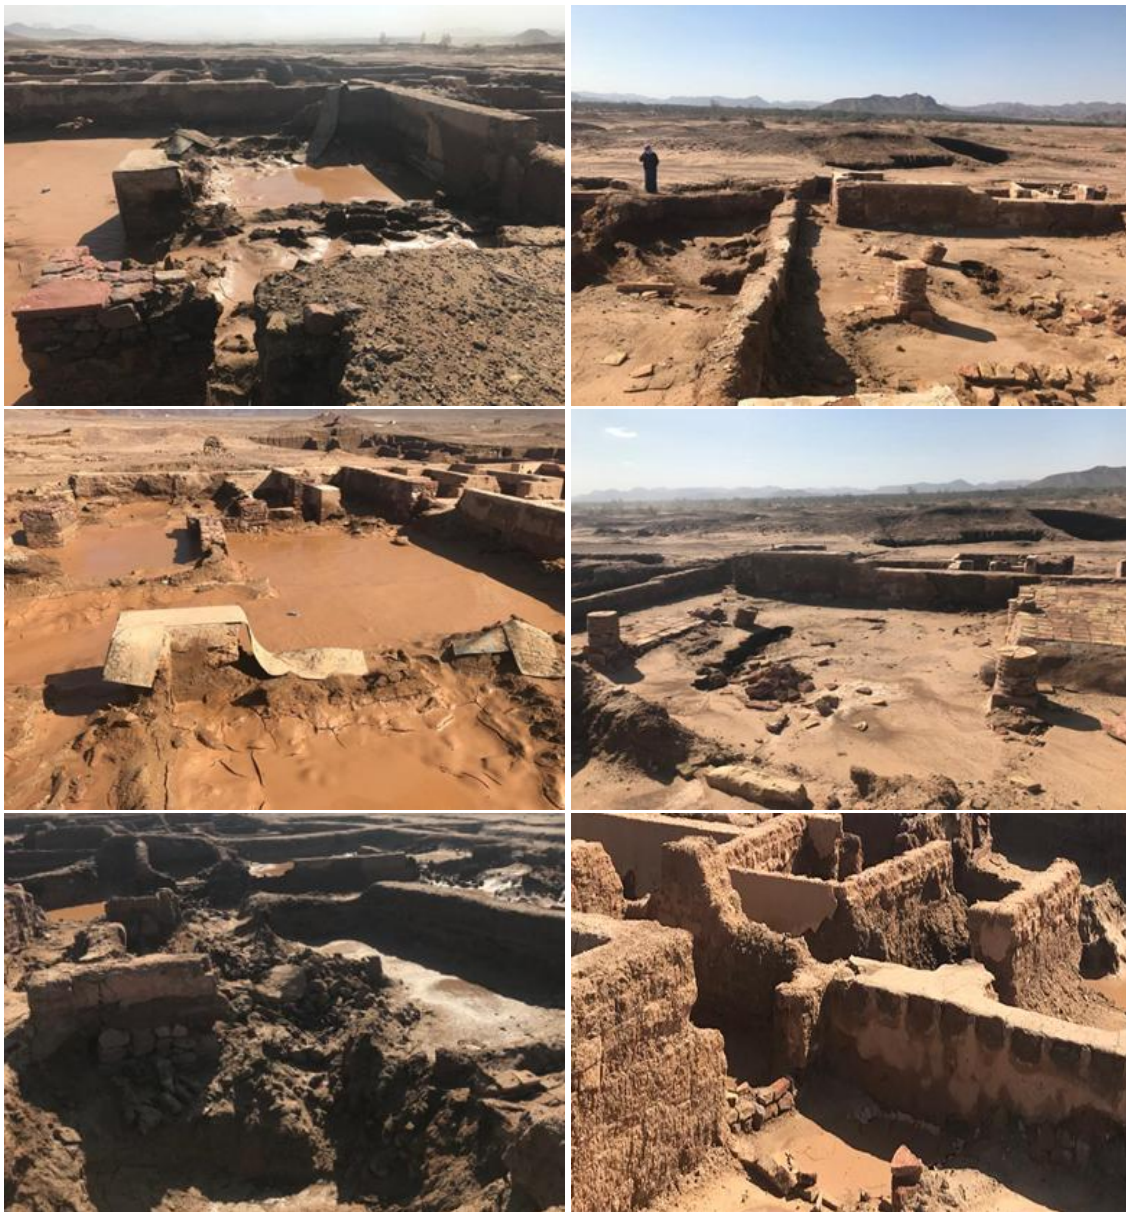
There were many factors that contributed to the destruction of the Qurh, including the risks associated with humans, natural hazards and erosion, the evacuation of the site and the lack of awareness by the local community about cultural heritage, which damaged part of the site under consideration. Mud bricks face challenge factors of deterioration from harsh weather, which causes mud mortar decay and mechanical properties reduction, which need to be urgently consolidated (Figure 6).

Figure 6. The Walls are Totally or Partially Destroyed by Natural Hazards and Erosion, Windstorms and Rainfall Mutually Influence Each Other, Resulting in Destruction of Mud Brick Features on Facades

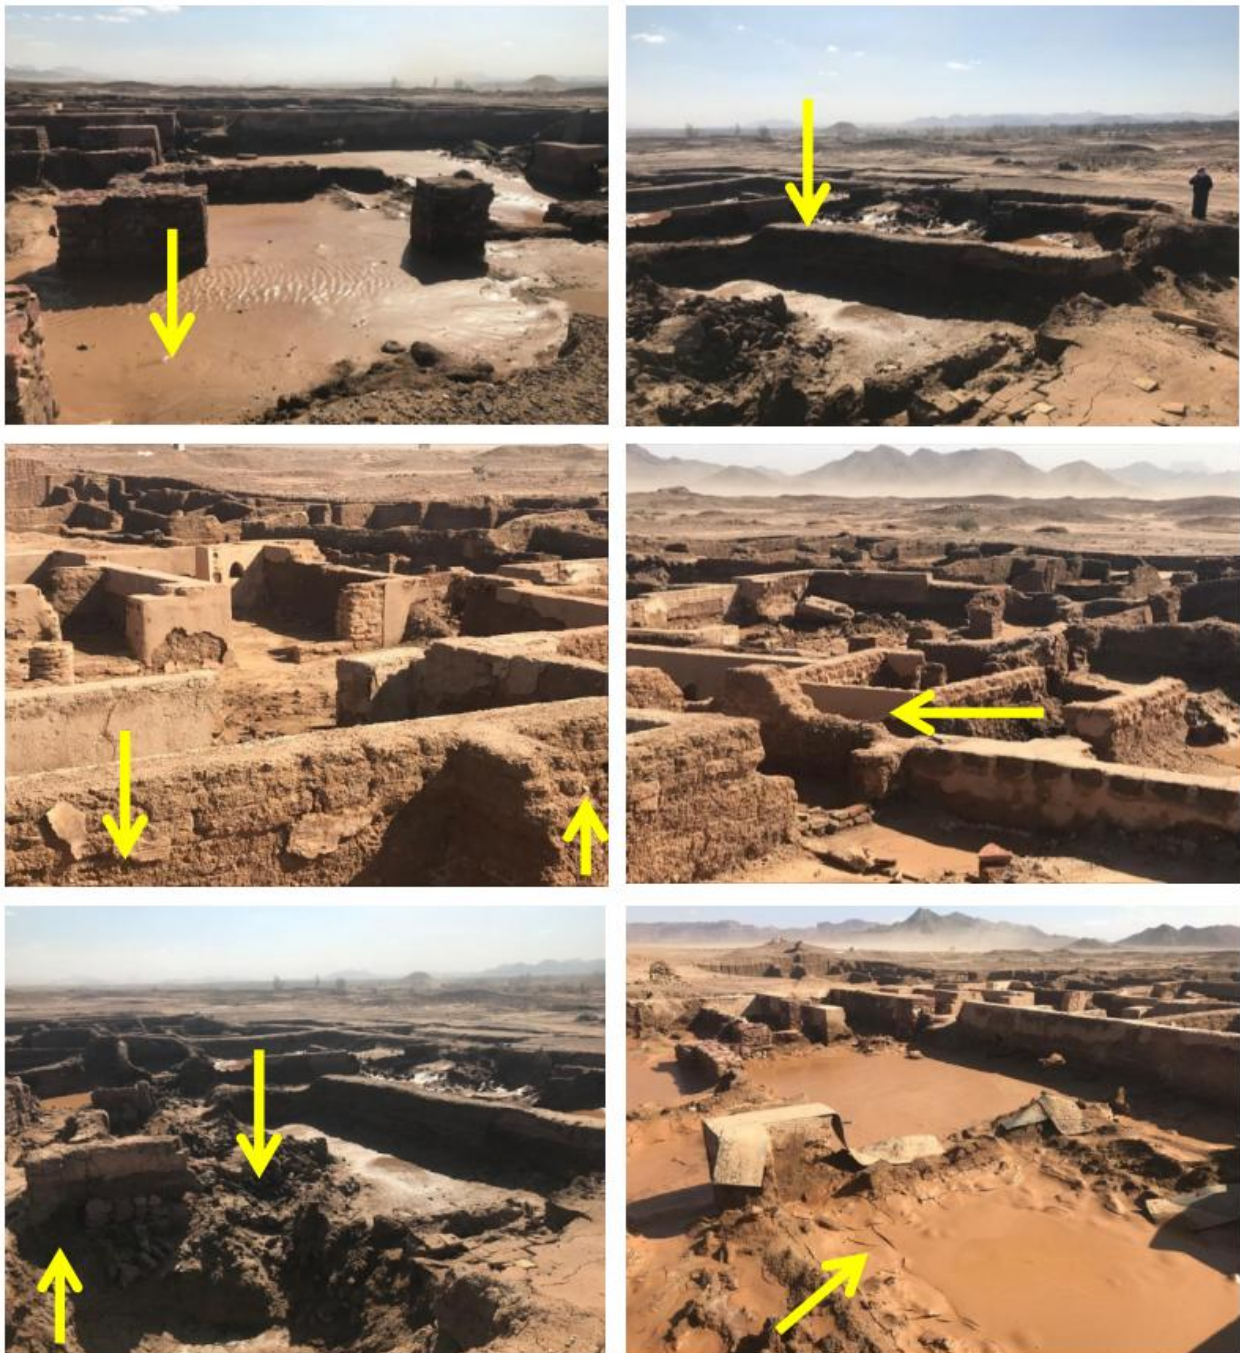
Hazards of climatic mostly affected the mud bricks causing increasing weakness, cracks and disintegration of mud bricks and most facades were deteriorated by wind erosion. As a result of the high temperatures at Qurh, there was an increase in thermal loads, which resulted in cracking and microcracking. Due to severe windstorms and heavy rain, mud brick features on facades are lost (El-Hafez, 2018). Many mud brick walls were destroyed by the sudden rain and blurred the features of the Qurh's mud brick facades (Figure 7).

Figure 7. The Facades of Adobe were Blurred Because of Flash Floods and Heavy Rain
