CHARACTERIZATION OF BRICKS USED IN THE EXTERNAL CASING OF ROMAN BATH WALLS "GADARA-JORDAN"

El-Gohary, M.A.

Al-Naddaf, M.M.

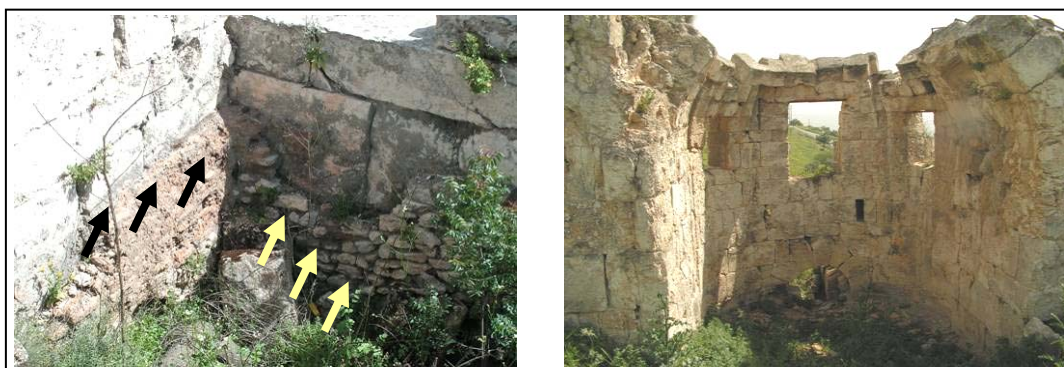
- **Category A:** Resulted essentially from the effect of *physical mechanisms* affecting *bath walls* that lead to create different deterioration forms such as in *unequal settlement, collapsing of internal architectural features and general instability*, (Fig. 3).

Fig. 3: Some *physical deterioration* forms affecting the brick structure

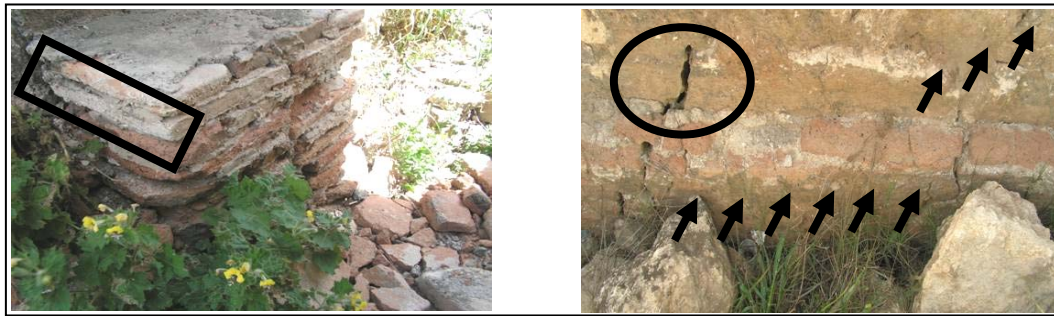
crystallization, poor carbonation of mortars, wearing out of mortar components and water saturation, (Fig. 5).

Fig. 5: Some *biological* deterioration forms affecting the brick structure

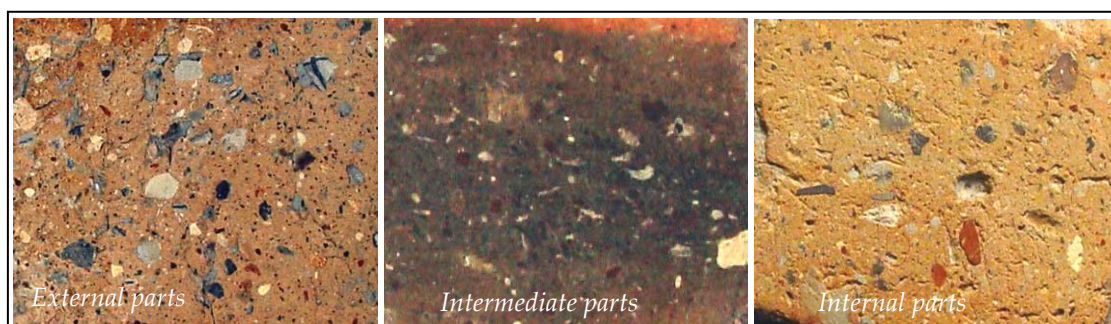
yellowish and black to brown according to firing degree, and the position of brick units in the kiln. Moreover, the *texture* of the samples vary from coarse, (i.e. most of the non clay minerals have a grain size higher than $\frac{1}{16}$ mm, such as sand) to fine grains in which most of the non-clays, made of grains, have a grain size finer than $\frac{1}{16}$ mm, such as silt (Fig. 6).

Fig. 6: Different colors and texture features of brick samples

According to Fig. (6), the color variation from light to dark (Warren, 1999)

may be due to the arrangement of bricks in the kiln, where the exposed parts being burnt to a light color and the parts resting against each others to a dark color. These variations depend on the quantity and quality of the raw materials, and on how a particular kiln or clamp was fired, in addition to the firing conditions of different parts of a kiln. Consequently, visual features of brick units indicate that they are noticeable variable colors such as *dark reddish* on external part of the brick facing directly the firing source, and *Light reddish* or *dark yellowish* characterizing the other part of brick units are due to the semi reduction conditions during the firing processes, while *black, brown and red* in the core middle part of the samples are attributed to the oxidizing

conditions. On the other hand, the sample texture varies from *coarse, intermediate* to *fine* which are particularly due to several reasons such as preparing and mixing of raw materials, as well as firing degree and firing conditions, in addition to the type and the appearances of different grains "raw materials" used in the brick manufacturing, or partly to the culture and tradition dominating at that time. Finally they are due to the deterioration factors affecting the brick units.
