DETERIORATION OF THE FLOOR OF INTERIOR COURTYARD OF SULTAN HASSAN MOSQUE IN CAIRO, EGYPT

Tarek Nazel

Department of Conservation, Faculty of Fine Arts, Minia University, Minia, Egypt

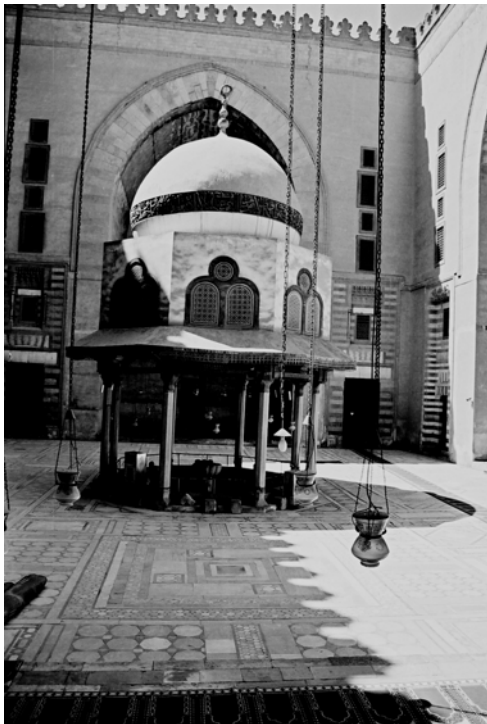
Fig. 1: General view of the studied open courtyard.

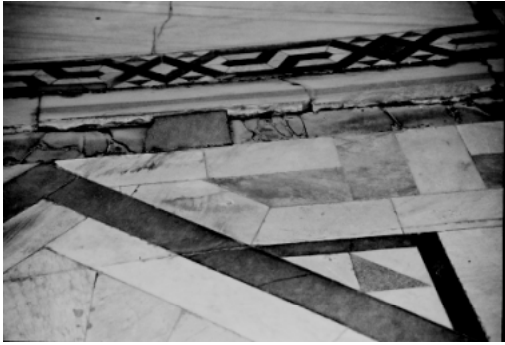
Much of the mortar of the setting-bed and of the joint had lost its cohesion and as a direct consequence detachments took place either between the slabs themselves or between the slabs and the statumen (the stone blocks) or both of them as shown in Fig. 3.

Fig. 3: Mortar of the setting-bed was altered to powder and dispersed on the surface of slabs causing their detachments

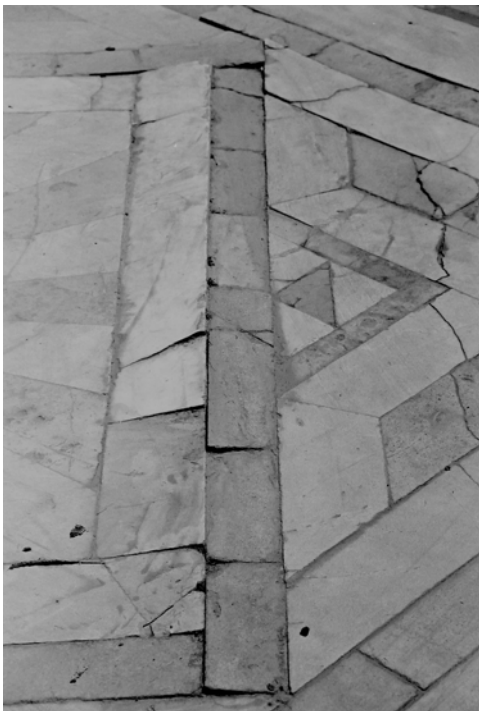
Fig. 4: General view of the severe deformations which affect the marble floor of the courtyard

Many slabs are not uniformly flat where a hump running the entire length of the north side of the courtyard. It was observed that the deformations which affect the marble slabs vary between slight and severe degrees therefore and as a consequence of this variation; different types of deformations were produced. The final result of marble slabs

deformations is their complete detachment from the statumen (see Figures 4 and 5). It can be said that the size of deteriorated slabs in terms of courtyard floor surface area is not less than 35 %.

The author attributes strongly all deformations types of marble slabs in the studied courtyard floor to the thermal expansion and not to the moisture expansion because the ocular examination proved that no deformations were found in the marble slabs around the ablution fountain centralized in the courtyard which is used up till now for washing (wdoa) before every prayer as shown in (Fig 11).

The author recommends do not leave the courtyard of the mosque continuously open especially in the summer season in order to avoid the very serious effect of the sun light and heat on the marble floor. Such this recommendation can be achieved by using mobile shelter which can be opened and closed at the

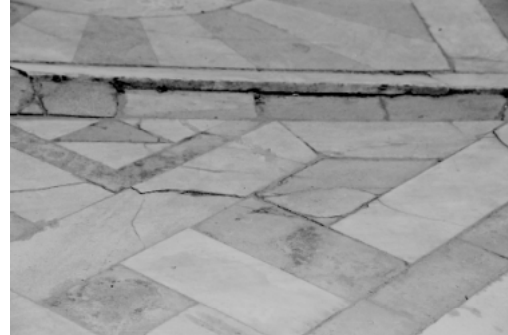
Fig. 5: Detail from the last figure from other angle

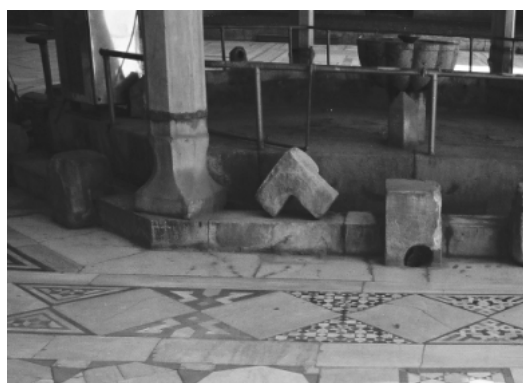
Fig. 11: The slabs which are around the fountain and always exposing to the water do not suffer from any deformations produced by expansion.
