INVESTIGATION OF ENVIRONMENTALLY DRIVEN DETERIORATION OF DIORITE STATUES IN MUT TEMPLE, EGYPT AND CONCEPTS FOR CONSERVATION

Nabil A. Bader¹, Karim M. Moubark², Abd El-Hakim El- Badry³

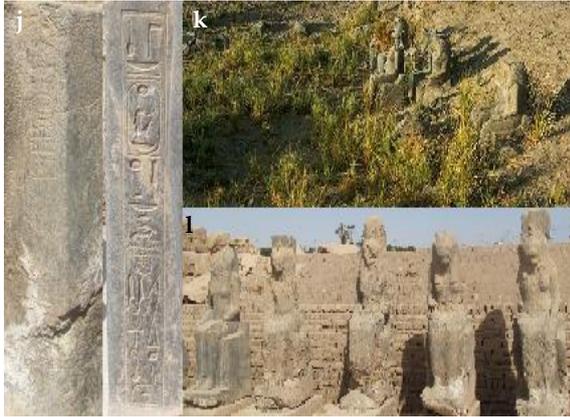
These statues suffer from different deterioration phenomena such as mechanical exfoliation detachment of diorite surface, disintegration of grains, separation of some of these grains and separation of the scales of the surface layer (Fig. 3a, b) as a result of the detachment and losing of the bonds that tie the grains of the surface area and those grains of the layer, (Helmi 1985). Missing parts, erosion of stone surfaces (Fig.3c, d), different type of cracks; macro, micro and wide deep cracks also were noticed (fig.3e). Crystallization of salts and accumulated dirt (Fig.3f,g), change in mineral composition (color & type of minerals), the stone surface of the statues became blackish in appearance due to deposits of dust, dirt, dried vegetation and mi-

cro vegetation (Fig.3h), some diorite statues are particularly damaged and the other fell into flakes and fissure (Fig.3i). Due to these deposits the aesthetic beauty of the statues is seriously affected, so the statues' inscription is difficult (Fig.3j), because the rear of the statue is badly degraded as shown in (Fig.3h). It was suggested that the damage was caused by intense heating and presumably rapid cooling with water, the arid climate of the region and continuous changes between day and night, and seasonal changes in temperatures especially in the south are considered very important participating factor in damage. The surface layers of diorite relief on the sunny sides often reach much higher temperature in July 40°C and relative humidity 50% in December, so the diorite stone can suffer from severe damage due to the cyclic thermal expansion in the range of 40°C and more. Repeated cooling and heating cause about 20% of irreversible deformation and is finally expressed as mechanical damage of diorite. The maximum temperature on the diorite surface due to solar radiation are indirectly related to the color of stone surface (Mauko et al 2006). (Winkler 1994) showed that, the surface temperature of diorite stone could be more than ten degrees higher than the air temperature, this might promote exfoliation, disintegration and cracking of the diorite. A more probable cause of this type of degradation is the infiltration of soluble salts into the rock pores and microcracks and crystallization of the salts therein. Salt weathering is one of the principle deterioration factors in Mut temple, these salts can be observed directly as efflorescence and appear at the surface of the statues. The most cited affecting the site is a moisture source (ground water) resulting from dramatic rise of the water level, great problems with the Mut temple that result from its proximity to the sacred lake and its intermittently high and low water levels. The ground water level under the Mut temple is less than 3m and the salinity minerals of this water have a negative impact upon the diorite statues above and under the ground surface (Richard, 2007). Biological effect of plants is one of the principle factors of the diorite statues at Mut temple resulting from rise of ground water (Fig.3k). The deterioration caused by plants is both mechanical and chemical. In this case the chemical action is influ-

Figure 3 details of deterioration at the diorite statues at Mut temple.

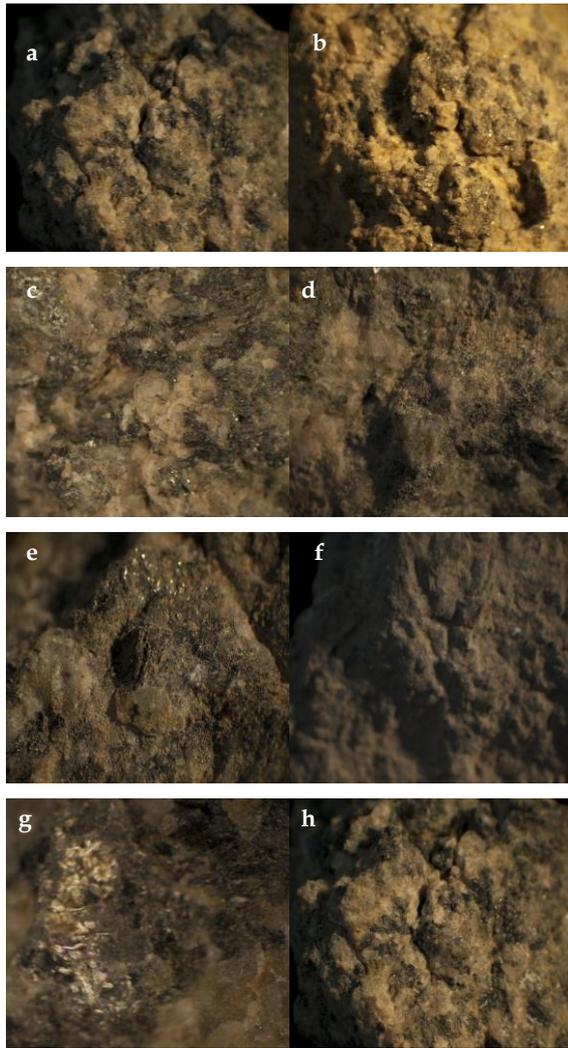
Examination of diorite samples by optical microscope reveals, the samples suffer from several deterioration of its structural coherence. Granular disintegration fractures was detected clearly. Exfoliation, crustification and cracks were also detected. Image showed a black superficial crust covered the grains. Pitting, voids and hollows were noticeable clearly. The observations revealed significant presence of muscovite clearly.

Figure 10 micrographs of investigated samples by LOM (4X) Granular disintegration, fractured, cracks, Exfoliation, cracks, voids, concentrated layer of dirt and mica noticed clearly.
