MORTAR ANALYSIS OF WALL PAINTING AT AMFISSA CATHEDRAL FOR CONSERVATION - RESTORATION PURPOSES

Liritzis, I¹, Al-Otaibi, F², Kilikoglou, V³, Perdikatsis, V⁴, Polychroniadou, E⁵,
Drivaliari, A⁶

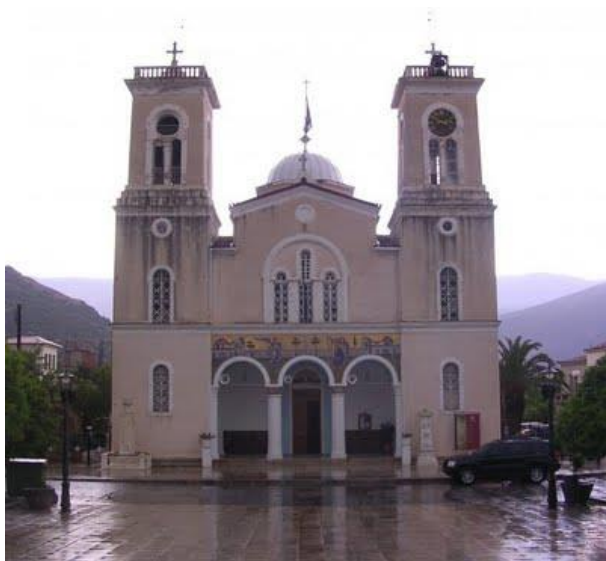
Figure 1. View of the Cathedral (Church of the Annunciation) at Amfissa (near Delphi, Central Greece)

Here we present the first results of pigment and substrate analysis of unique wall paintings of Amfissa Cathedral, made by famous artist Papaloukas, an initial stage towards a conservation project of the church (Fig.1)

That work and the present one result to a prerequisite step to any further conservation work. Sampling locations ranged from in apparent deteriorated and thus exposed wall parts (Schwan, 1998; Baumann *et al.*, 1998) (Figs 1-3 & Table 1).

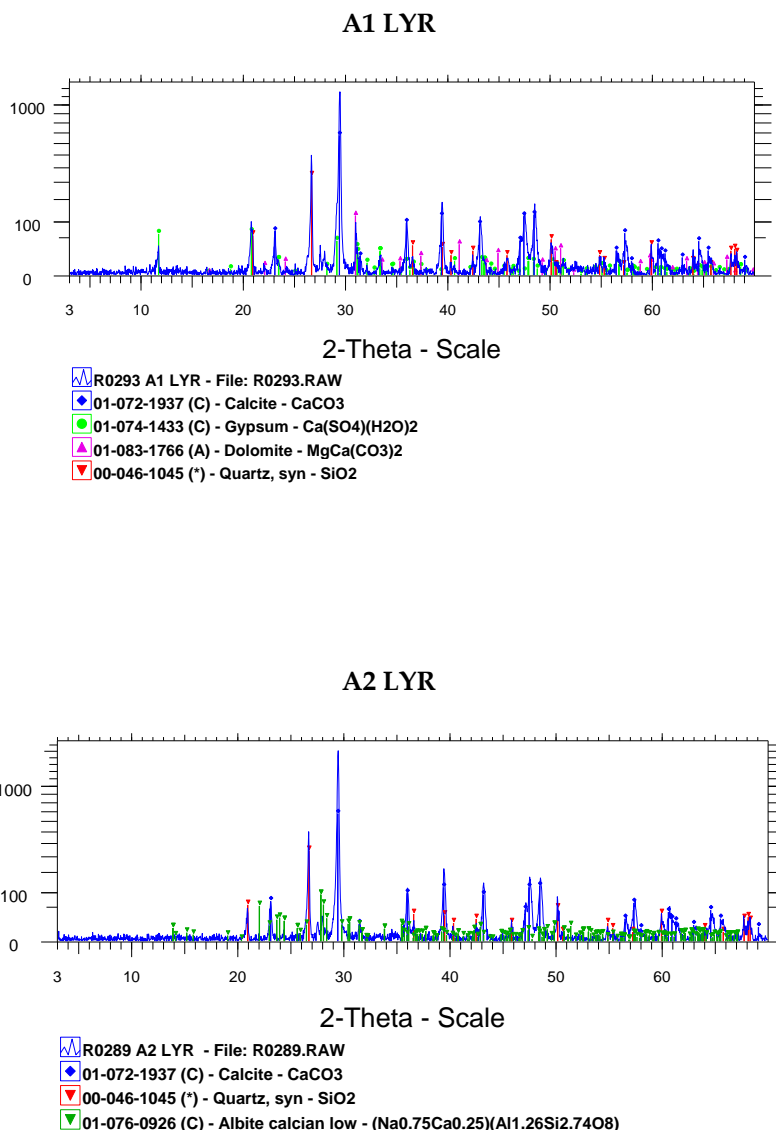
X-Ray Diffraction for powder by D500 Siemens Cu radiation was used. The evaluation used Diffrac Plus of Bruker. The quantitative analysis was carried out by Rietveld method. Qualitative and quantitative content of samples is given in Table 1 and Figs.4). Samples are calcareous mortars with significant quartz and lower feldspars, while apparent

presence of gypsum is in only two samples (A1, A8) derived mostly from upper coating. Optical microscopy Polished cross-sections of the samples, containing all the microstratigraphy from the surface to the mortar substrate, were prepared and studied by an optical polarizing microscope in reflected light. Micro photos were taken, by a digital camera, which were analyzed by image analysis techniques, using the software Image Pro Plus.

Figure 4. XRD spectra of A1, A2

XRD, Microscopic examination and SEM analysis showed that the mortars are calcitic. The mortar consists of calcite grains with small amounts of quartz or albite. In all cases two generations of calcite were distinguished; primary calcite grains up to 2mm and very fine calcite material with grain size less than 2 μm . That means that the plaster material was primary a mixture of calcite grains and slaked lime ($\text{Ca}(\text{OH})_2$), which was then transformed to secondary calcite during drying by carbonization. This secondary calcite acts as a cement binder to the primary calcite grains. The final surface layer consists mainly of secondary calcite. Characteristic in the microanalysis was that in the primary calcite grains only Ca was detected, as expected, while in the secondary calcite matrix Si and Al were found, which are impurities in the slaked ($\text{Ca}(\text{OH})_2$).

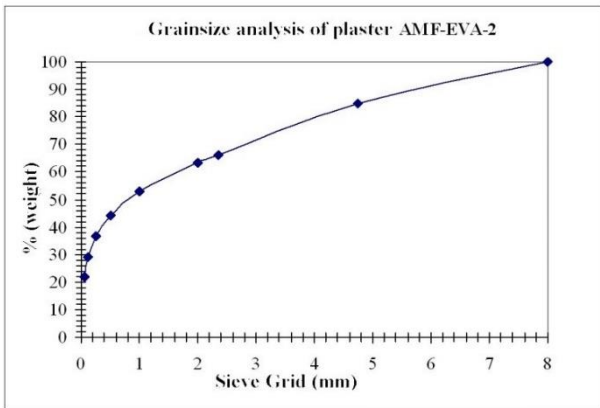
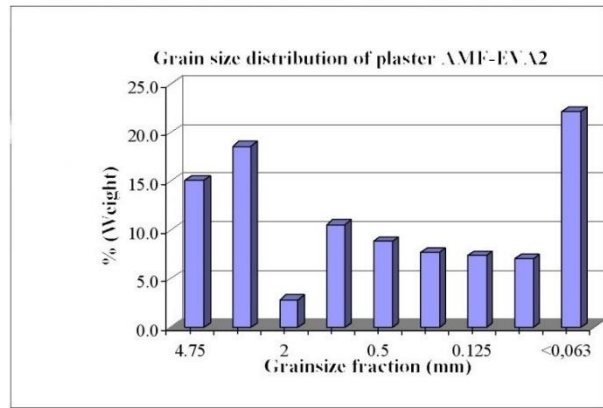
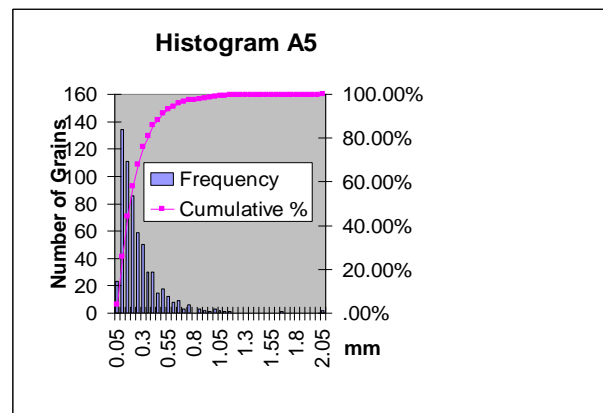
Figure 6 Grain size distribution of samples A1-A8 and EVA-2 in histogram and cumulative curves.

The granulometric distribution are given in respective histograms of Figs.6. Around 60% of grain sizes are less than 0.30 mm, and 50%/w of EVA-2 plaster is <1mm.. The morphology of inert matter with rounded grains is characteristic for rivers or sea sand.

The proportion of the adhesive cement (secondary calcite) is of the order of 22 to 25%.

The morphology of inert matter with rounded grains is characteristic for rivers or sea calcitic sand. The proportion of the adhesive cement (secondary calcite) is of the order of 22 to 25%.

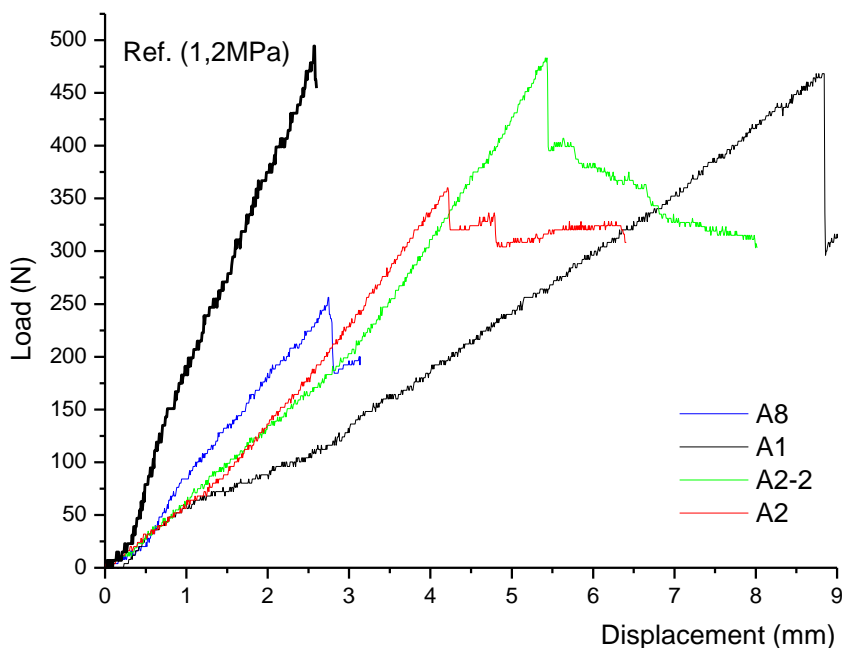
The compressive strength of mortars is described in the first step of the curve, wherein the outer layers are compressed, by a relatively small surface (Fig.8) The value of the maximum load is proportional to

their maximum strength. The maximum displacement is inversely proportional to the hardness and consistency of samples and is proportional to the thickness of the sample.

A comparison of the diagrams obtained from the samples studied to that of the reference sample it is estimated that the mechanical strength (*tensile strength*) of mortars ranges between 0.5-0.8MPa (modern concrete reaches at least 50 MPa). This is considered a low mechanical strength mortar that resembles Portland cement- hydrated lime mortars used for straw bale construction (MacDougal & Vardy 2014).

Figure 8. Load versus displacement of analysed mortars.

For the study of the mechanical strengths of mortars an approximation method is applied that relates the assessment of the hardness of the mortar to macroscale (macro-hardness). During measurement the distortion caused on the sample surface by a metal ball (diameter 8.5mm) is recorded, by applying onto it an increasing load. Of the samples collected and submitted to the above test, only four yielded usable deformation curves, the rest was loose (Table 2).

The level / extent of mechanical strength was determined by comparing the power vs. displacement diagrams of the test samples with the reference chart, which has emerged from the study of a plaster with natural aggregates (river sand). The value of the compressive strength has been determined in cubic samples, with unconfined compression.
