SEISMIC EVALUATION OF MASONRY MONUMENTS THROUGH THE UTILIZATION OF IN SITU MEASUREMENTS CASE STUDY ON A BYZANTINE BASILICA

Thomas N. Salonikios* and Kostantinos E. Morfidis

Institute of Engineering Seismology & Earthquake Engineering EPPO-ITSAK, P.O. Box 53 Finikas

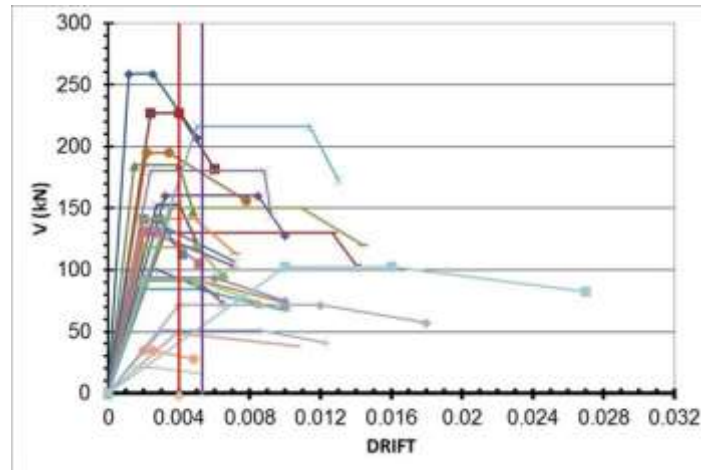
Figure 5. Load-drift envelope curves for the considered specimens. Limits between states: damage limitation (0-4‰), significant damage (4-5.3‰) and near collapse (>5.3‰). Horizontal axis represents the ratio of horizontal displacement of the specimen (δ) divided by its height (H), $DRIFT = \delta/H$.

Figure 5 presents the three points that define the tri-linear envelope curve of the load-drift curve for the considered specimens. The ascending branch is defined by the zero point located at the beginning of the axis and the curve point located at $0.8V_{max}$. This branch intersects the horizontal line defined by the maximum strength of the specimens. The descending branch connects the point of maximum strength with the 80% strength reduction point of the behavior law curve for the specimens. An equivalent yield point can be defined at a drift ratio of 2.0‰. In this case, it is possible to develop an equivalent ductility capacity for the masonry wall of approximately $\mu_{mid,eq} = 5.3/2.0 = 2.6$. The aforementioned comparisons shows that the masonry walls are not quite brittle when subjected to seismic loads. In some cases, the equivalent ductility factor is higher than the medium

ductility value, thus indicating that there are inelastic deformation reserves that are quantified in Figure 5.

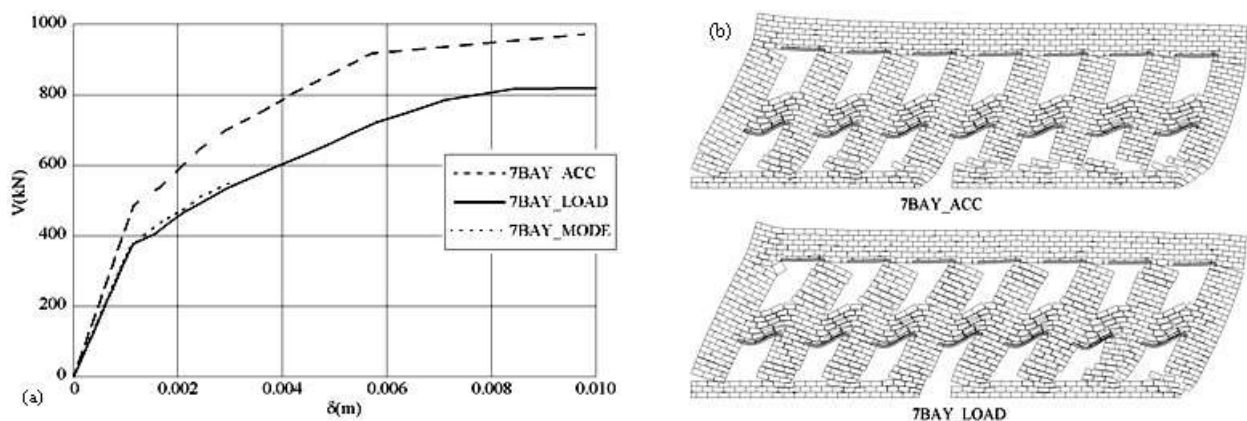
Figure 7. (a) Load-deformation curves for two-story, seven-bay masonry frames with discrete finite elements, (b) failure types

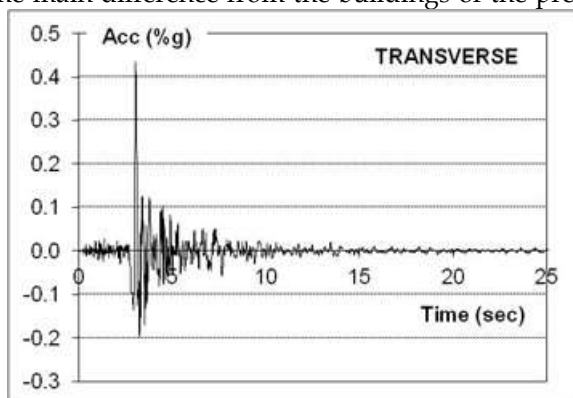
Accelerogram and response spectrum for the Pyrgos Earthquake, 1993, Mw=5.5, Trans. Direction

Figure 9. Recorded accelerogram and response spectra for the Pyrgos earthquake normalized (0.67 of the maximum value) at damping levels of 5%, 10% and 20%.

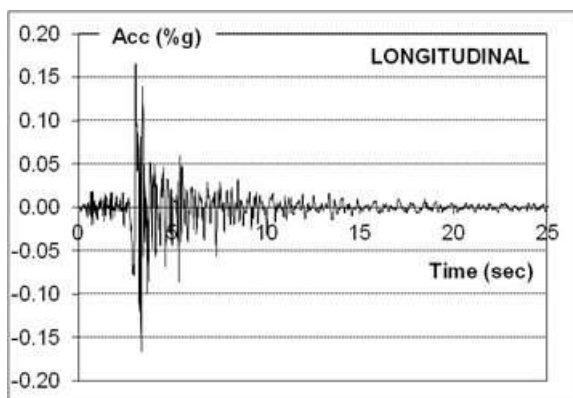
Accelerogram and response spectrum for the Pyrgos Earthquake, 1993, Mw=5.5, Long. Direction

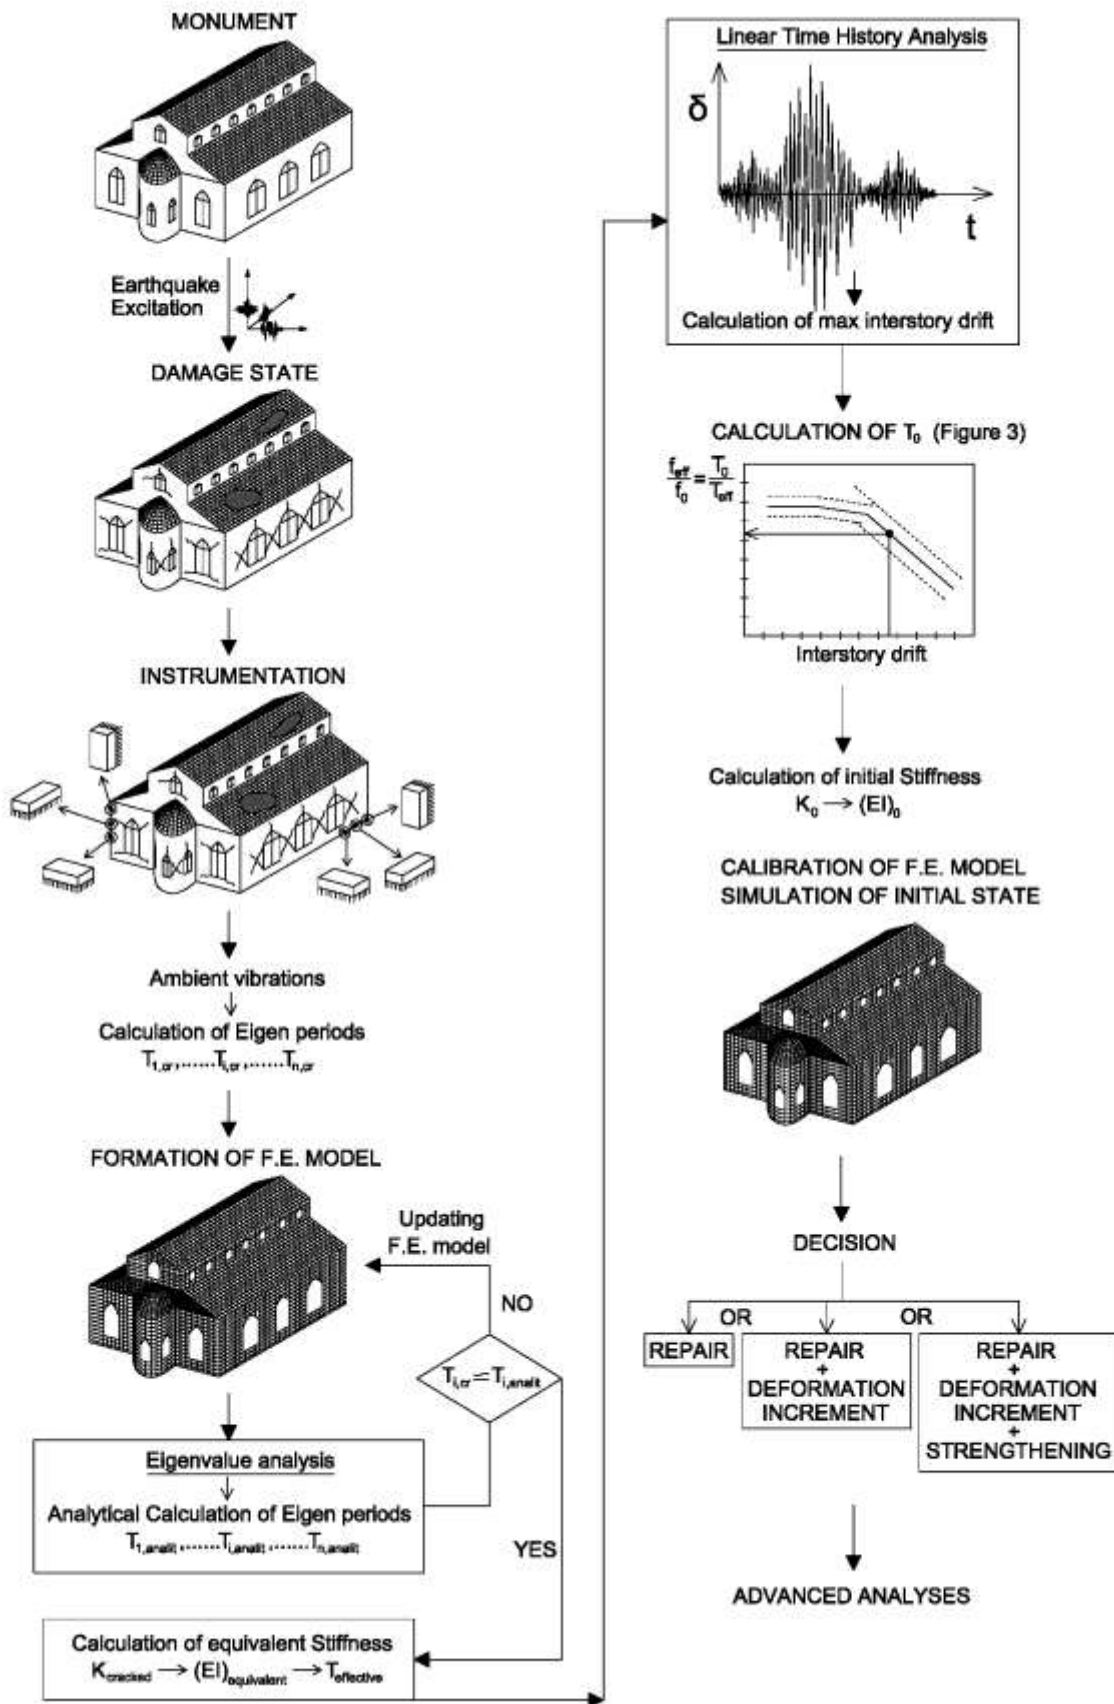
Figure 15. After-event method.

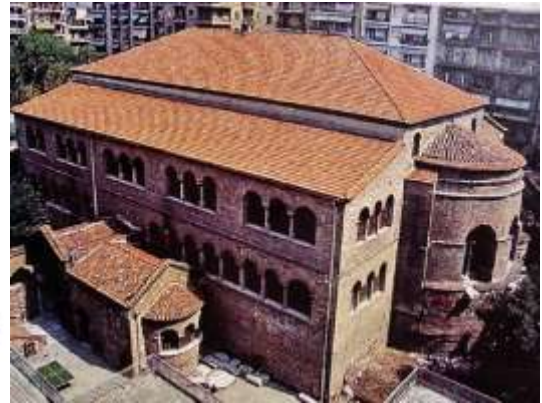
Figure 16. Left: North - East view of the model of the temple (Initial construction phase). Right: South - East view of the temple (Current period construction phase).
