PHYSICAL, MECHANICAL AND MICROSTRUCTURAL CHARACTERIZATION OF BASILICA PLASTERS AND BOULEUTERION MORTARS IN SMYRNA AGORA

Burak Felekoglu¹, Eren Gödek*² Akın Ersoy³, İ.Murat Kuşoğlu⁴, Altuğ Hasözbeğ⁴

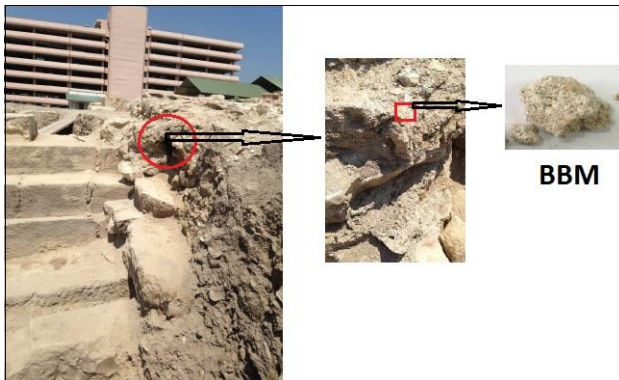
Blockade mortar between stones was detached from Bouleuterion (BBM). It was a weak and porous mortar used for filling the spaces between blockade stones. Approximately 50-100 g of mortar was collected from the site shown in Figure 3. Another mor-

Figure 3. Bouleuterion blockade mortar between stones (BBM).

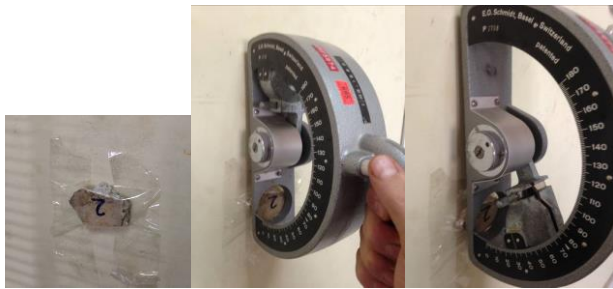
Figure 6. Surface hardness measurement of P2 specimen with Pendulum type Schmidt hammer (Sound specimens with no damage after pendulum hammer hit)

At least four specimens tested with pendulum type Schmidt hammer. Due to the geometrical compatibility plaster sample specimens (constant thickness), they were vertically fixed to a flat surface with a band. Schmidt hammer is located to hit the specimen surface and rebound number is measured. As seen in Figure 6, there was no problem and rebound number is determined for P2 specimens. However, no rebound value was recorded due to the low strength of P1 specimens. P1 specimens damaged with the hammer hit (Figure 7). Mortar specimens were geometrically irregular and they should be cut in parallel before hammer testing. BWM specimen particles were easily cut and tested due to their sufficiently high strength. However, BBM specimens fractionated while cutting and no Schmidt rebound number was obtained from the fractured pieces. It is possible to evaluate that the strength grade of P1 and BBM are less than 1 MPa which is out of the measur-

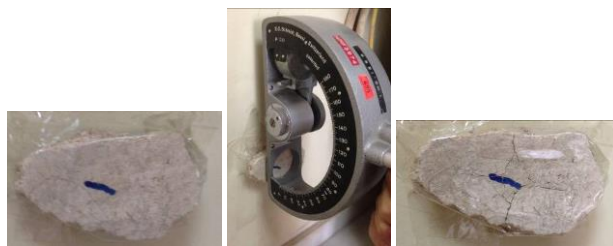
Figure 7. Surface hardness measurement of P1 specimen with Pendulum type Schmidt hammer (Crushing and fracture of specimen after pendulum hammer hit)

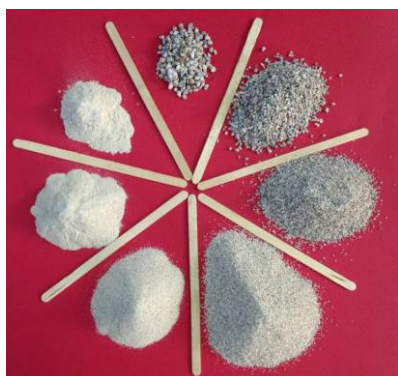
Figure 9. Aggregates of P1 plaster sieved by ISO 565 series meshes (4, 2, 1, 0.500, 0.250, 0.125 and 0.063 mm). All aggregates of P1 passed 4 mm meshes.

Identification of plaster and mortar types requires the granulometric analysis of samples by mechanical sieving. For this purpose plaster and mortar specimens gently ground in an agate mortar. Care was taken not to crush aggregates. This method has proved its success, if plaster or mortar is weak in terms of aggregate matrix bonding ability (Figure 9). However, if aggregate-matrix bond is strong, the grounding affect may also cause the fracture of some aggregates. In this case, underestimation of aggregate particle size distribution from the actual value can be expected (Figure 10). ISO 565 series sieve meshes of 8, 4, 2, 1, 0.500, 0.250, 0.125 and 0.063 mm were used and the granulometry curves are plotted in Figure 11 (Moropoulou et al., 2000). Granulometry of pure aggregate phase can also be obtained by sieving mortar remnants after dissolution in dilute HCl. However, in that case the carbonates based aggregate will be lost during the acid attack (Franzini et al., 2000). Due to this reason, only mechanical separation technique (by gently grounding in agate mortar) is used.

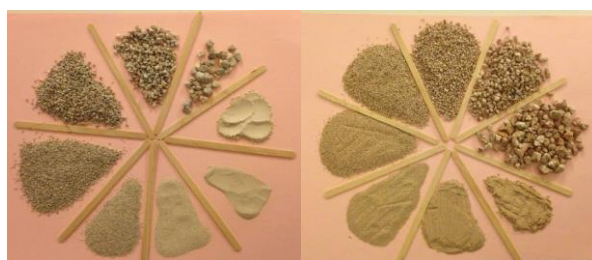
Figure 10. Aggregates of a) BBM and b) BWM mortars sieved by ISO 565 series meshes (8, 4, 2, 1, 0.500, 0.250, 0.125 and 0.063 mm). All aggregates of BBM and BWM passed 8 mm meshes.

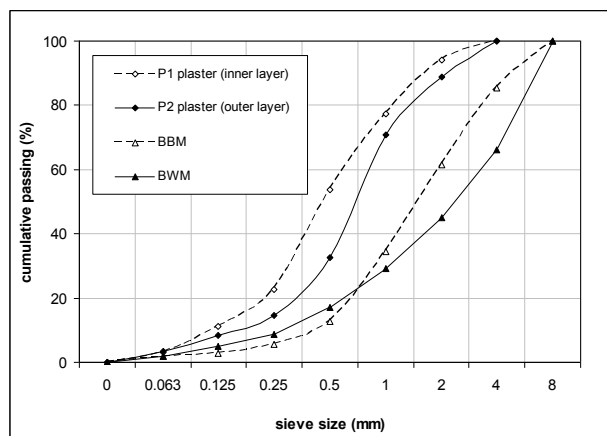
Figure 11. Particle size distribution curves of P1, P2 plasters, BBM and BWM mortar aggregates

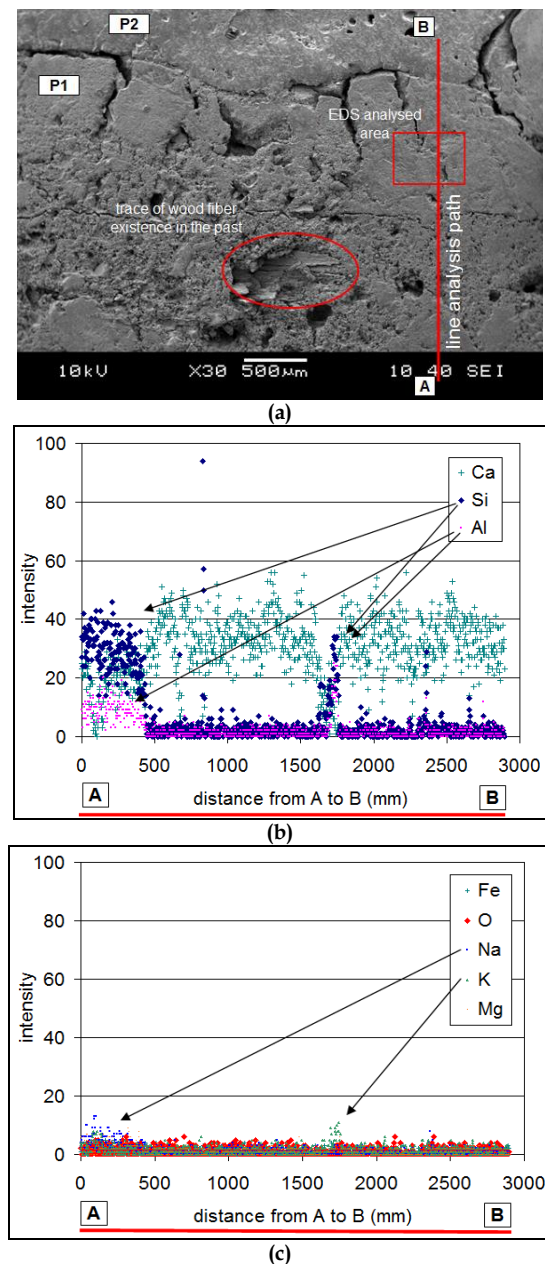
Secondary electron (SE) images of P1 and P2 plaster layers with the boundary region captured at 30x magnification is presented in Fig 15a. While the P2 plaster layer (outer) is comparatively more compact, P1 plaster layer (inner) exhibit more porosity. In some sections polishing was not possible due to the weak matrix structure of P1 plaster layer. A linear EDS analysis has been performed from the point A to B in order to observe the element distribution (Ca, Si, Al, Fe, O, Na, K, Mg) of P1 and P2 plaster layers (Figure 15a red line) (Riccardi et al., 2007). Both plaster layers are mainly composed of Ca element and Si, Al, Na and K elements were observed when the aggregates exposed to the polished surface (Figure 15b). Other elements detected as traces (Figure 15c). These results are in conformity with the chemical compositions of the detected aggregate types (quartz, biotite and feldspar minerals) from petrographic analysis.

A rectangular area plotted in Figure 15a is also analyzed to determine the composition of matrix phase of P1 plaster. EDS analysis indicated the existence of C (23.2%), O (24.8%) and Ca (51%) elements respectively. This composition is significantly different from the theoretical composition of calcite (C(12%), Ca(40%), and O(48%)). Note that unexpected high amount of C atom may arise from the carbon band background which was used to provide the conductivity of specimen. A small amount of Si element (1.1%) is also detected possibly due to the presence of aggregates close to the surface of polished section. A closed view of a point captured at 2000 \times magnification from this rectangular area is presented in Figure 16. Based on crystal morphology observed in this figure, these formations may be micritic calcite (CaCO_3) crystals which previously formed due to the carbonation of lime (Çizer *et al.*, 2008).

Some traces of natural fibers were also detected in P1 plaster (Figure 15a, marked with red circle). These traces were possibly due to the addition of short cut wood fibers into the P1 plaster mortar at fresh state. Fiber addition may improve the cracking resistance of plaster mortars by bridging the cracks. Another advantage of addition of natural fibers is the decrease in the unit weight of plaster which brings application easiness. However, natural cellulose based fibers may degrade in alkaline environments. Since lime-based mortars are highly alkaline these fibers may deteriorate with time and possibly only their traces are observable. It should be noted that a lightweight plaster incorporating high amounts of pores (previously fibers) also exhibit mechanical weakness.

Figure 15. SE images of P1 and P2 plaster layers with the boundary region captured at 30 \times magnification (a), line analysis results Ca, Si, Al (b), line analysis results Fe, O, Na, K, Mg.
