MORTAR AND PLASTER ANALYSIS AS A DIRECTIVE TO THE DESIGN OF COMPATIBLE RESTORATION MATERIALS IN FRANGOKASTELLO (CRETE)

In this study the results of physico-chemical analysis for mortar and plaster specimens from Frangokastello castle in Sfakia (western Crete) and the subsequent designing of compatible restoration mortars are being presented, as part of a wider project for the sustainable management of the monument.

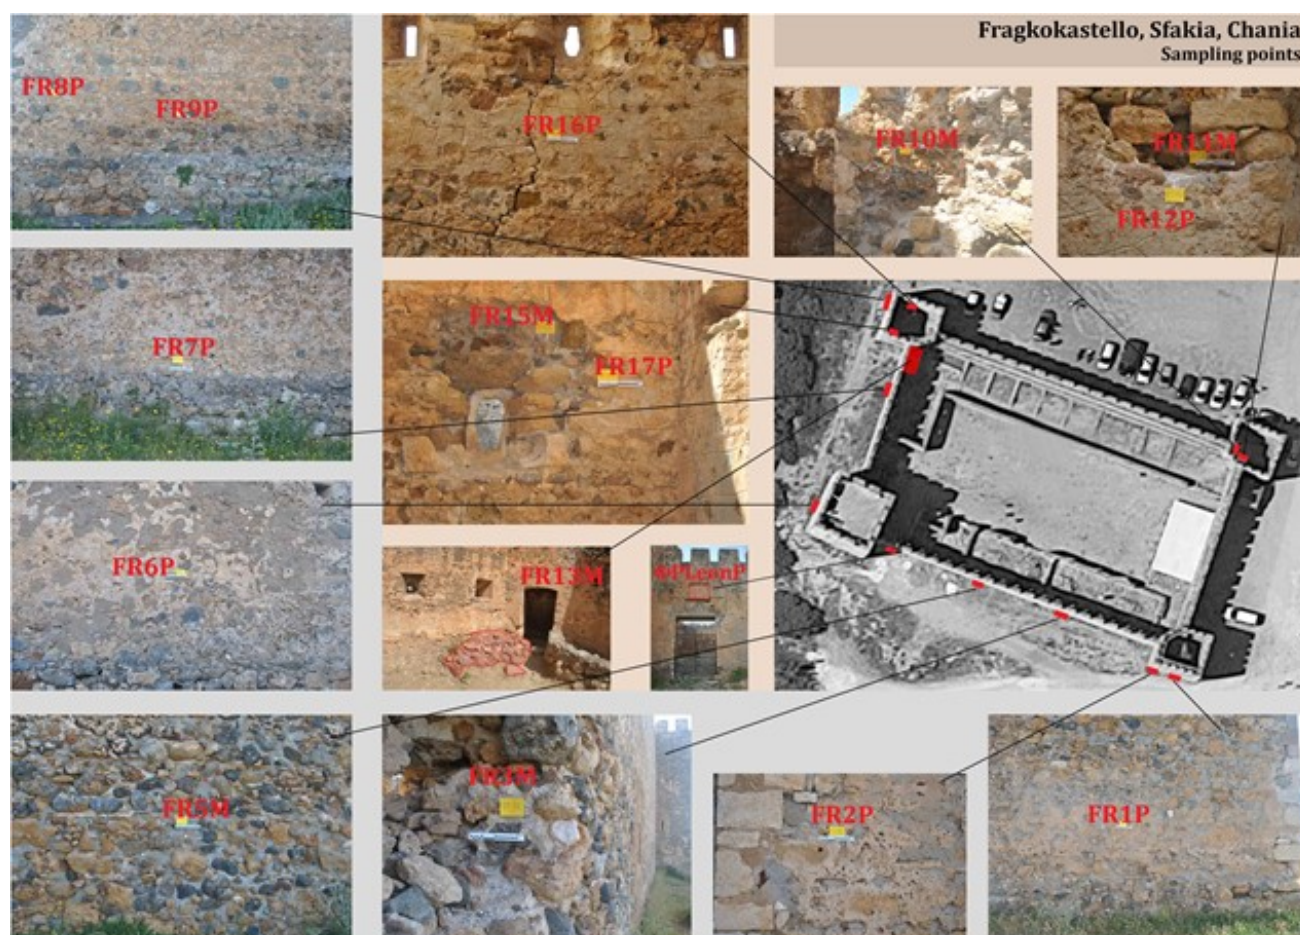
Figure 2. Overview of sampling points on Frangokastello castle.

Every sample receives a laboratory code. The term FR designates for Frangokastello, followed by a number and at the end "M" or "P" indicates mortar or plaster specimens, respectively. Totally, sixteen small samples were extracted, specifically six mortar and ten plaster samples.

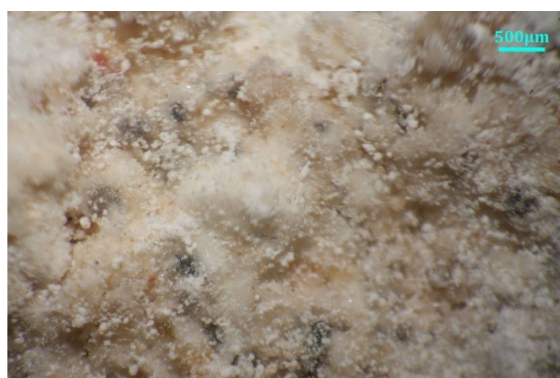
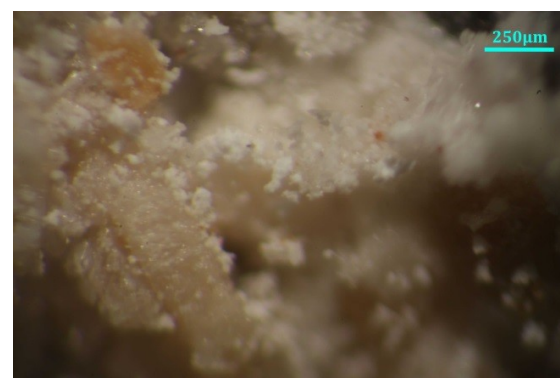
Figure 3. Optical microscopy pictures of mortar FR3M; a whitish mortar with a high content of lime binder and much fluorescence on its surface.

(FR10M, FR11M and FR15M). This hypothesis was confirmed later from the chemical examination of the specimens. The specimen FR3M (as shown in Figure 3) was of interest, as it was extracted from the internal layer of the masonry of the south wall. Consequently, it could probably be an original Venetian mortar which survived all the repairs and alternations of the castle. This hypothesis was reinforced by its macroscopic characteristics. The abundance of binder, the whitish colour and the sporadic ceramic fragments made it comparable to other Venetian mortars from similar structures identified and analysed in the past (Biscontin et al., 1993). Moreover, it was the only one that contained plenty of white crushed limestone aggregates, a more demanding practice that involves transportation and processing of aggregates.¹

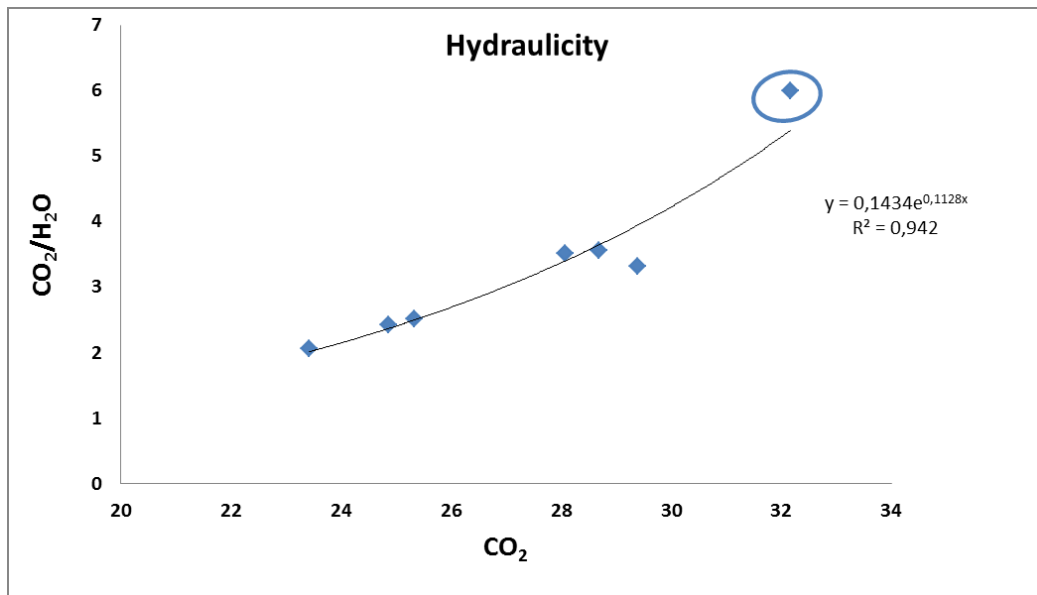
Figure 10. The CO₂/H₂O to CO₂ diagram of the analysed mortars, expressing their hydraulicity.

The thermal analysis results identified the reactions of the hydraulic compounds in temperature ranges up to 1000°C. The presence of gypsum was confirmed due to the endothermic peak in temperature ranges between 125-135°C for specimens FR10M, FR11M, FR12P and FR16P. Furthermore, the estimation of the CO₂/H₂O ratio, which is in fact the ratio of the carbonates to the hydraulic compounds, constitutes an indicator about the hydraulicity of the mortars (as shown in figure 10). For values 0 to 5 the mortar is regarded as hydraulic, from 5 to 10 as partly hydraulic, while for values greater than 10, the mortar is air-setting (Maravelaki-Kalaitzaki et al. 2005, 2011). All of the mortars were classified as hydraulic (FR3M, FR10M, FR11M, FR12P, FR15M, FR16P), or semi-hydraulic (FR17P). This leads to an assumption that the

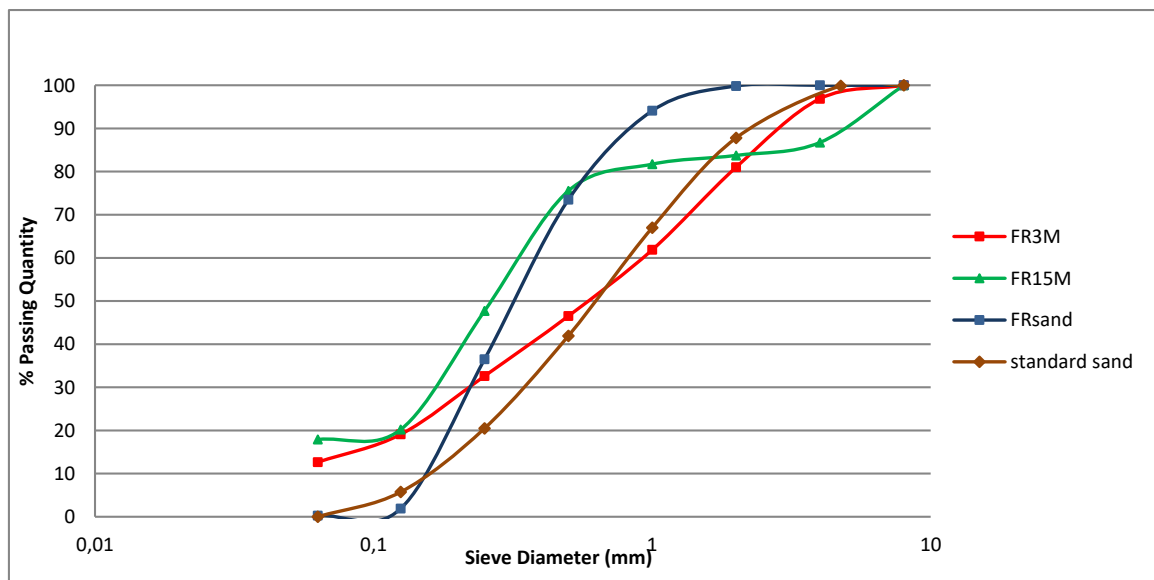
Figure 11. The granulometric curves of the mortar and sand samples, compared to the standard sand's.

The grain size distribution of FR3M and FR15M are demonstrated in Figure 11, compared to the standard sand's granulometric curve and also to the local sea sand's curve. There is a clear difference in the production technology and know-how on mortars between them. The granulometric curve of FR3M, which appears to be of Venetian origin, is very close to a standard sand's curve and shows a normal grain size distribution. The curve of specimen FR15M, which is

classified as an Ottoman mortar, is rather irregular, showing a high proportion of large aggregates, a low proportion of middle-sized ones, and again a high one of small grains. It is generally accepted that the Venetians possessed a great knowledge on construction technology and materials and a good grain size distribution is expected in their mortars. On the other hand, during the Ottoman domination in Greece the architecture and building quality deteriorated (Bouras 1998; Moropoulou *et al.*, 1998).

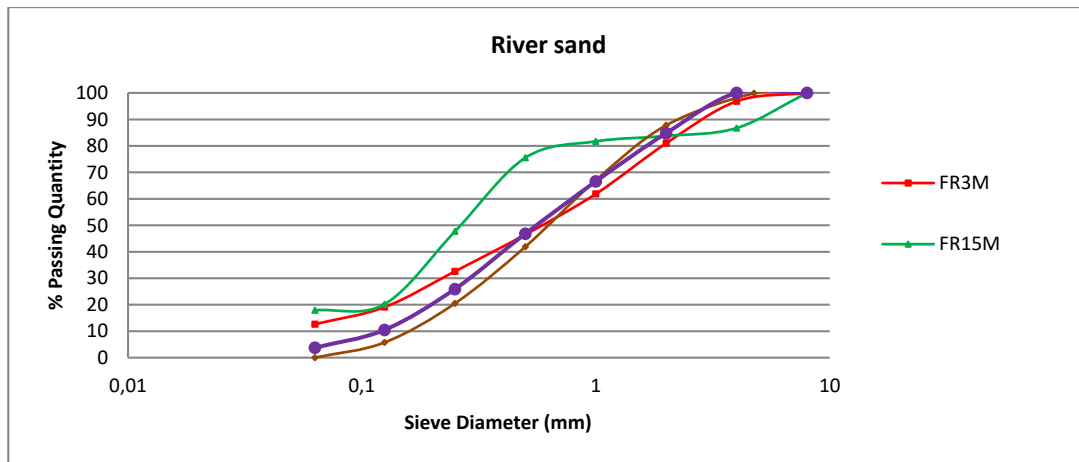
Figure 12. The selected river sand's granulometric curve in comparison with the ones of FR3M, FR15M and the standard sand.

The selection of aggregates was mainly determined by their grain size distribution. Several samples of sand were sieved in order to obtain their grain size distribution curves and compare them with the analysed historic mortar's and the standard sand's curve.
