THE ADOBE BARREL VAULTED STRUCTURES IN ANCIENT EGYPT: A STUDY OF TWO CASE STUDIES FOR CONSERVATION PURPOSES

Abdou A. O. D. El-Derby¹ and Ahmed Elyamani²

ABSTRACT

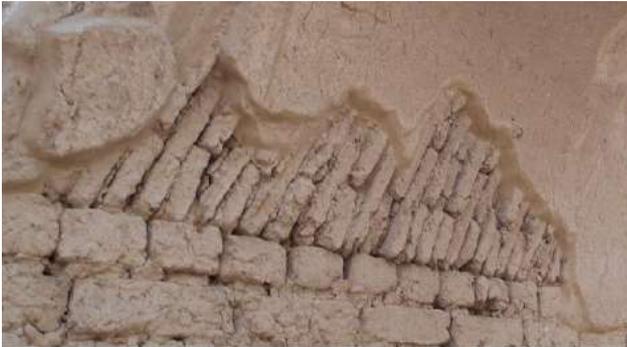
Figure 2. Mud-bricks laid tilted in an Ancient Egyptian barrel vault (in the storerooms of the Ramesseum temple).

The adobe masonry barrel vaults in Ancient Egypt were constructed of courses of horizontal or upright mud-bricks laid tilted, at a slight angle to the vertical, against the supporting wall, Figure 2 (Van Beck, 1987; Spencer, 1979a). The inclination of the bricks from the vertical led most of the weight of each brick to transfer to the lower course which already had been laid rather than acting downwards, thus, the weight of each new brick was borne by those already laid. The brick was held in its position and stuck to the brick of the lower course by mud mortar.

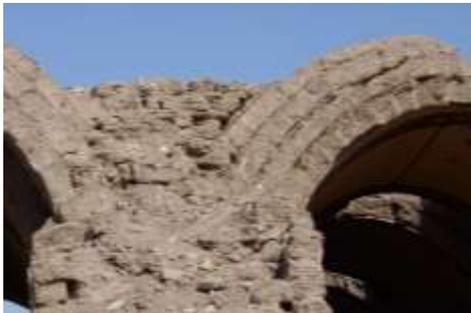
Figure 3. The adobe vault of the storeroom of the Ramesseum temple composed by four courses, the filling between the adjacent vaults can also be noticed.

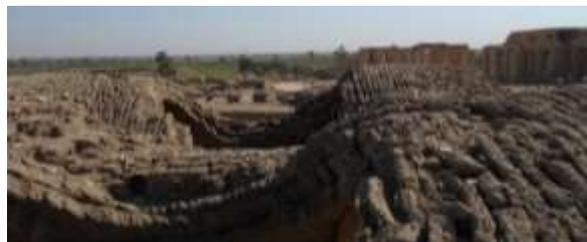
Figure 11. Current state of holes used in filling the storerooms with grains.

These storerooms were filled with grains from top via holes in the vault located each six meters, Figure 11. The holes were likely strengthened with stone frames and had covers. With time passing and due to different decaying factors, these holes became larger and representing nowadays weakness points participating in more collapses of vaults.

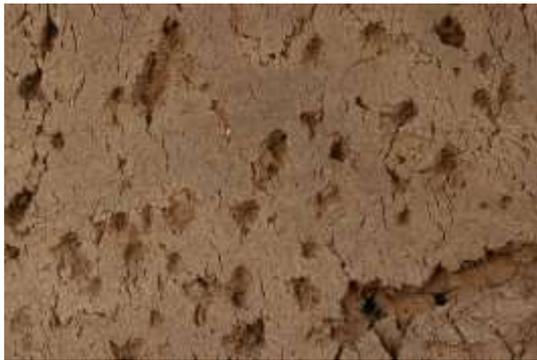
Figure 17. Holes made by wild bees after eating the straw in the plaster in the Ramesseum storerooms.

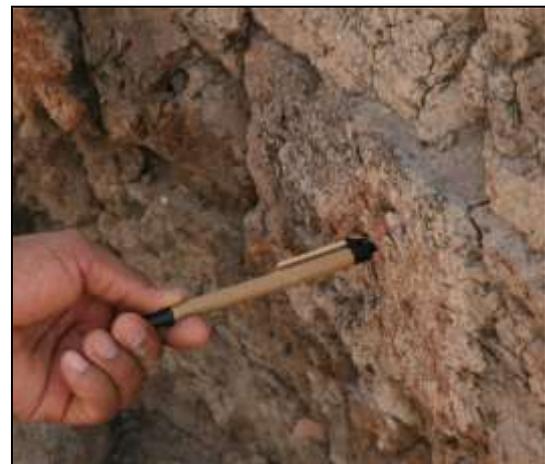
Figure 19. (a) Agricultural lands and houses around the Ramesseum, and (b) salt crystallization on the wall surface.

In the case of the Ramesseum storerooms, recently, the water table has risen due to the surrounding agriculture lands and houses, Figure 19. The ground water seeps into the bottom of the walls that absorbs the water by the capillary rise. This causes the swelling of the clay minerals contained in the adobe. Afterwards, the evaporation of water results in shrinkage and cracking, and after water drying the salts in the water crystallizes on the wall surface making it much more fragile, Figure 19. The wind blows removes that fragile parts resulting in more erosion of the wall in a continuous process.

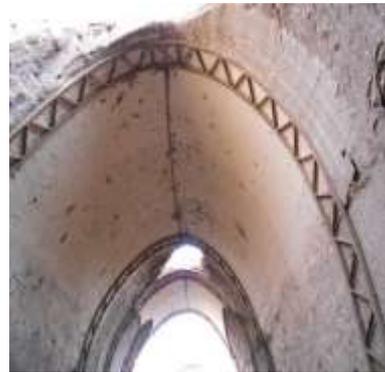
Figure 29. Two forms of the steel supporting structures used as strengthening interventions in the Ramesseum storerooms.

The existing parts of the storerooms of the Ramesseum were provided in earlier times with steel supporting structures, Figure 29. This strengthening intervention is believed to be one of the reasons behind the survival of these parts up to date. Therefore, it is proposed to apply the same intervention for the remaining parts of the Ramesseum storerooms. This intervention, however, has some disadvantages that should be avoided. First, it decreases the authenticity of the storerooms. Second, steel corrodes. Third, the compatibility in the mechanical properties between the steel and the adobe is low. The steel has much higher tensile and compressive strengths than the adobe. Finally, the steel is supporting the adobe structure and is not working with it monolithically. When the structure is subjected to the external forces, the steel structure does not absorb all the developed tensile strains and the adobe structure is subjected to some of them. Therefore,

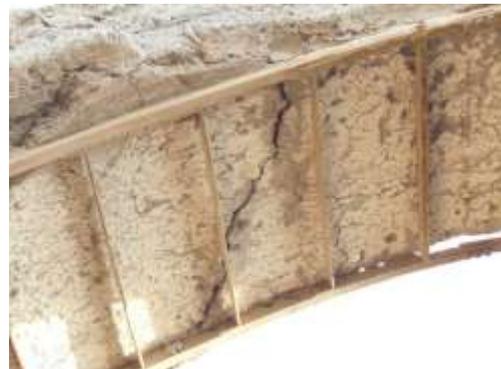
Figure 30. Large cracks at places of strengthening intervention.

some cracks are present at the locations where the intervention exists as can be noticed in Figure 30.

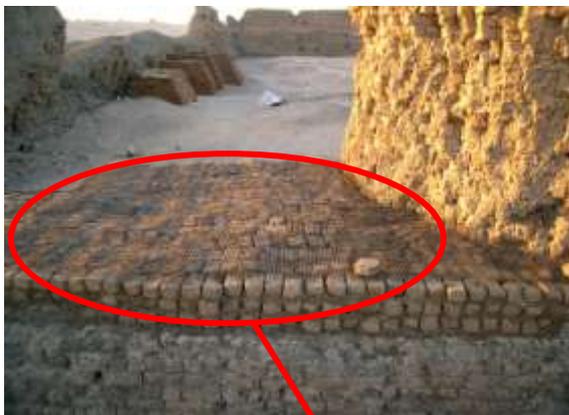
Figure 32. The application of polymer grids between adobe wall courses in Shunt el-Zebib in Abydos.

For reconstruction justification of the two case studies, (see: warrants for ancient Egyptian buildings and sites's remains and ruins reconstruction, in: El-Derby, A. A.O.D., 2012), consequently: reconstitution of damaged parts of original mud-brick walls and vaults, through reconstituting damaged parts of original mud-brick by using mud-bricks had fallen from the original buildings, with using BX1200 Geogrids among courses to reinforce the walls and vaults.

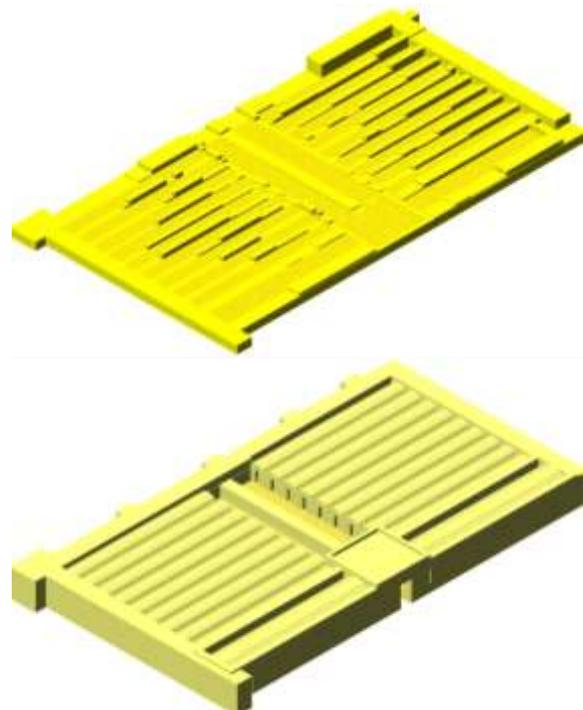
Figure 33. The documentation of the current state of collapse of the Sety I storerooms (top) and a 3D view of the proposed reconstruction (bottom) (after, El-Derby, 2005, figs. 224, 281).
