# NON-LINEAR STATIC ANALYSIS AND SEISMIC PERFORMANCE OF MODERN ARCHITECTURAL HERITAGE IN EGYPT

Sayed Hemedda

The objective of this paper is the investigation of the behavior of historic masonry structures subjected to static and seismic forces and the formulation of numerical models for use in structural analysis. The case study presented here regards the seismic analysis of El-Sakakini palace (1892 AC) in Cairo, Egypt (damaged by the earthquakes occurred in 1992 and 1995).

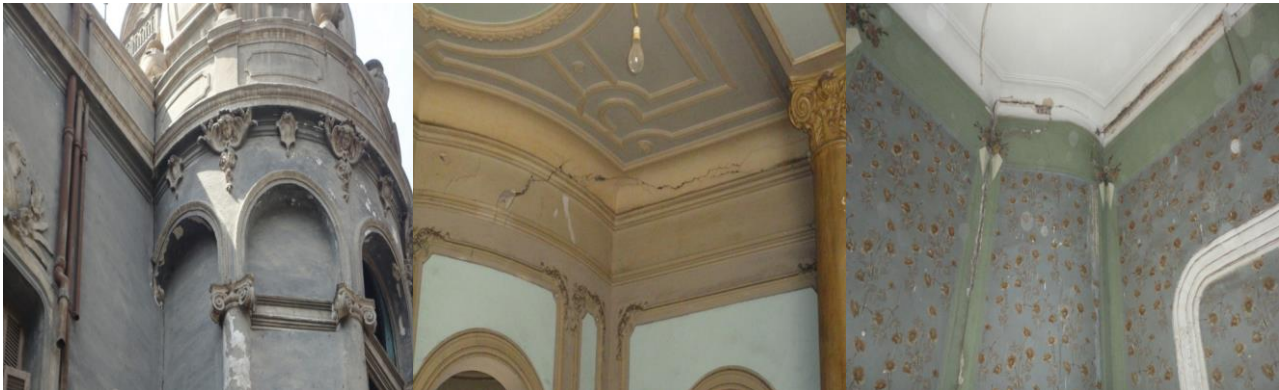
*Figure.3a. present state of in plane and out of plane structural deficiency of Sakaini palace.*

The superstructure and substructure of the palace has suffered considerable damage due to extensive cracking associated with soil settlement and foundations movements undergoing a shear failure accompanying with large settlement both towards to the western and northern directions as well as the centre of the palace;

Cracks widths were 10-20mm and exhibiting periodical widening. The cracks had a preferential orientation in two principal directions namely E-W, which includes typical views of major cracking in the masonry walls and foundations. Such effects were attributed to earthquake damages, permanent deformations and large settlement of the bearing soil 'due to the secondary Consolidation', natural wear

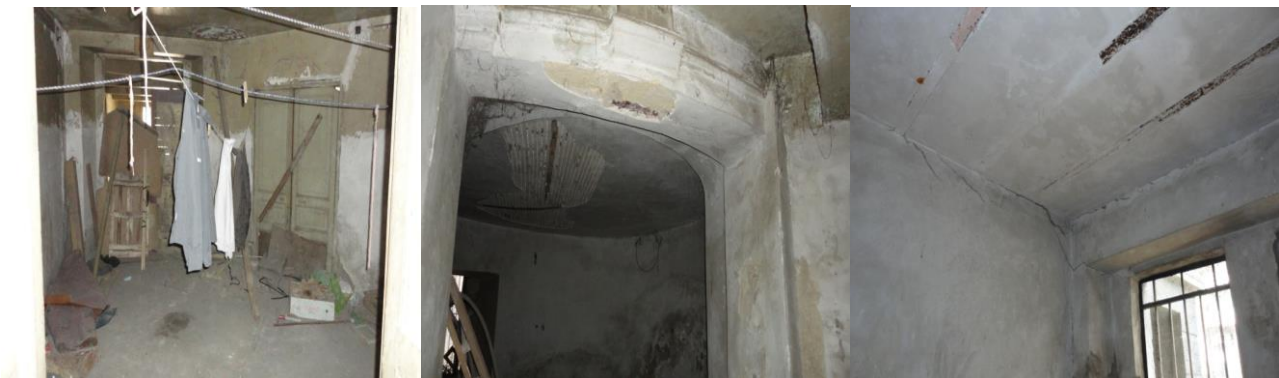
*Figure.3b. present state of in plane and out of plane structural deficiency of Sakaini palace.*

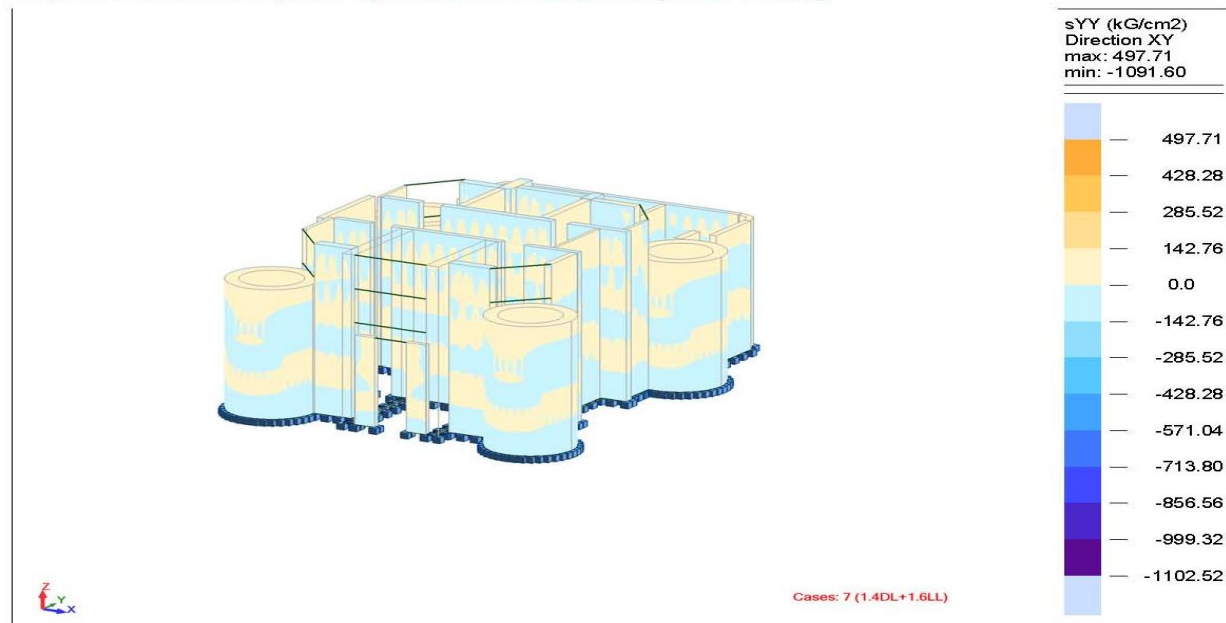
Maps for Solids - sYY (kG/cm2) Direction XY Cases: 7 (1.4DL+1.6LL)

Figure.12. Maps of solids- Effective horizontal compressive stresses  $\sigma_{yy}$  (Kg/ cm2) Direction XY cases: (1.4DL+1.6LL).

Max. Stress)<sub>1.4DL + 1.6LL</sub> = 122 Kg / cm<sup>2</sup> < 200 Kg / cm<sup>2</sup>  
SAFE

Max. Stress)<sub>1.4DL + 1.6LL</sub> = 350 Kg / cm<sup>2</sup> > 200 Kg / cm<sup>2</sup>  
**UNSAFE**

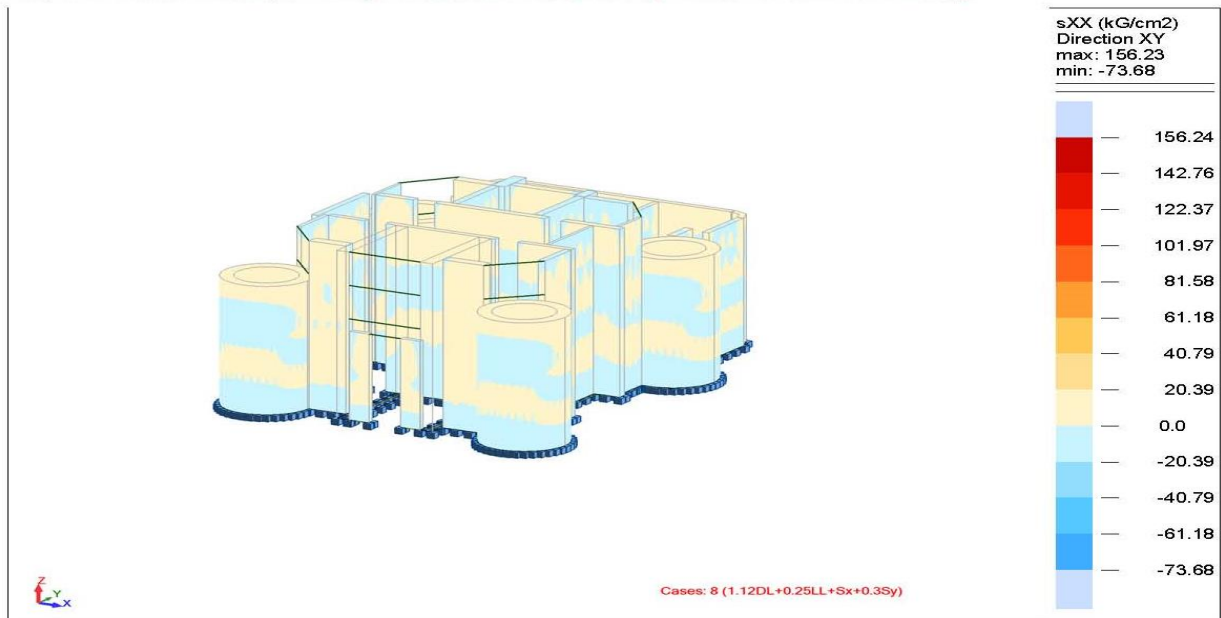
Maps for Solids - sXX (kG/cm2) Direction XY Cases: 8 (1.12DL+0.25LL+Sx+0.3Sy)

Figure.14. Maps of solids- Effective horizontal compressive stresses  $\sigma_{xx}$  (Kg/ cm<sup>2</sup>) Direction XY cases: (1.12DL+0.25LL+Sx+0.3Sy).

Max Stress)<sub>1.12DL + 0.5LL + S<sub>x</sub> + 0.3S<sub>y</sub></sub> = 23 Kg / cm<sup>2</sup> < 200 Kg / cm<sup>2</sup> SAFE

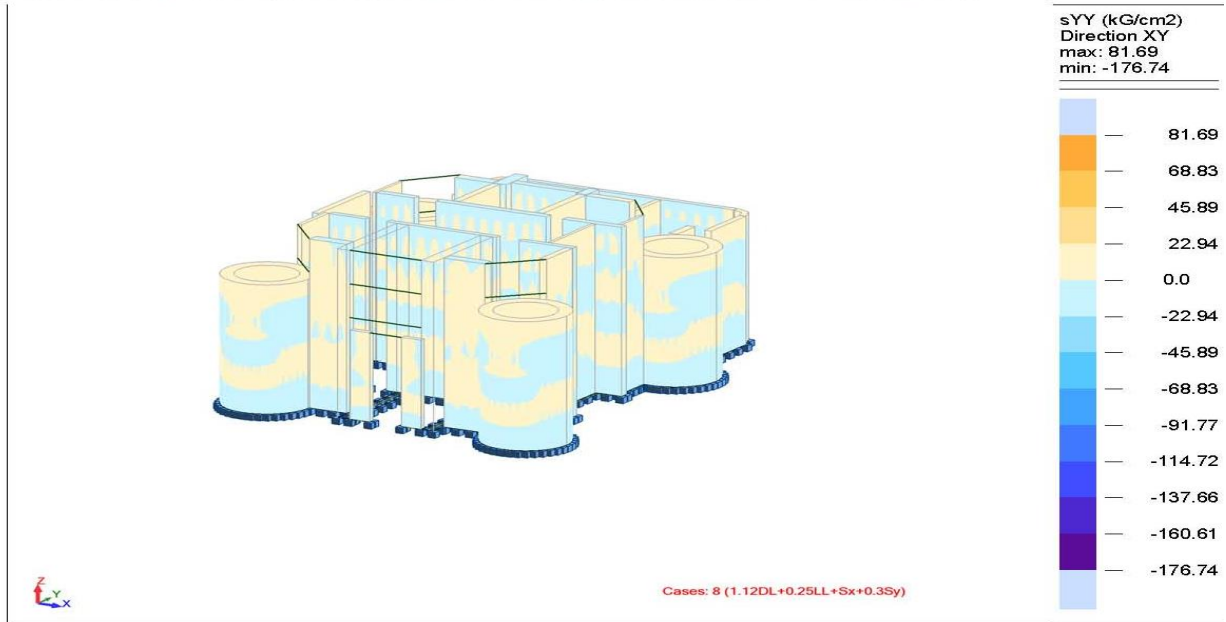
Maps for Solids - sYY (kG/cm2) Direction XY Cases: 8 (1.12DL+0.25LL+Sx+0.3Sy)

Figure.15. Maps of solids- Effective horizontal compressive stresses  $\sigma_{yy}$ (Kg/ cm2) Direction XY cases: (1.12DL+0.25LL+Sx+0.3Sy).
