IMPACTS OF FIRE ON HISTORIC STONE MASONRY STRUCTURES: PHYSICO-CHEMICAL ANALYSIS AND APPLICATION TO THE AL-MUSAFIRKHANA PALACE (CAIRO)

Sayed Hemeda^{1,2} and Tabina Osman³

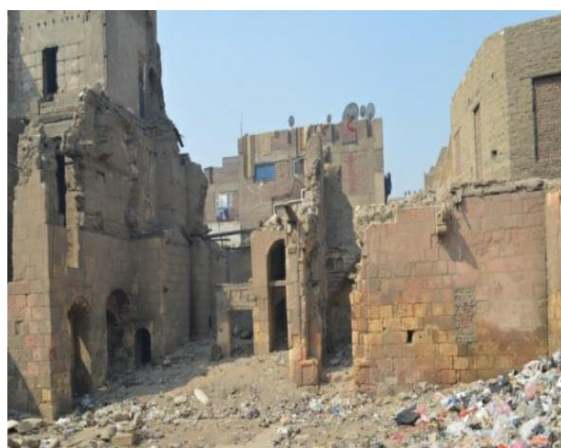
Figure 2. General view for the ground floor of Musafirkhana palace after fire.

Al-Musafirkhana palace was designed and constructed by Mahmoud Muharram in 1779. The house consisted of two sections, the northern section one we reach from Darb al-Musamma; and the southern section one we reach from Darb al-Tablawi; the house has four facades, three entrances, and three floors (Revault and Maury, 1979), the general layout of the palace is a large open courtyard in the middle of the house, and there is the southern side Al-Takhtabush (a rectangular shape covered by a wooden ceiling with decorations). The ground floor contains three halls (Fig.1); the first hall a large located to the left of Al-takhtabush, the Qashani hall on the eastern side of the courtyard, another hall on the northern side of the courtyard, the house contains some storerooms for storing things and food, servants' rooms, and more than the reception hall for visitors. Also, contains on a water woman and water tank, and each main hall is attached to a bathroom, the house consists of three floors (Fig.2).

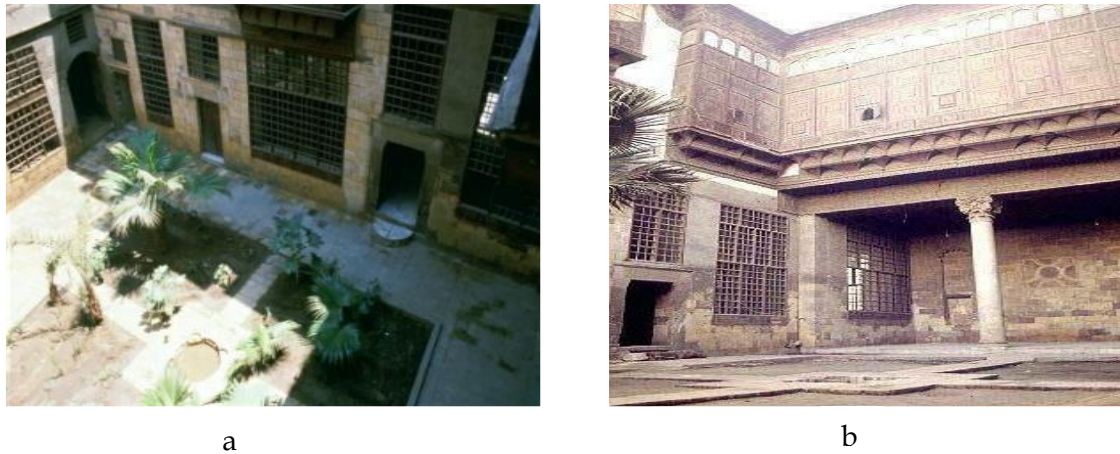
Figure 3. various views showing the palace from the inside before the fire, a) The open courtyard before the fire; b) The Takhtabush before the fire.

The ground floor it contains the main open courtyard, and the three main halls, the reception hall, the bathroom, some rooms, stores and the garden, the reception hall, which is a large hall for receiving merchants, consists of one hall and three iwan (Fig.3a), the open courtyard, A large courtyard in the middle of the house, arranged around most of the elements of the house. Al-takhtabush it is a rectangular area extending from east to west and overlooking the courtyard and it is an important architectural element in residential buildings in Islamic times (Fig.3b), the roof is based on a round marble column, and the second floor is topped by the façade covered with a mashrabiya. Al-Qashani Hall it is the great hall for receiving merchants, the upper part is covered with Qashani and decorated with drawings, geometric

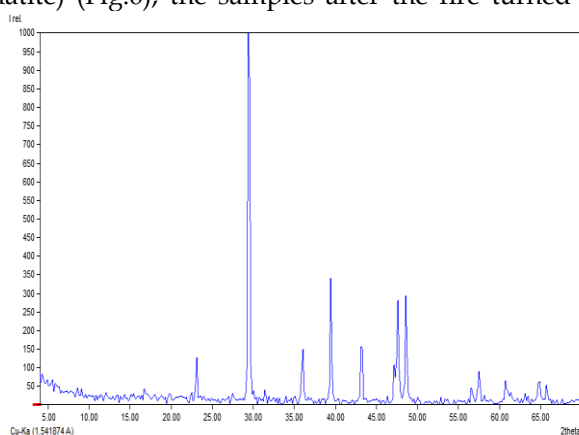
Figure 5. Representative XRD pattern of limestone specimen before exposed the fire. (Fresh sample) Major Constituent; Calcite, Dolomite, quartz. Minor Constituent; feldspar, Goethite, Clay mineral.

in a fire on natural stones. The physical and mechanical properties of the studied limestone samples before and after fire are presented in Table 1. The accessible porosity of the limestone samples increased progressively by 4.92%, 9.45%, 22.70%, after heating at 200 °C, 400 °C, 600 °C, respectively. This increase of porosity is attributed to the thermally induced cracks between calcite grains. Similarly, the capillary water absorption of the limestone samples increased progressively with increasing high temperature due to the increase in the proportion of capillary pores and the improved connectivity of pores caused by heating (Ahmad, 2020). The effect of temperature on the physical properties of limestone seems to be intensified by heating at temperatures higher than 200 °C; the microscopic investigation of the heated samples confirms this result. Remarkable changes represented by development and expansion of intergranular and intragranular cracks, in the microstructure of the limestone samples heated beyond 200 °C have occurred. Below this heating temperature, the induced microstructural changes are relatively small and less significant (Fig. 5).

X-Ray diffractometric data of the limestone samples before to the fire. Show that calcite is the main mineralogical phase in both the studied materials (fresh sample). With few percent of secondary minerals. Such as quartz and the microcline (KAlSi₃O₈), but samples after fire at 200 °C. Show that calcite is the main component of limestone (Fig. 5)., this explains that the limestone were not affected by the fire at this temperature, but samples at 400 °C, show calcite with few percent of quartz, microcline, and iron oxides (hematite) (Fig.6), the samples after the fire turned

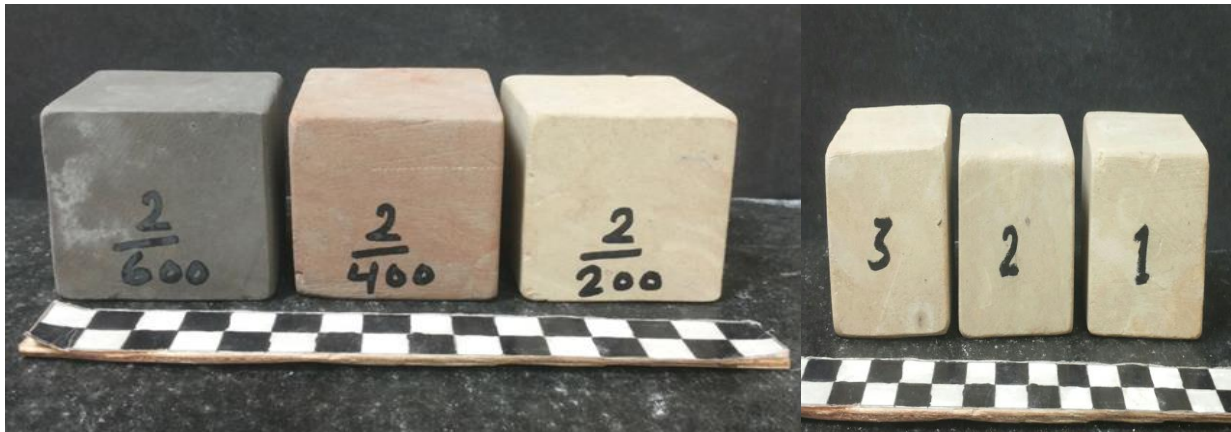
quantity of white coat also appears at 800°C. Following the exposure to high temperatures through the methodology outlined above a discolouration of the limestone was noted. The original sample is character by a natural creamy white colour. Changes in mineral composition of limestone after heating were accompanied by changes in colour. No changes in the samples heated at 200°C (Fig. 11), but significant changes in colour of limestone were visible macroscopically in samples heated above 350°C and higher temperatures. Using polarized microscopic examination, was possible to record the colour changes which cannot be discern by human eye. A reddish-brown discolouration was noted once the stone was exposed at 400°C. A light grey colour was observed following exposure hours at 600°C. The colour of the stone became white after exposure at 800°C; however, some alteration products as a result of the calcite deterioration could not be identified under microscope.

Figure.11. photos showing the colour change of stone samples before and after the fire.

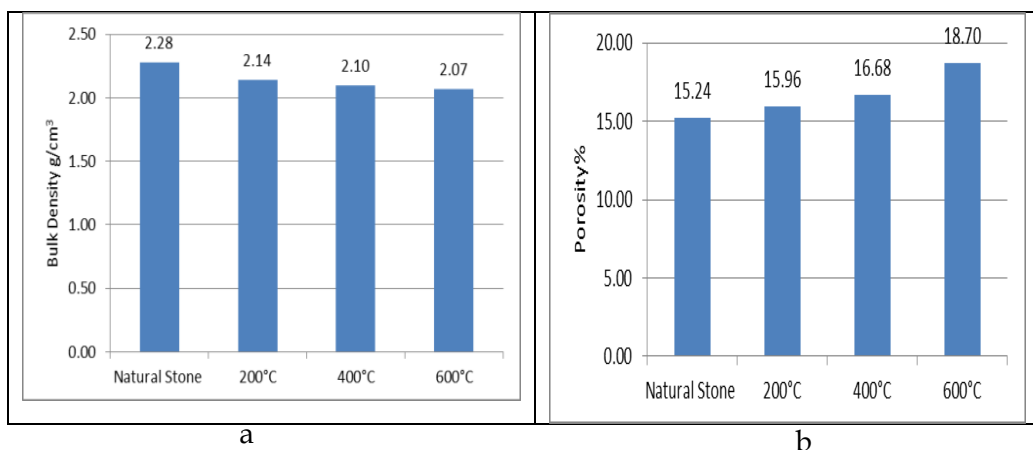
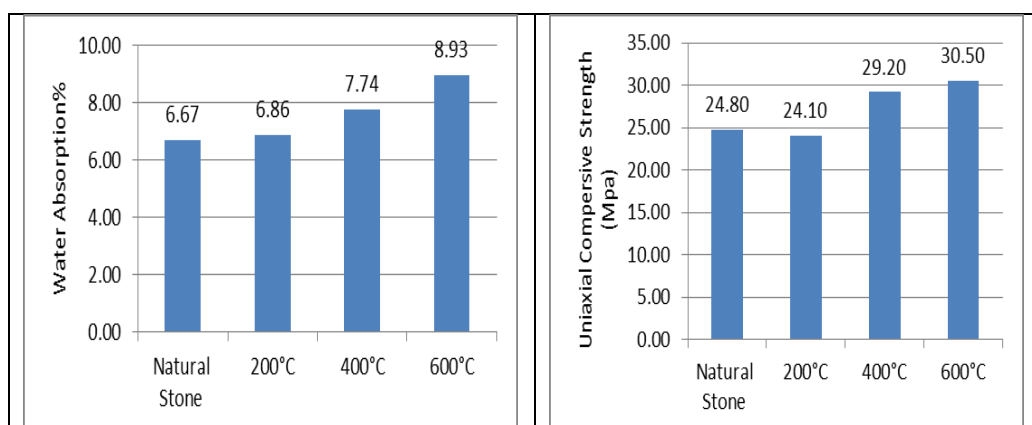
The effect of the fire on the physical properties of the limestone is investigated by determining the variations of porosity and water absorption by weight before and after the fire-exposed limestone (Yavuz et al., 2010). Porosity tests were performed on samples taken from the limestone blocks. Several tests on samples representing the fire-exposed side yielded an average porosity value of fire 16.64%. On the other hand, five limestone samples from the undamaged side were gradually heated in the oven. Heating process has progressed in such a manner that samples were heated by increasing temperature of the oven from 20°C to the target value at varying rates so that heating temperature was reached in 45 min for all temperature levels. Samples were then kept in the oven for 6 h after the temperature increased to the target value. Uniaxial compressive strength of the limestone samples exhibited strong dependence on temperature elevations (Hall & Hamilton, 2016). This was well reflected by the samples. It can be seen in that uniaxial compressive strength of five samples tested at varying temperatures including the room temperature (20°C) decreased with gradually increased temperature with some exceptions (Fig.14.a). Tests at 400 and 600°C deviated strongly from the general trend. This behaviour can be attributed to temporary strength gain due to the reduction in moisture content of the samples prior to crack initiation. The uniaxial compressive strength corresponding to the fire temperature, however, can be read in Fig. 10 as fire

30MPa. Samples from the fire-exposed surfaces, on the other hand, were tested in two groups. One of the groups consisted of five samples that were preheated up to 300°C. (Fig. 14.b). Samples heated beyond this temperature were not suitable for uniaxial compressive strength testing due to excessive disintegration. It is noteworthy that uniaxial compressive strength corresponding to the room temperature in this group is very close to the one obtained at the average fire temperature in the group of samples from the intact block surface (Fig. 14.c). The overall response of the samples to temperature increase in these two groups is similar. It appears that strength of the samples are close to each other when the 400–600°C residual off set temperature in the fire exposed block samples is taken into consideration. It is noteworthy that uniaxial compressive strength at 200°C is corresponding to the room temperature in this samples is very close to the one obtained at the average fire temperature in the samples before fire. As for the uniaxial compressive strength of the samples heated at a temperature of 400°C, 600°C, it showed a rise in the compressive strength, which may be due to the burning and solidification of clay minerals. Closer inspection of these samples showed that samples failed along a residual crack, which might have been developed during the fire or have been already there before the fire hazard as shown with (Fig. 14.d).

Figure 14. Average values of the physical and mechanical for samples stone before and after fire; a) Average values of bulk density; b) Average values of porosity; c) Average values of water absorption; d) Average values of compressive strength.

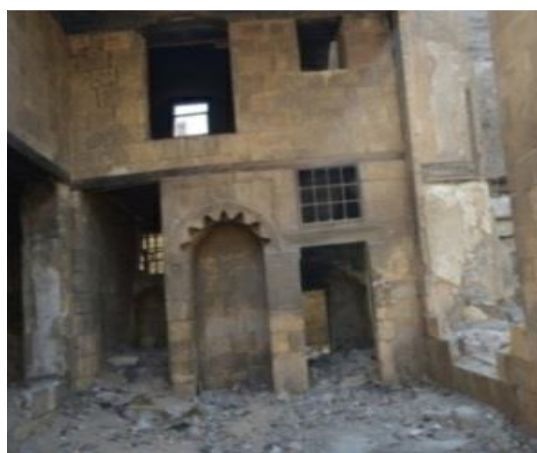
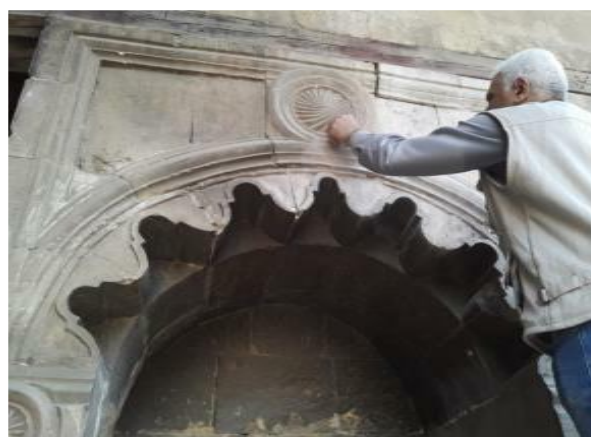
Fig.15. General View showing the State of Preservation and the degradation of building stones; a) photo showing the current state of the hall before restoration; b) photo showing the mechanical cleaning process using simple tools

Mechanical cleaning depends on removing dust, dirt, and foreign objects stuck on the outside of the buildings, using some tools and a simple manual number of brushes (Brian and Srphen, 1987), chisels and various scalpels. The nature of suspended materials and their connection to the surface control the variety and multiplicity of tools, as well as the different cleaning process. Chemical cleaning use wet chemical cleaning to remove inks, varnishes and various fatty materials in which no chemical cleaning is used, where the high polarity of water helps to dissolve and dissolve the links between particles of dirt. Water used with some chemical solutions that increase work efficiency. Moreover, remove dust and

dirt with the help of the brush, and water is used under pressure as a fine mist either by spraying or in water vapour (Fig.15).
