DETAILED DOCUMENTATION AND IN SITU CONSERVATION ACCORDING TO MORTAR CHARACTERISATION OF OPUS SECTILE UNCOVERED IN THE SAINT PHILIP CHURCH OF HIERAPOLIS (PAMUKKALE-TURKEY)

During the archaeological excavations carried out in the ancient city of Hierapolis (Pamukkale-Turkey) in 2011-2012, a colourful opus sectile (ancient stone-art) dating back to the Middle Byzantine Period was revealed at the pavement of the Saint Philip Church. As the opus sectile was badly damaged, it was decided to preserve the opus sectile with the minimum of intervention. Before in situ conservation activities were initiated, a sample was taken from bedding mortar of the opus sectile and the following analyses were carried out: loss on ignition, deal with acid and particle size distribution analysis, petrographic analysis (thin and thick sections, Stereo and Polarizing Microscope observations), as well as Scanning Electron Microscopy and Energy Dispersive X-ray Spectroscopy (SEM-EDX). According to results of the analyses, a mortar closely resembling the original mortar was produced and applied to a total of 14 opus sectile panels.

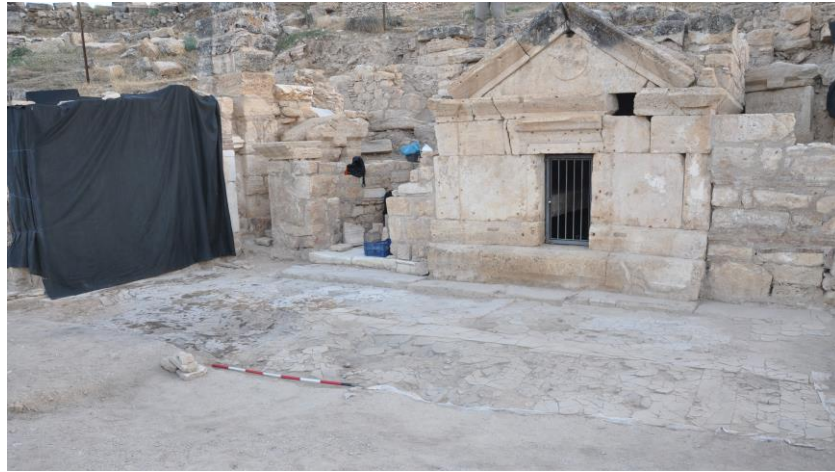
period, consisting of coloured slabs of different types of stone unearthed at the base of the Saint Philip Church. The opus sectile was unfortunately badly damaged due to environmental factors, earthquakes, and human activities (Figure 2). So, the pavement required urgent action and it was decided to carry out conservation treatments and save the opus sectile pavement from further damages.

Figure 2. Tomb of Saint Philip and damaged opus sectile.

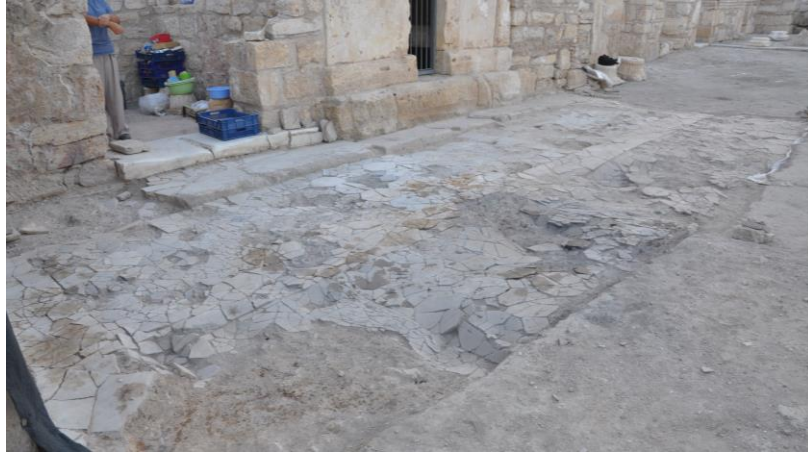
Figure 3. Partially preserved 14 panels right in front of the tomb.

As mentioned above, the floor of the Church was severely damaged and only 14 partially preserved panels were found side-by-side placed in situ position right in front of the burial chamber (tomb). In some parts of the church, the panels were completely disintegrated, in other parts panels they were completely destroyed, and large gaps had formed at the base of the nave. Some depressions in different forms presented in some panels which may have been due to the general weakness of the foundation layers or a result of loading or collapse of heavy objects over the panels (see below Fig. 12), signifying great destruction brought on by earthquakes. In some parts of the panels, the attachment between the stones and bedding mortar was also lost due to collapses and human activities. None of the panels and borders were in

good condition and approximately 90% of the stones were broken. Furthermore, the panels were also affected by different forms of bulges caused by plant growth and plant roots which cut the connection between the stones and the bedding mortar. Another aspect of negative impact, especially near the main entrance (North Wall of Nave) of the church, was damage from the use of an oven dating back to the Seljuk Period (D'Andria, 2018). The smoke and heat emanating from the oven over a period of time produced a sticky thick black layer of oil and ash that covered the surface of the panels (Fig. 4), and it was observed that the stones were also affected with cracks and sugaring effect (Sassoni et al., 2016) due to the high temperature in the areas of closer proximity.

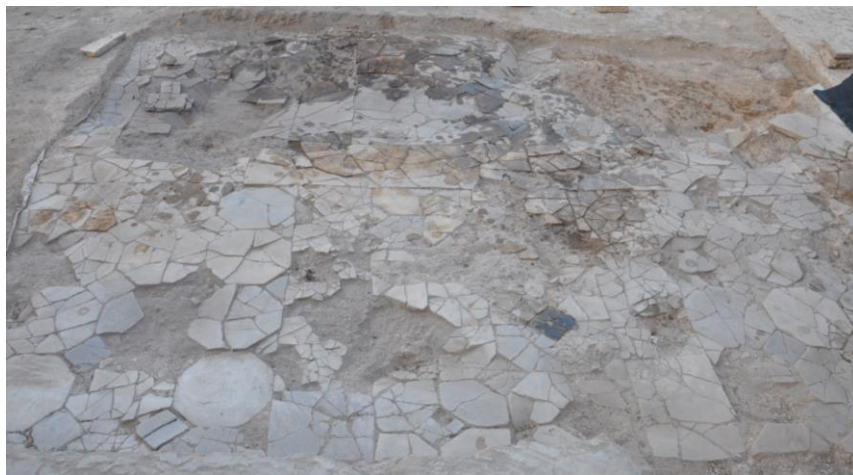
Figure 4. Layer of oil and ash at the top of the picture.

A large layer of ash was detected on three panels opposite the room (chapel) next to the tomb. In the middle of this area, there was an oily layer covering a panel and plant roots at the bottom. Plant roots under the panels were completely cleaned during these applications. A “sugaring” effect was detected on the marbles of the panels, a type of deterioration usually caused by high temperature and soluble salts. To consolidate these marbles, 10% (v/v) concentration of Primal AC 33 acrylic resin in water was applied by

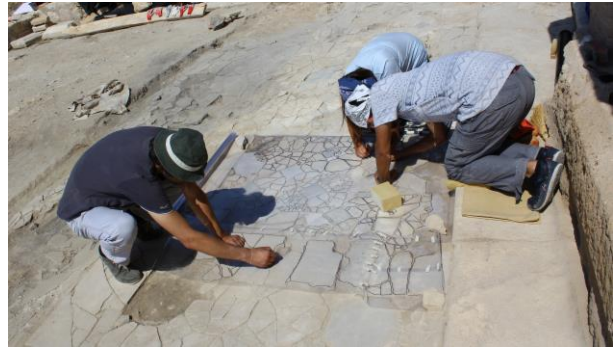
and soil accumulated on the surface, documentation began in 1:1 scale drawing (Fig. 9) on polyethylene sheets with permanent pen (Faber-Castel) and shoot a series of detailed photographs with using a digital camera (Nikon-EOS 60 D) by placing measurement points at intervals of approximately 50 cm according to size of panels. During this time 1:20 scale drawings were also made with the Auto-CAD program. Each panel was drawn separately and finally all the drawings were assembled into a complete image (Fig. 10).

Figure 9. 1:1 Documentation on polyethylene sheets.

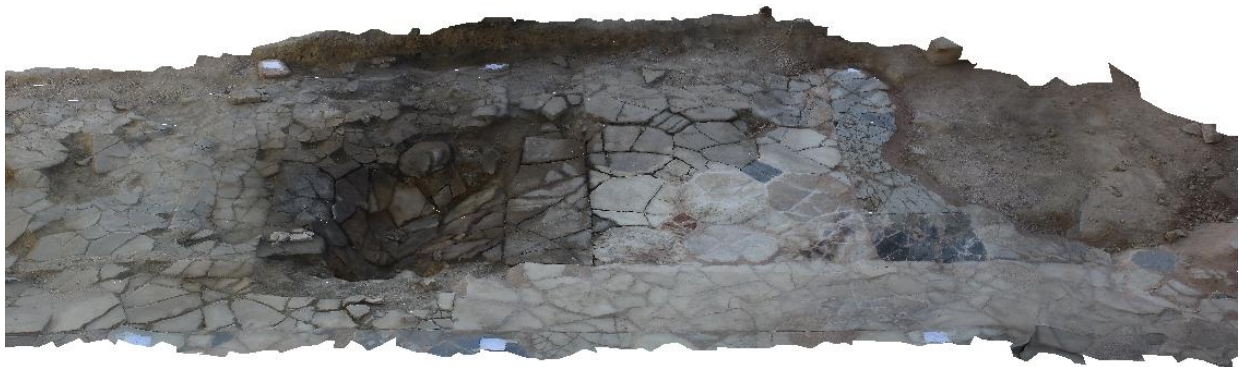
the Agisoft program and finally detailed 3D documentation was rendered (Fig. 11). At the end of the 2014 season after finishing the in-situ conservation treatments of the panels, the aerial photos were taken, and the documentation activities were finished (Fig. 12). As a result, the detailed documented data that was gathered will also be used in monitoring the condition and state of preservation of the opus sectile for future conservation projects and seasons.

Figure 11. 3D image shows collapse of heavy objects over the panels.

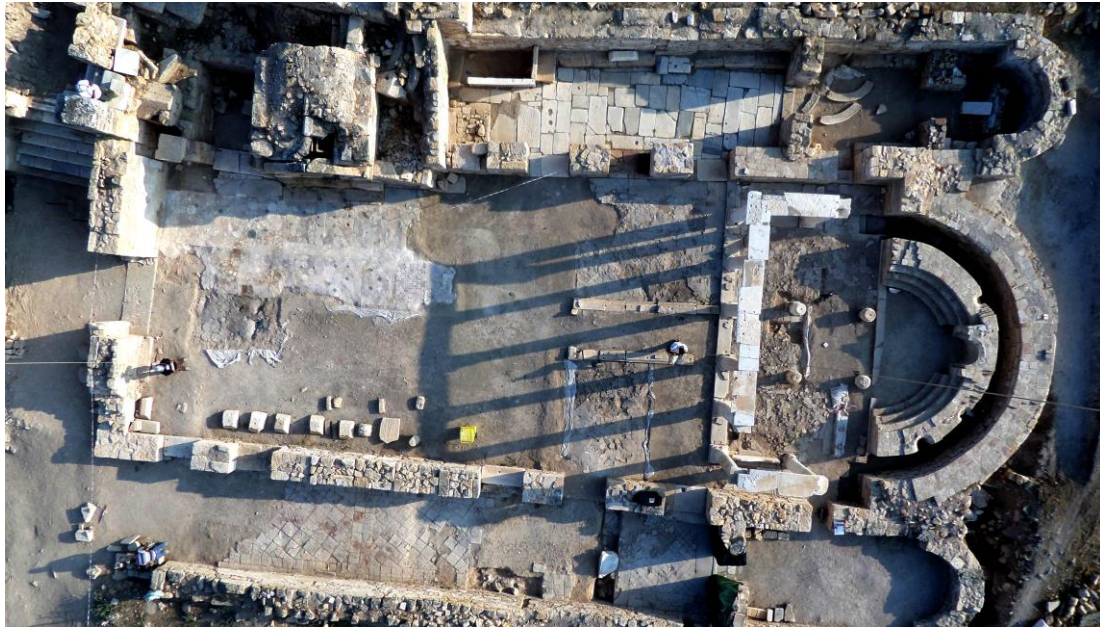
Figure 12. Aerial photo of Saint Philip Church.

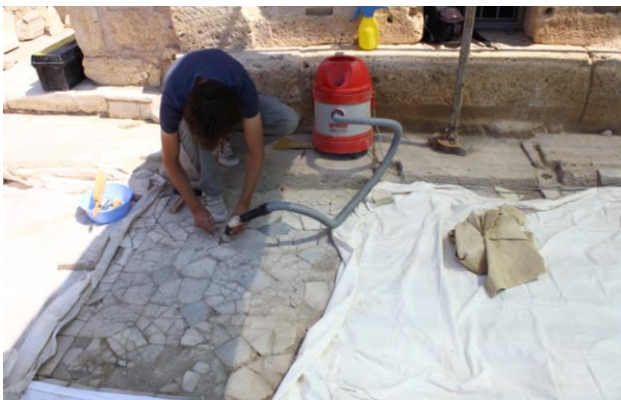
Figure 13. Detail cleaning with a vacuum cleaner.

Before the work was started, a temporary and portable canopy system was installed over the area in order to prevent the mortars from cracking due to loss of water, and also to protect the area from visitors who were entering the Church. In order to fill the cracks between the broken parts and joints with mortar, it was necessary to clean the spaces between the cracks and joints of broken pieces to remove deteriorated bedding layers and accumulated soil. After drawings were completed, the detailed dry-cleaning phase was initiated. The soil and dirt accumulated on the surface and between the gaps was cleaned with the use of different types of brushes and bulb pipettes. For the final phase a vacuum cleaner was used for detailed cleaning. The cleaned panels were immediately covered with a layer of geotextile, so that dust and sand would not get in the way again (Figure 13). The roots that had spread among the joints and cracks were already dry and withered, so they were carefully cut and the remains were completely cleared.

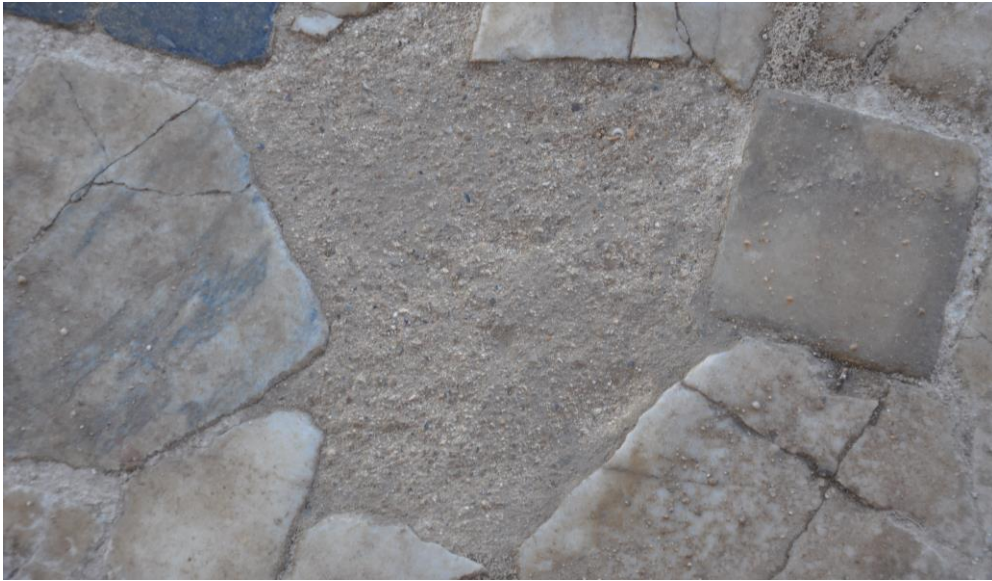
Each of the panels was evaluated separately and implementations were carried out according to the situation that they were in. On the left side of the entrance door of the tomb chamber, the old repairs made with ancient mortar were found in two places

Figure 14. Old repairs made with ancient mortar.

on panel number 3 and the border, so these parts were preserved as they were and consolidated (Mora, 1984) with 5% (v/v) concentration of Primal AC 33 acrylic resin in water by brushing (Figure 14).

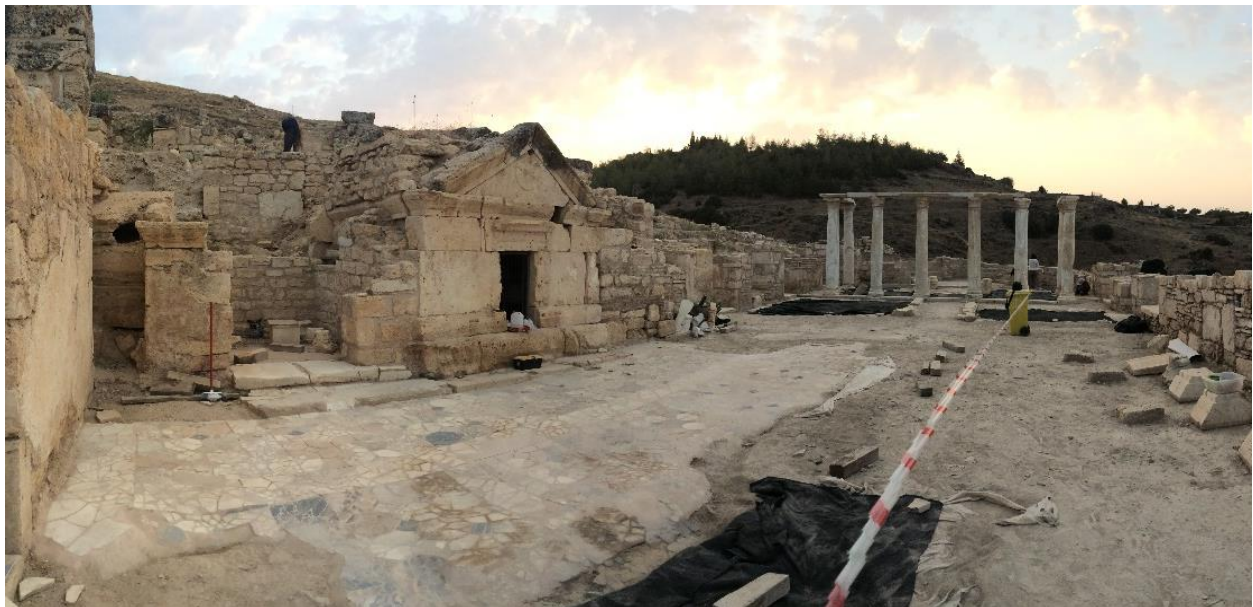
Figure 17. Tomb of Saint Philip and opus sectile after conservation.

spraying. All the information and details obtained during the conservation of the opus sectile were noted and were shown on the drawing sheets (Fig. 16). The whole restoration work was carried out over 3 excavation seasons in total. Thus, 14 panels in two rows (7 panels each) on the left side of the entrance of the Church nave in front of the burial chamber (Fig. 17) and the borders between them were conserved in situ (Fig.18).

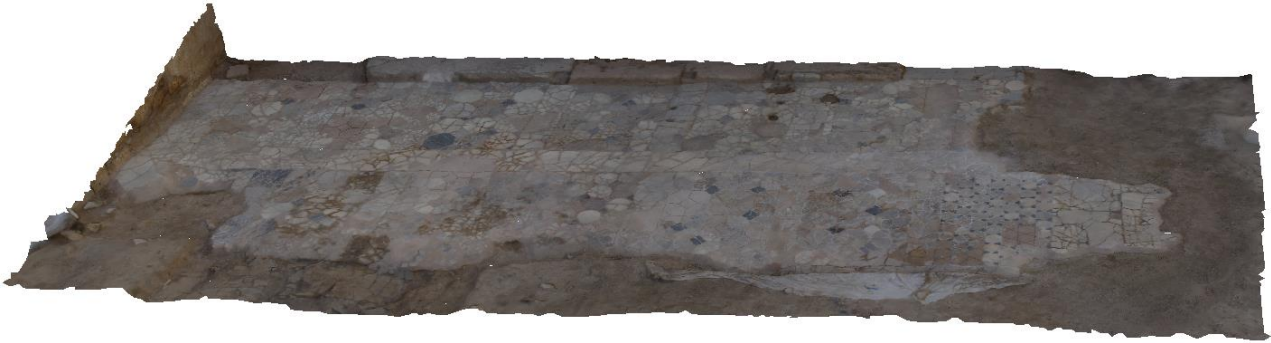
Figure 18. 3D image of all panels at the end of the Project.

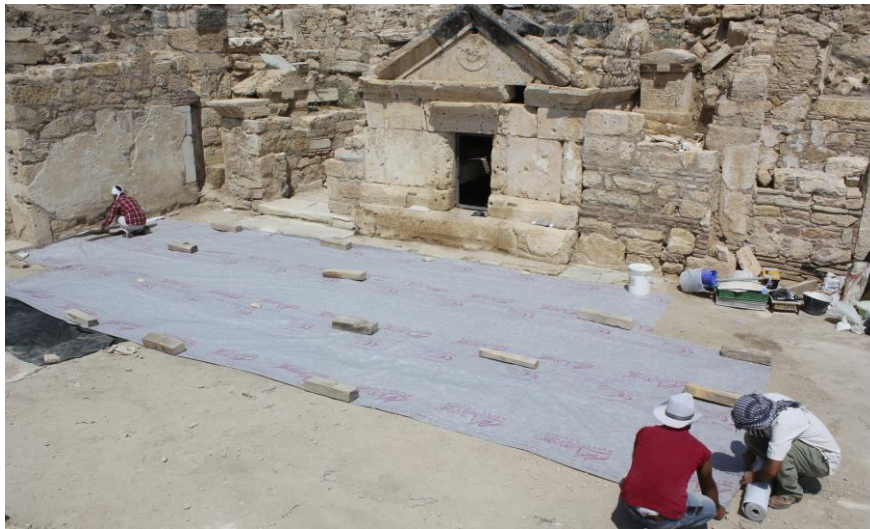
Figure 19. Panels were covered with *Gore-Tex* geotextile.

As reburial is one of the best passive conservation treatment methods for pavements on archaeological sites (Theodorakeas et al., 2010), at the end of the 2014 season the panels first were covered with a *Gore-Tex*

geotextile layer (Fig. 19) and then a mixture of local clay, sand and gravel size aggregates in thickness about 30 cm in different layers (Fig. 20).

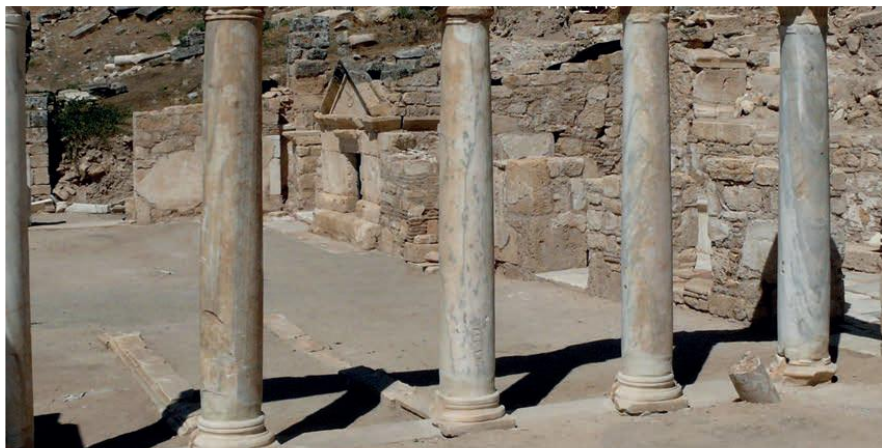
Figure 20. Reburial of pavement.
