EVALUATING VISITOR MANAGEMENT AT THE ARCHAEOLOGICAL SITE OF PETRA

Mairna H. Mustafa¹ and Fadi A. Balaawi²

KEYWORDS: Tourism impact, Tourist behavior, Visitor Management, Interpretation, Petra Archaeological Park

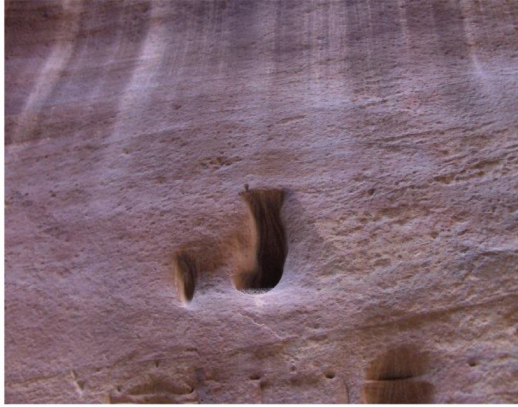
Figure 2. The "Luck Niche" in Siq area, tour guides and tourists keep throwing stones, which caused more erosion of the sandstone

Dushara and al-Uzza gods are located in the middle of this gorge. Horse and chariots rides (used by tourists) are raising the dust which becomes encrusted on the sides of the Siq; some graffiti can be also noticed. One of the niches in the Siq is known as a "niche of luck", guides and tourists keep throwing stones as trying to place them in the niche, which is causing a quick and drastic erosion of the stone (Fig. 2).

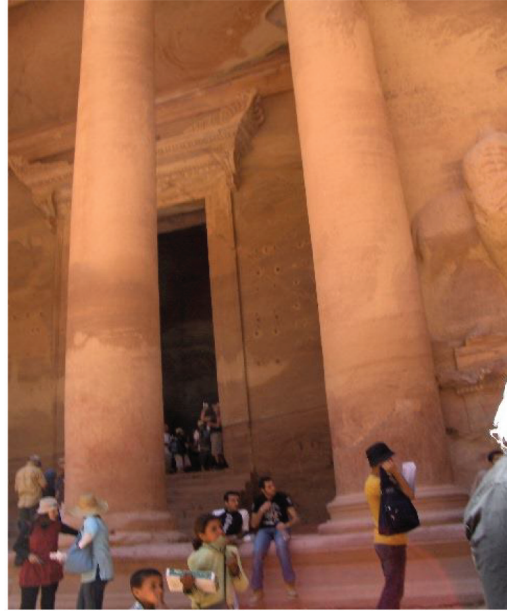
Figure 3 Tourists setting on the lower parts of the Treasury

The Siq then widens upon the most magnificent of all Petra's monuments al-Khazneh (meaning Treasury in Arabic), there is an uncertainty about the function of this monument, and it is believed to be a temple or a royal tomb. According to Tom Paradise, a geomorphologist from the University of Arkansas at Fayetteville, tourists are wearing shoes with soles that grab on everything instead of the rubber-soled working boots or soft sneakers, a quick disappearance rock carved features is taking place, parts of the façade of the Treasury had lost sand, tour guides and tourists usually sit on its lower parts, which caused the loss of half a cubic meter of sandstone over few years (Fig.3). Another form of deterioration is the existence of white deposits on the walls of carved tombs, mainly the Treasury; such deposits are of stearic acid. This acid is formed when people rest by leaning against the wall with sweating hands, where they leave a scum of fat behind (Lubick 2004).

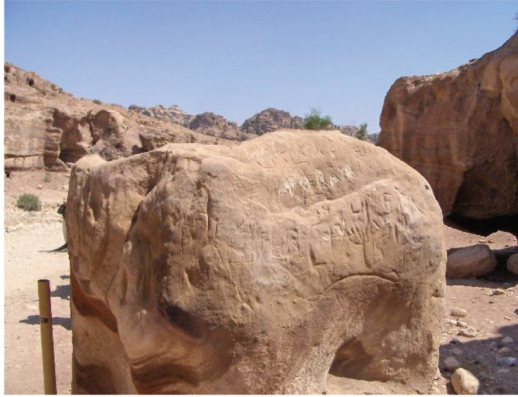
Figure 4 Graffiti on a stone in the Street of Facades Area (Incised with sharp tools).

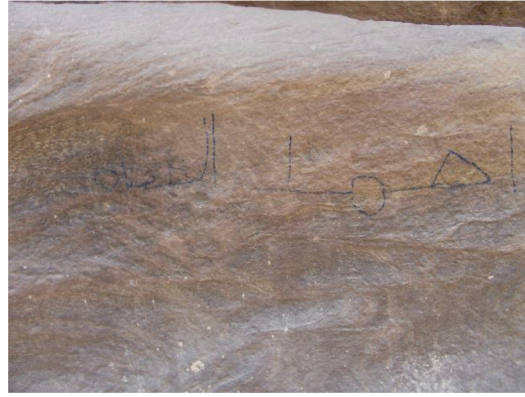
Figure 5 Graffiti in the Siq area (a name of a tourist written with a marker)

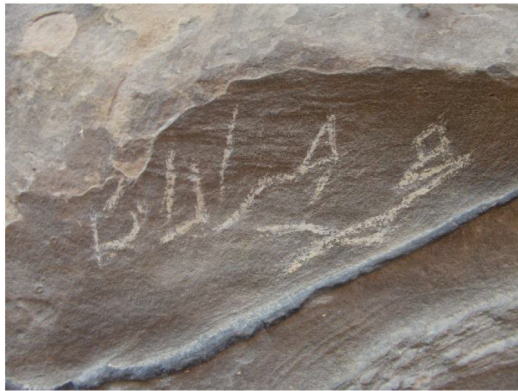
Fig.6: Graffiti in the Siq area (a name of a tourist incised with a sharp tool)

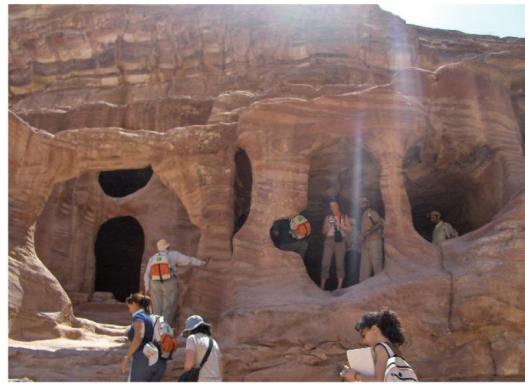
Fig.7 Random climbing and touching by tourists causing sandstone erosion (the area in front of the Theater)

For the problems of random climbing and stepping, littering, graffiti, and touching; the following actions can be taken: informing potential visitors about the disadvantages of their behaviors, conducting awareness programs about appropriate behaviors and respect for site's resources, discouraging or prohibiting use when impact potential is high, involving guides in making tourists aware of

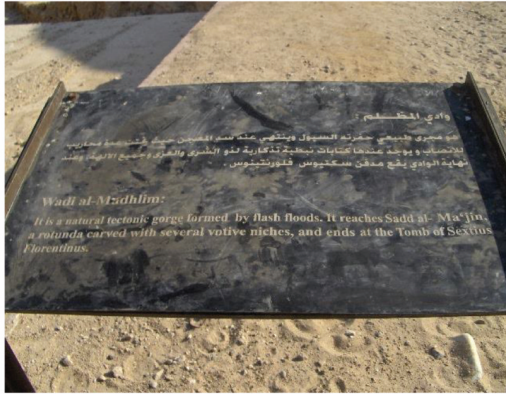
interpretational signs are distributed at the site, for about two decades and till 2011, the signs at the site were giving a brief description for each feature (in Arabic and English), these were metallic and of a black color, with being highly exposed to dust, the clarity of text becomes less. Very few behavioral signs are found at the outer Siq and Treasury areas; these are for prohibiting visitors from climbing cliffs. Unfortunately, these signs are not to be easily seen by tourists since they are small in size, of a pale yellow color, and written in a very small size font. There are also displays at the visitor center; these include only general information about the site, maps of trails, and entrance fees. Just recently, new signage system was installed along the way

Figure 8. One of the old interpretation signs at the site

from the Siq to Qasr al-Bint; the signage gives more information on the cultural significance of the site. Though, the site still lacks behavioral interpretation (Figs. 8, 9).

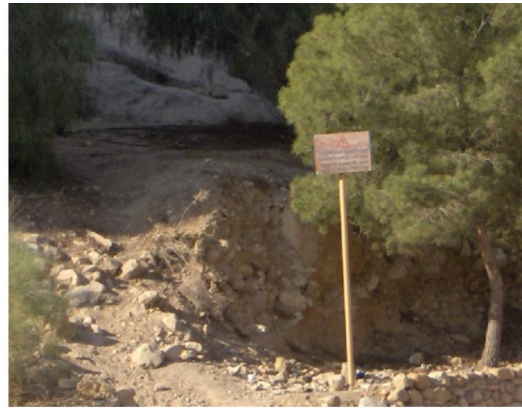
Figure 9. One of the warning signs at the Outer Siq area, it prohibits climbing the cliffs behind

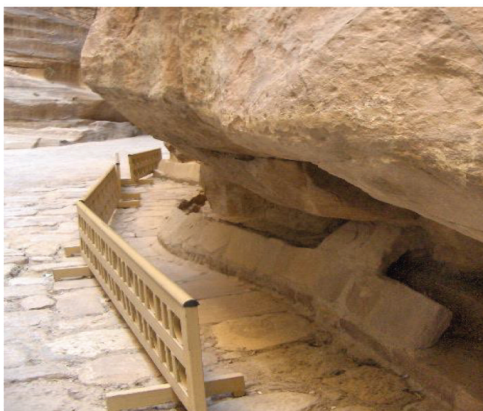
fencing; these include the Treasury, a small section of the water system at the Siq area, and some tombs at the Street of Facades (Figs. 10 & 11).

Figure 10. A fence in the Siq area that was put to protect a portion of the water system (pottery pipe)

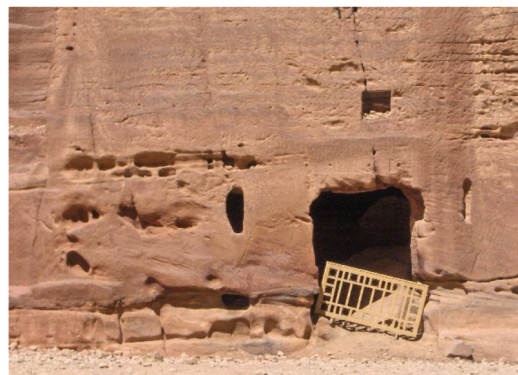
Figure 11. A fence in the Street of facades area that was put to prevent tourists from entering the tomb
