MULTIDISCIPLINARY PROCESS AIMED AT THE DIAGNOSIS AND TREATMENT OF DAMAGES IN STONY CULTURAL HERITAGE: THE BALUSTRADE OF VILLA CERAMI (CATANIA)

Giulia Sanfilippo¹, Erica Aquilia²

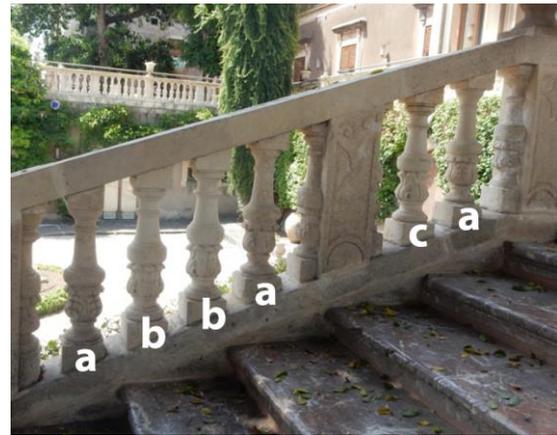
Figure 2. The three balusters typologies, labelled 'a', 'b' and 'c' (from Sanfilippo et al., 2015, modified)

The historical analysis and the study of the stylistic, geometric and proportional balustrade components allowed to define the different formal types existing in the staircase. The balusters were made with tender limestone; they consist of a succession of small columns, alternated by small pilasters decorated with flower motifs and engraved jars. Three different kinds of columns were identified, apparently identical, but showing typical forms and decorations (labelled 'a', 'b' and 'c' in Fig. 2). These three types of balusters are distributed along the stairs without a precise pattern, with only an element ('b') defining a common theme; these columns are located into the apse and they are likely to be remains of the original balusters. The identification of the degraded areas and the related casues have not been performed with traditional survey methods, because of the complexity of the eroded surface. A thorough understanding of the three-dimensional features of these elements were further complicated by the disgregating action of pathogens, which gradually transformed some of the balustrades into shapes not attributable to any Euclidean geometrical figure. For this reason, the geometric study was performed by means of a 3D laser scanner, which provided the volumetric data on the amount of degradation (Sanfilippo et al., 2015).

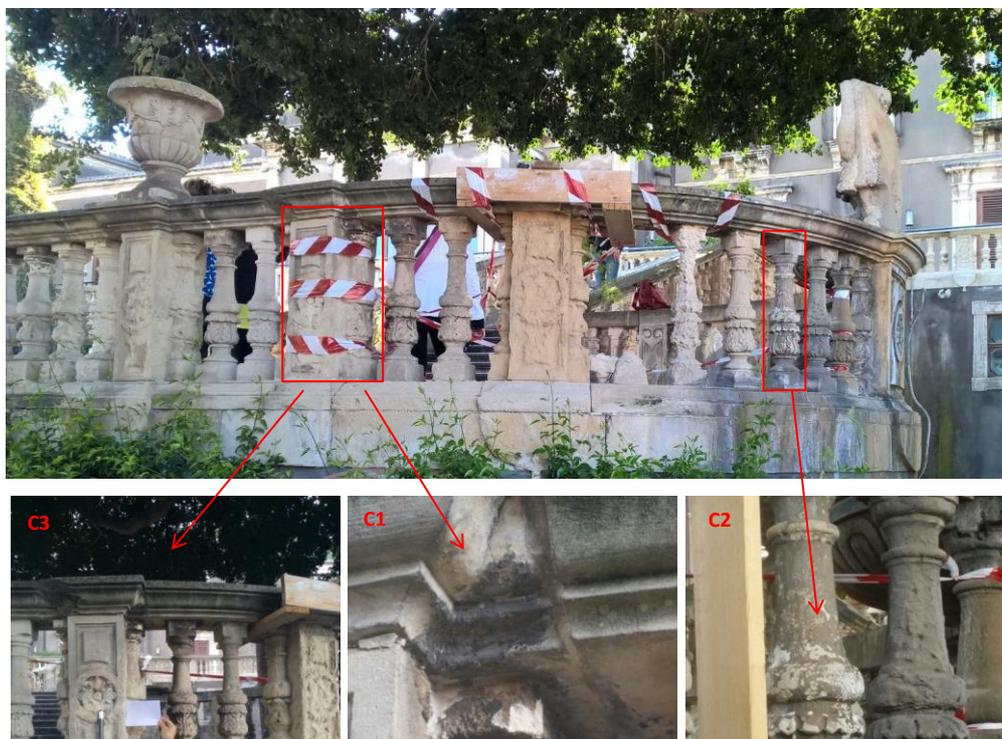
Figure 4. Black crusts sampling points.

iting a high degree of damage and extended exfoliation phenomena. Overall, the sampled damaged layers can be divided in two types, from which three samples were extracted (Fig. 4) as follows:

- samples C1 and C3 from the lateral portion of balustrade (sensitive to touch, about 1mm thick);
- sample C2 from below the tree (more tenacious to the touch, about 3 mm thick).

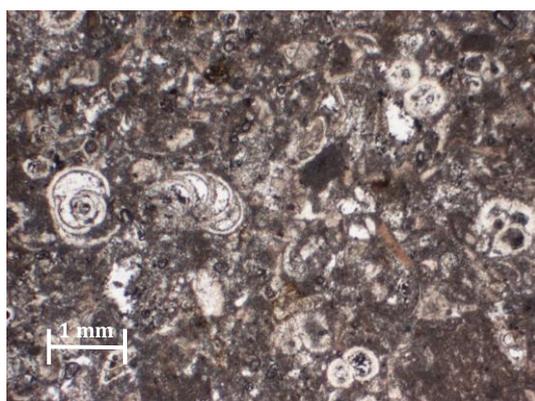
Figure 5. Photomicrograph (plane polars light; 10x) representative of the Noto Stone samples.

show a mud-supported texture, with about 70% mud. Allochemical components consist of various small bioclasts, including echinoids, foraminifera, bryozoa and plankton, extensively reworked by tubeworms represented by skolithos (Fig. 5). Sample porosity is about 30%. Pores are regular or irregular and show various sizes, ranging between 0.08 and 1.6 mm. According to these textural features, the stone can be classified as biomicrite (Folk RL., 1959), wackestone (Dunham RJ, 1962, p. 108-21), and calcarenite limestone, belonging to the Palazzolo Formation (Pietra di Noto, yellowish variety; Anania et al., 2012).

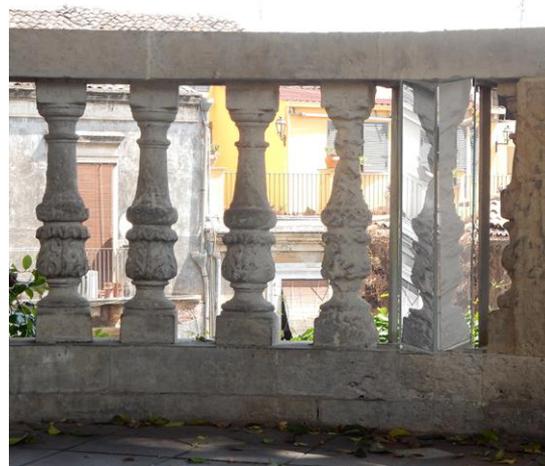
Figure 10. Mirror plates, virtually reconstructing the aspect of the balustrades.

Finally, as an alternative further hypothesis, a virtual reconstruction of the missing balustrade could also be considered. In order to do this, two mirror-finished structural slabs could be inserted instead of the lack, with the aim to have a dual function: i) to structurally support the handrail above; ii) to visually reassemble the missing element. In fact, the mirror plates, if arranged at a specific angle, would virtually reconstruct the aspect of the balustrades alongside (Fig. 10 and Table 7).

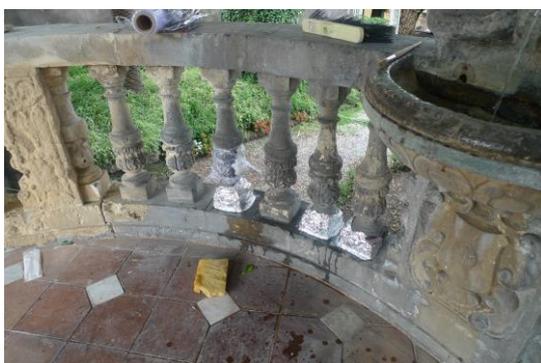
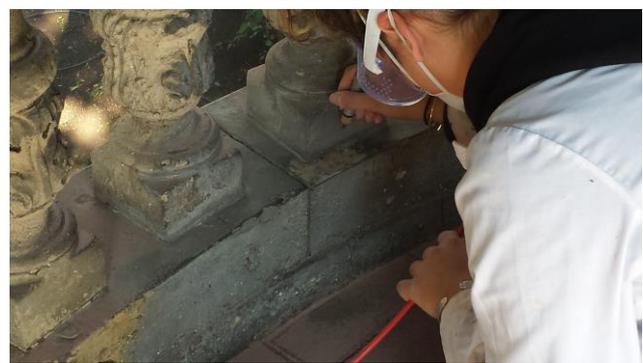
Figure 11. Cleaning operation with wrap and micro-blasting.

In the first step, a general cleaning with water spray was carried out; biocide brushes were also applied to the parts affected by biological patina. On the balustrades compromised by black crusts, a compress made of paper pulp and a solution consisting of demineralized water, EDTA, ammonium bicarbonate and sodium bicarbonate was tested on a selected test site (Fig. 11). The solution was tested at several concentrations and in different time steps, i.e., each solution was applied for 1, 2, 4 and 6 hours. However, the wrap did not allow to remove the incrustations.

According to the SEM analyses, the thickness of the crust is about 2 mm and consists of recrystallised calcite associated with a homogeneous matrix formed by Na and Ca sulphates, highly resistant to detachment. For this reason, we opted for a varia-

ble-pressure micro-blasting with 2-4 atm, at the basis of the crust (Fig. 11). The employed abrasive product was GARNET 200 MESH, having a hardness lower than that of the predominant lithotype (Gasparoli et al, 2002) but slightly higher than the black crust.

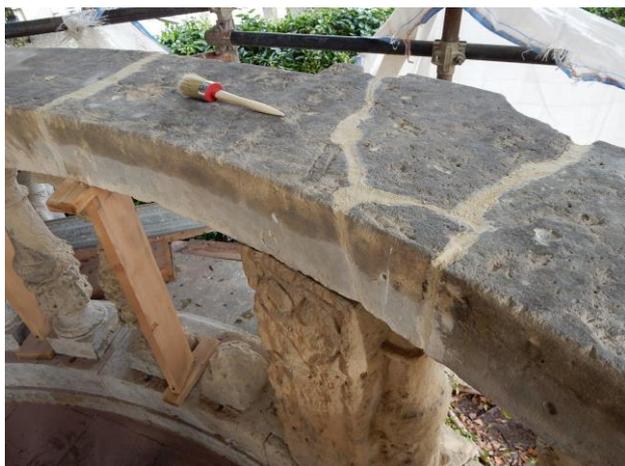
Figure 12. Treatment with micro steel bars and fillings.

However, as described before, the surface layer had been severely compromised by the effect of the black crusts. Consequently, some balustrades lost cohesion not only superficially, but also due to alveolization (with loss of a large amount of material). By excluding the hypothesis of replacing the degraded columns with new ones, it was necessary to intervene with fillings, in order to replenish those cavities excavated by the deterioration agents. The mortar used for the partial reconfiguration of the stone surfaces was made of natural marble powders, (60% aggregate), with a binder made of white caolins and limestones mixed with baking powders with white

The porosimetric analyses show that the stone does not show substantial changes, if compared to its original condition. Therefore, it was sufficient to intervene with cyclical applications of ethyl silicate by means of a brush, until reaching the healthy nucleus.

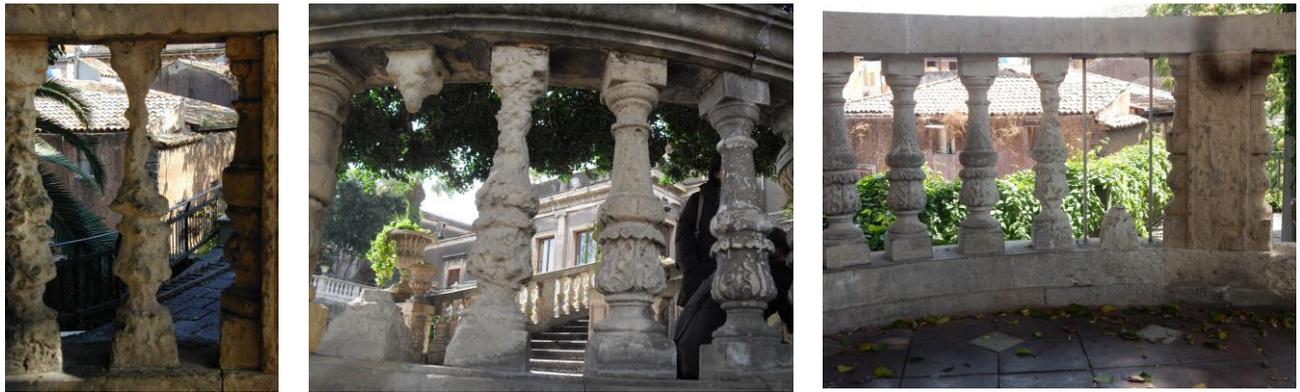
Figure 13. Three stages of decay: on the left photo of 2001; in the centre, the baluster without spindle (February 2015) and on the right, a minimal intervention was chosen, inserting sheets of stainless steel supporting the handrail.
