LASER INDUCED BREAKDOWN SPECTROSCOPY AND OTHER ANALYTICAL TECHNIQUES APPLIED ON CONSTRUCTION MATERIALS AT KOM EL-DIKKA, ALEXANDRIA, EGYPT

Sayed Hemeda

Conservation Department, Faculty of Archaeology, Cairo University, Egypt

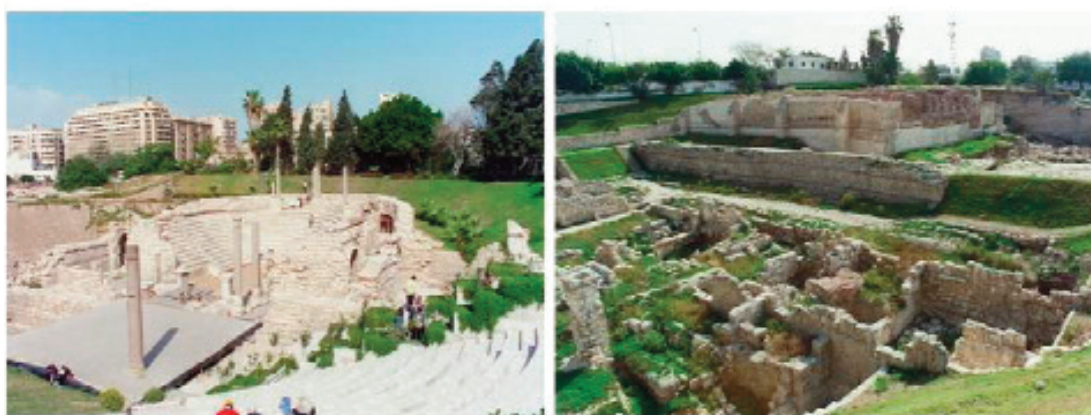
Figure.1. General Overview of Kom El-Dikka archaeological site, the remains of the site is consisted of foundations and of low height brick and stone masonries by which the houses and Baths are circumscribed.

been roofed over to serve as an Odeon for musical performances. Inscriptions suggest that it was sometimes also used for wrestling contests. The theatre stood with thirteen semi-circular tiers of white marble that was imported from Europe. Its columns are of green marble imported from Asia Minor, and red granite imported from Aswan. The wings on either side of the stage are decorated with geometric mosaic paving. The dusty walls of the trenches, from digging in the northeast side of the Odeon, are layered with extraordinary amounts of potsherds. Going down out of the Kom, you can see the arches and walls, the brick of the Roman baths, and the remains of Roman houses, (Figure 1).

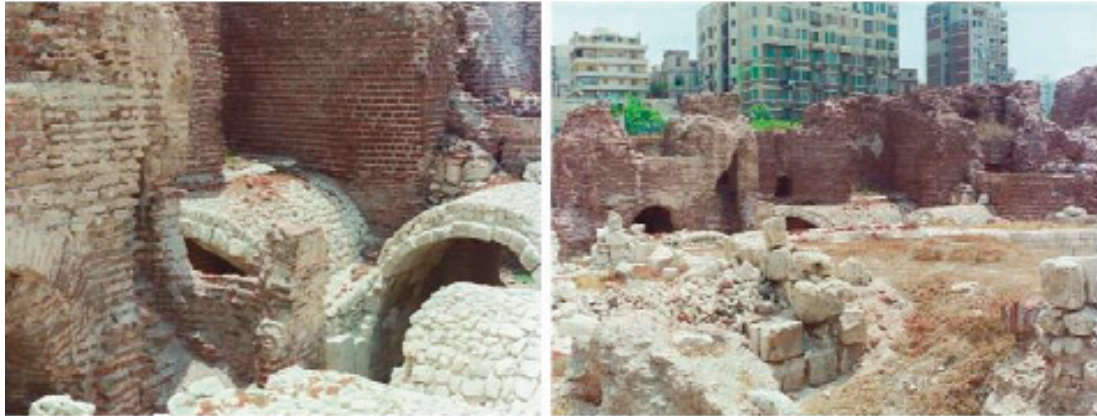
Figure.2. The structural damage of the remains and masonries is obvious.

The field study includes sampling from the parts presenting sound forms and weathering forms, measuring rates of each weathering form (for example, depth from stone surface, width ...etc.) to quantitatively define its damage category. Thirty limestone samples, twenty mortars samples, and seven brick samples were extracted and taken from the foundations

and walls structures as shown in figure (2).

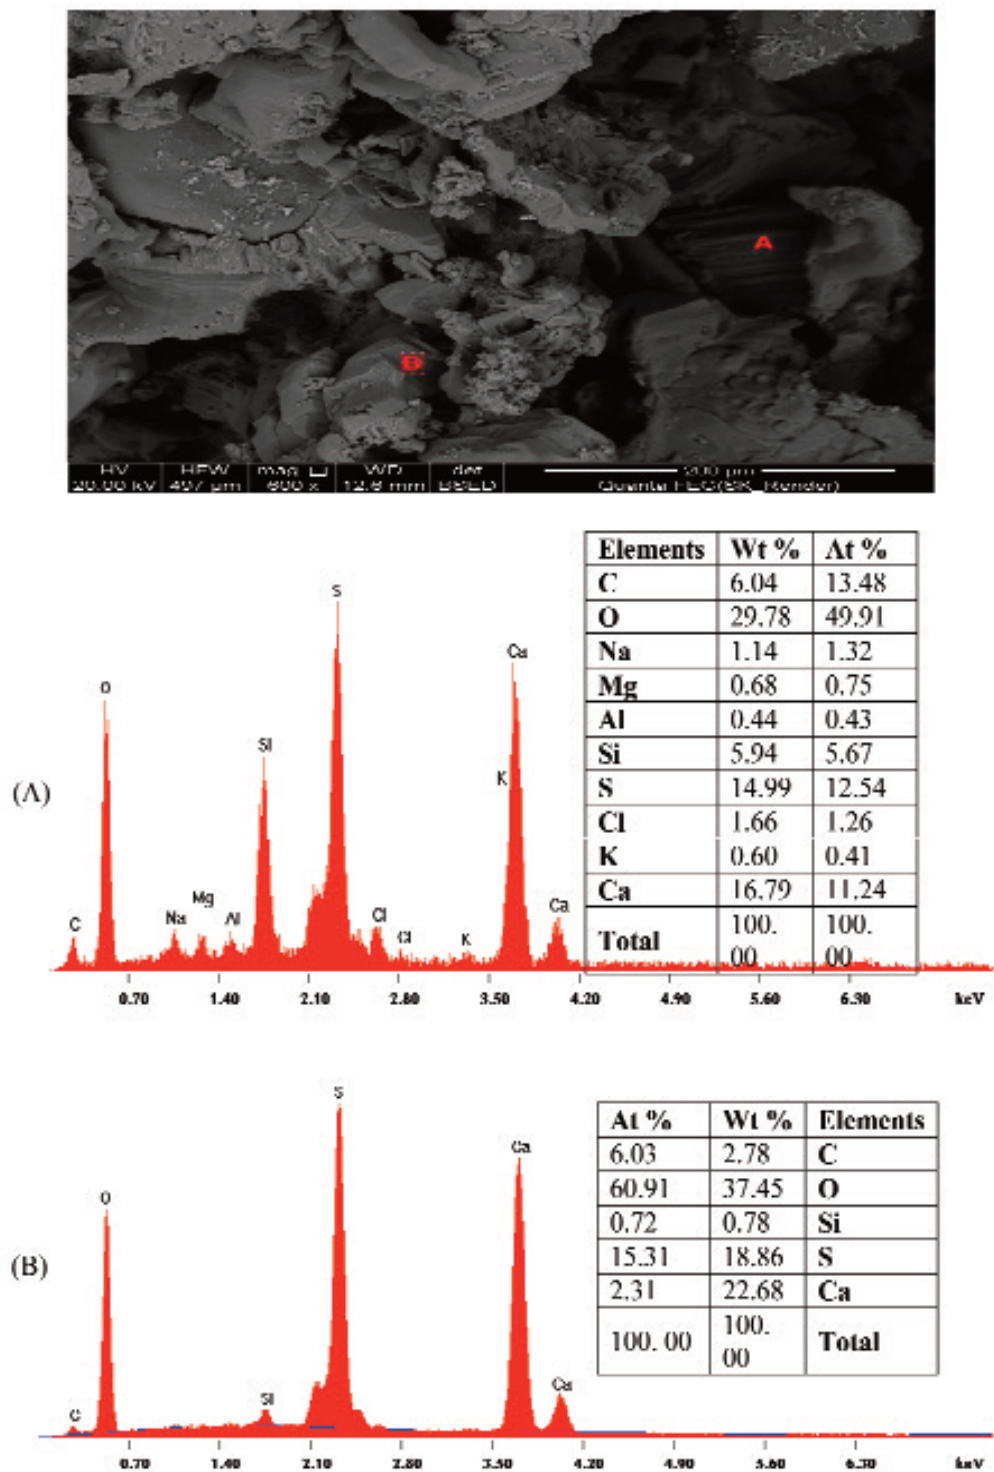
Figure.6. SEM micro structure image with EDX micro analysis spectra for renders and plaster layers.

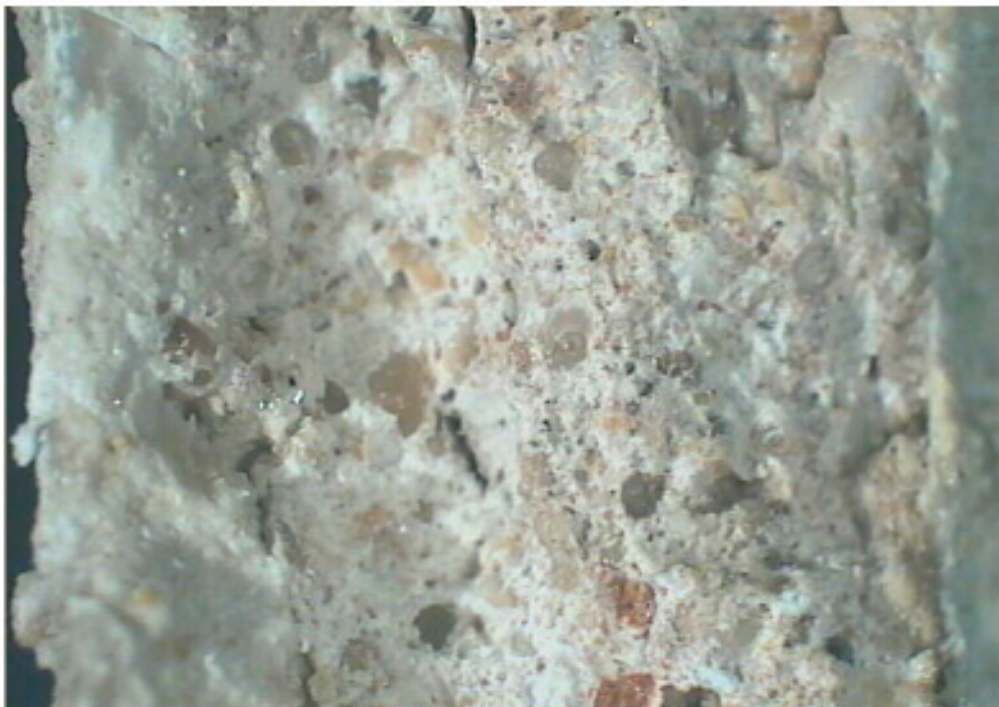
Figure 8. Well-compacted structural mortar with shrinkage cracks.

layers (Figures 7, 8). The thickness of renderings ranges from 6 to 7 cm. In the mortar layers of the external coverings of the corpus of the stone and brick masonry that were in contact with draining channels, a reactive soil acting as pozzolanic material seems to have been used. The analysis shows that the insoluble residue of their composition as well as the content in SiO_2 , Al_2O_3 and Fe_2O_3 are relatively high. These mortars with pozzolanic material are dense in structure and it seems that they were purposely manufactured to resist moisture.

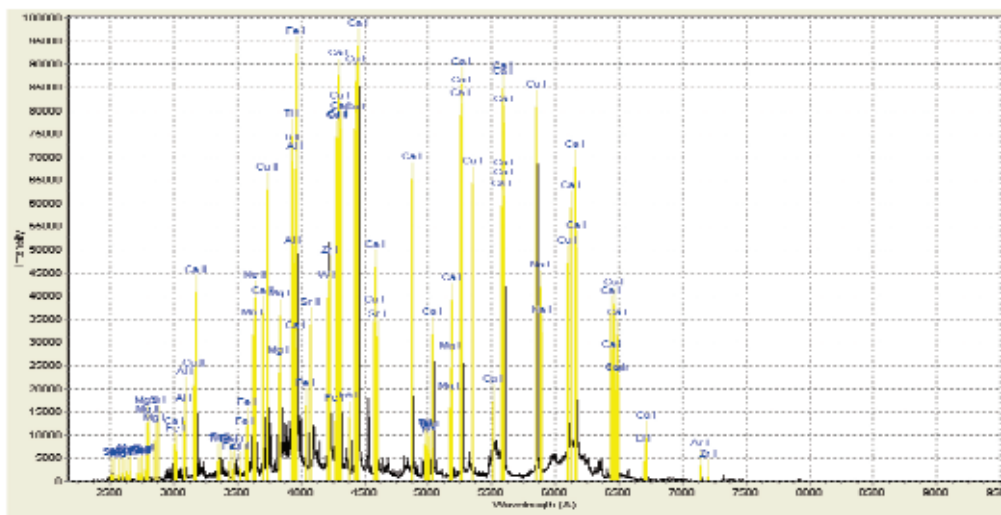
Figure.10 . LIBS spectrum for a sample spot on oolitic limestone.
