# CHARACTERIZATION OF MATERIALS USED IN THE QUART TOWERS (VALENCIA, SPAIN) PRIOR TO RESTORATION

Quart Towers are one of the remaining gates in the medieval wall of the city of Valencia (Spain). They were built in the 15th century and have recently been cleaned and consolidated. Prior to this work, a multidisciplinary team conducted a physicochemical study to diagnose the state and composition of different materials. Stone, mortar, patinas, salts etc., have been analyzed as well as their state of deterioration. Remains of previous interventions have been found in mortars of restitution and application of consolidants that have caused damaging salts. The methodology used is optical microscopy, X-ray diffraction and scanning electron microscopy with X-ray microanalysis. The results have been used together with documentary data to identify the components of the materials in order to, if possible, compatibility the material in the damaged areas and to determine the most appropriate techniques and procedures for applying cleaning systems, enabling consolidation and protection of the building without altering the unique characteristics of the original building typology.

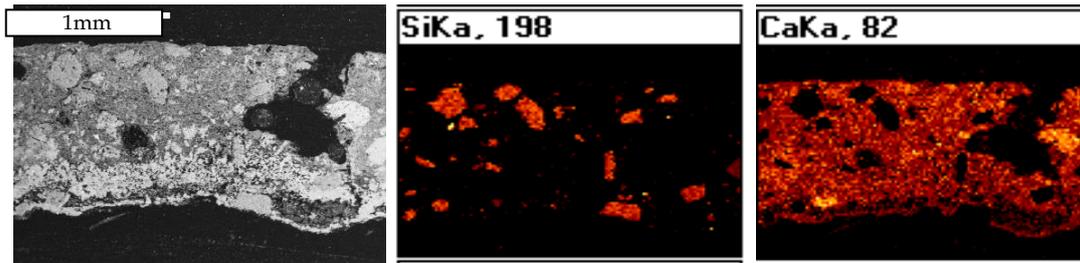
Figure 10 Original exterior rendering on the towers. Microphotography at 50X. Mapping of Si and Ca.

The results confirm that the original cladding for the towers was lime mortar with silica aggregate (Fig. 10). The exterior restitution mortar is also a lime mortar with two types of air lime, dolomitic and calcitic. EDX microanalysis also confirms the presence of S, Al, Cl, Na, Mg and K.

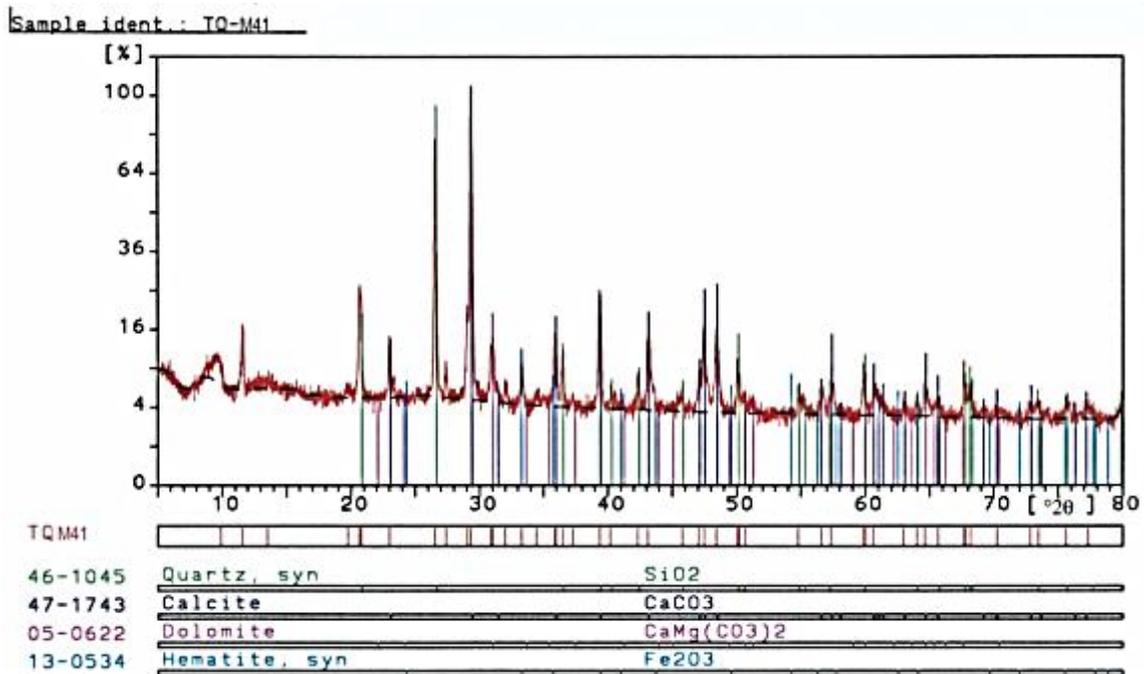
Figure 11 XRD of the restitution mortar.

XRD in this mortar coloured with natural earth pigments with aluminium silicates and iron oxides (Fig. 11). Cl and Na are also present in other areas corresponding to sea spray as Valencia is on the Mediterranean coast.

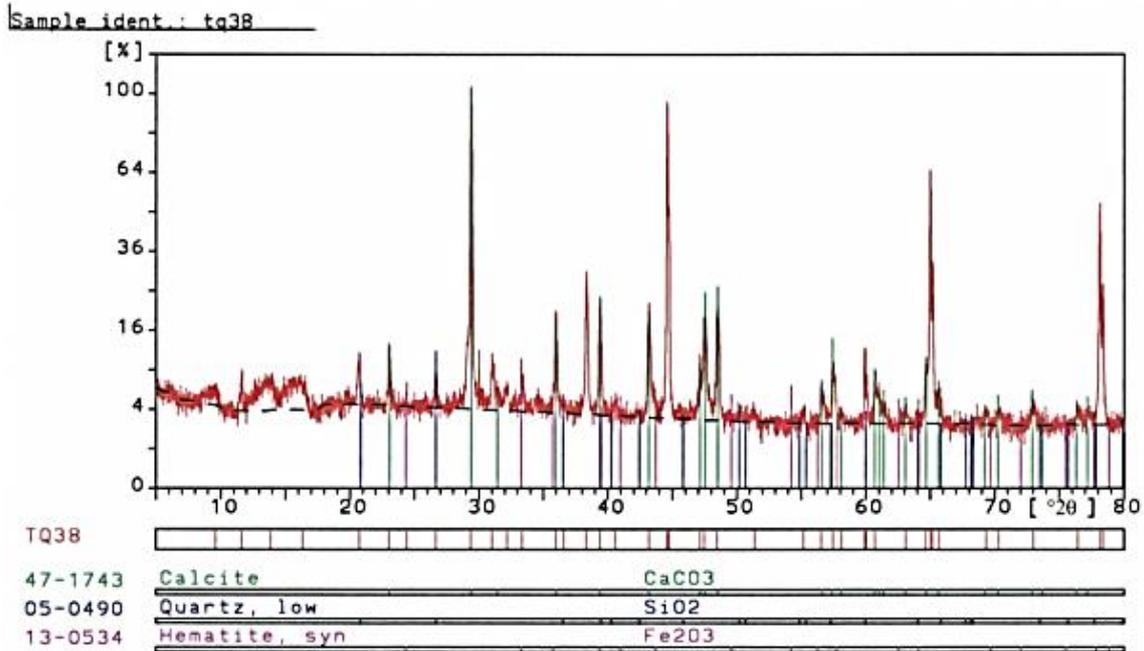
Figure 12 XRD mortar next to stone.

The stone is limestone and analysis of the mortar used in the joints of the stone and the central battlemented passage (Fig. 14) shows a lime mortar with silica and coloured on the surface with natural earth pigments (Fig. 12). The patina on the stone also has the same composition.

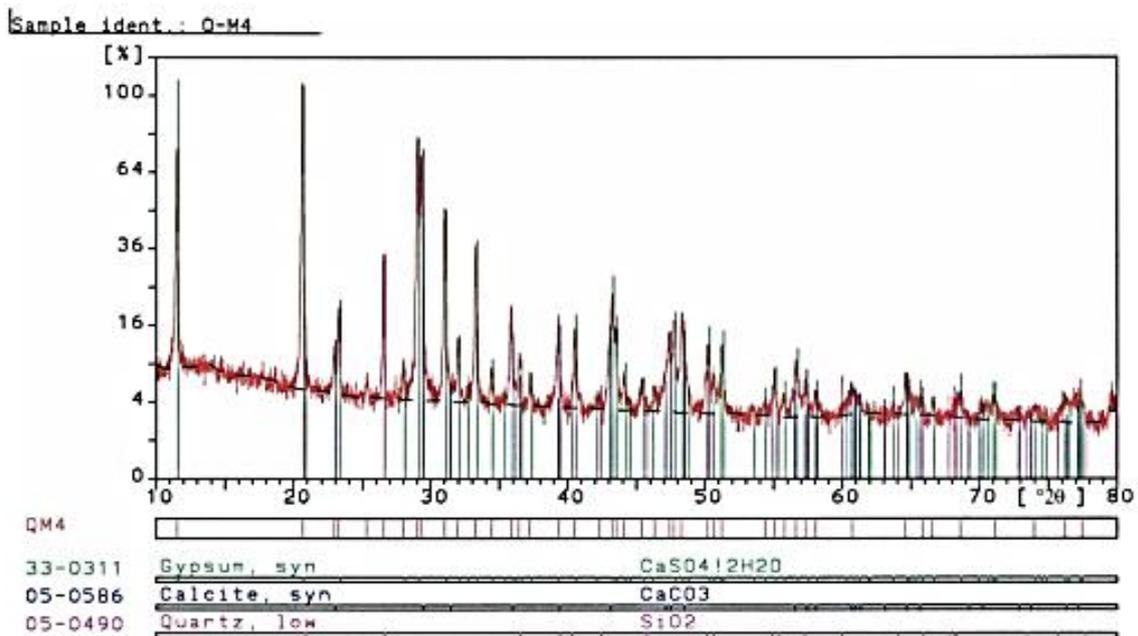
Figure 13 XRD cladding mortar.

The cladding is plaster with lime paint on the outside. Fig. 16 shows the elemental analysis and XRD sample of the compounds present (Fig. 13).

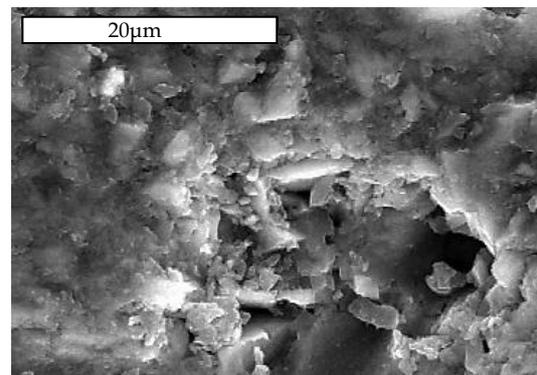
Figure 18 Microphotograph obtained at 3000X.

In the deposit of dirt on different materials, (stone, mortars, etc) plaster neo-formation deposits have been observed. The black colouration is due to the presence of carbonaceous products of pollution like soot, dust among others. The results are presented for the masonry work on the battlemented passage in microphotographs at different magnifications and mapping of the distribution of elements in the sample (Fig. 17 and Fig. 18.).

The stone is limestone with a reddish patina over some of the stone surfaces. The stone has black deposits which are calcium sulphate crusts (newly formed plaster) and the average thickness of the layer is 1 mm, caused by reaction of the stone substrate with pollutants present in the atmosphere (heavy urban traffic in the surrounding area). The black colour is due to the presence of carbonaceous products of pollution like soot and dust. The filler material for the joints between stones is calcium mortar with a reddish colour on the surface and the pigments found are natural earths. Part of the salts, affecting the external sides of the building, correspond to sea spray.

The in situ study of the construction materials, their state and the modifications they have undergone and the analytical results permit certain recommendations on the appropriate cleaning, consolidation and protection treatments. Limestone in general has acceptable compactness and therefore plaster crust neof ormation can be eliminated without damaging the stone by a controlled solid microprojection system that will respect the natural and artificial patinas present on the stone. This waterless system also enables the removal of biodeterioration process symptoms (bird droppings, moss, lichens, etc..) and saline deposits.
